**Hydrologic Reconnaissance for Stream Stability
And Sediment Consequences
Morris Creek, West Virginia**

6/1/05

Prepared by:
Ryan Gaujot
Geologist
Canaan Valley Institute

In Partnership with:
Morris Creek Watershed Association

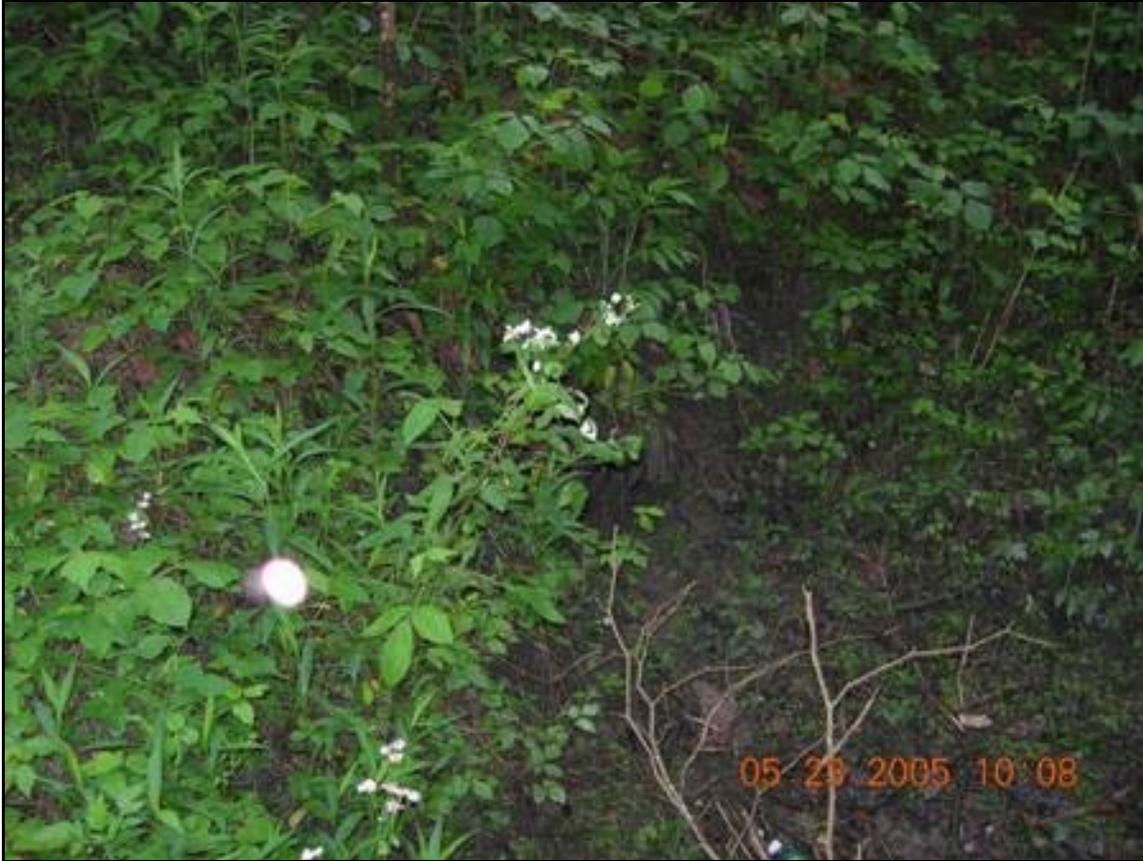
MC#1

This location is near the mouth of Gibson Hollow. Near the tributary confluence, a small pond impounds water from flowing to the mainstem of Morris Creek.

Restoration goals would include better sediment transport and hydrologic connectivity. This could be accomplished through channel relocations and better channel crossings that work for the frequent bankfull flow. The impoundment is approximately 80 x 30 ft.

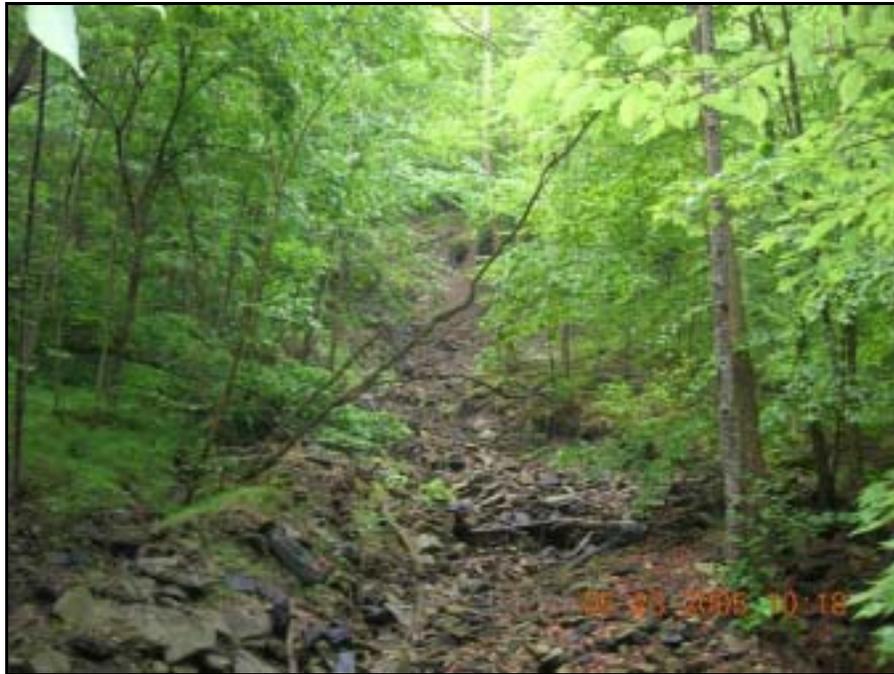
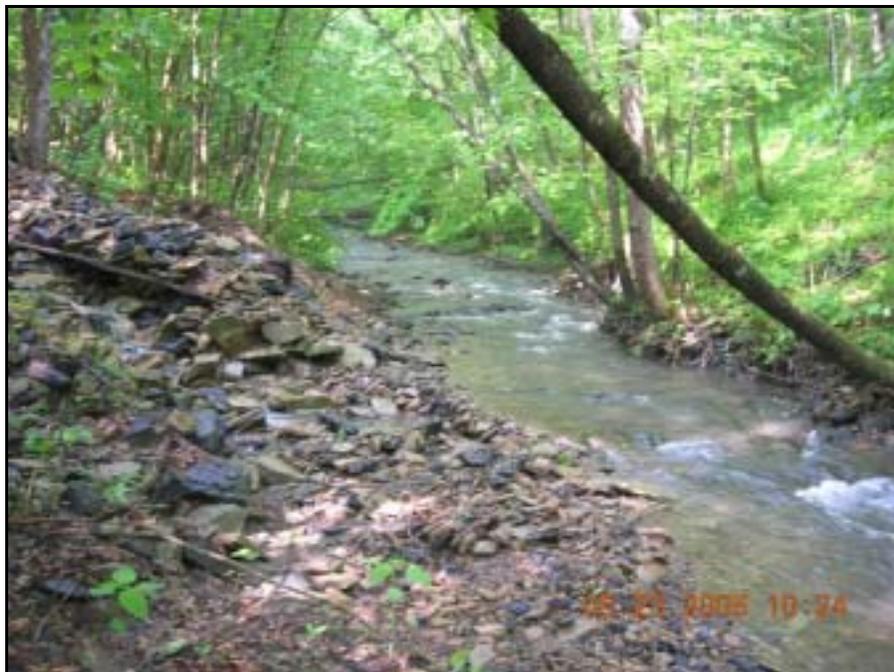
Jones Hollow

This location is estimated to be one the main sediment contributing problems in the basin. Channel realignment, well above the top of the slip, has caused accelerated erosion and mass wasting of bedrock and coal refuse creating a modified drainage network. Restoration would include reestablishing the flow of water and sediment into the 'old' existing channel above the slip to the west (out of photo). A significant 'plug' would need to be built in order to keep flow from reentering the slip seen below.

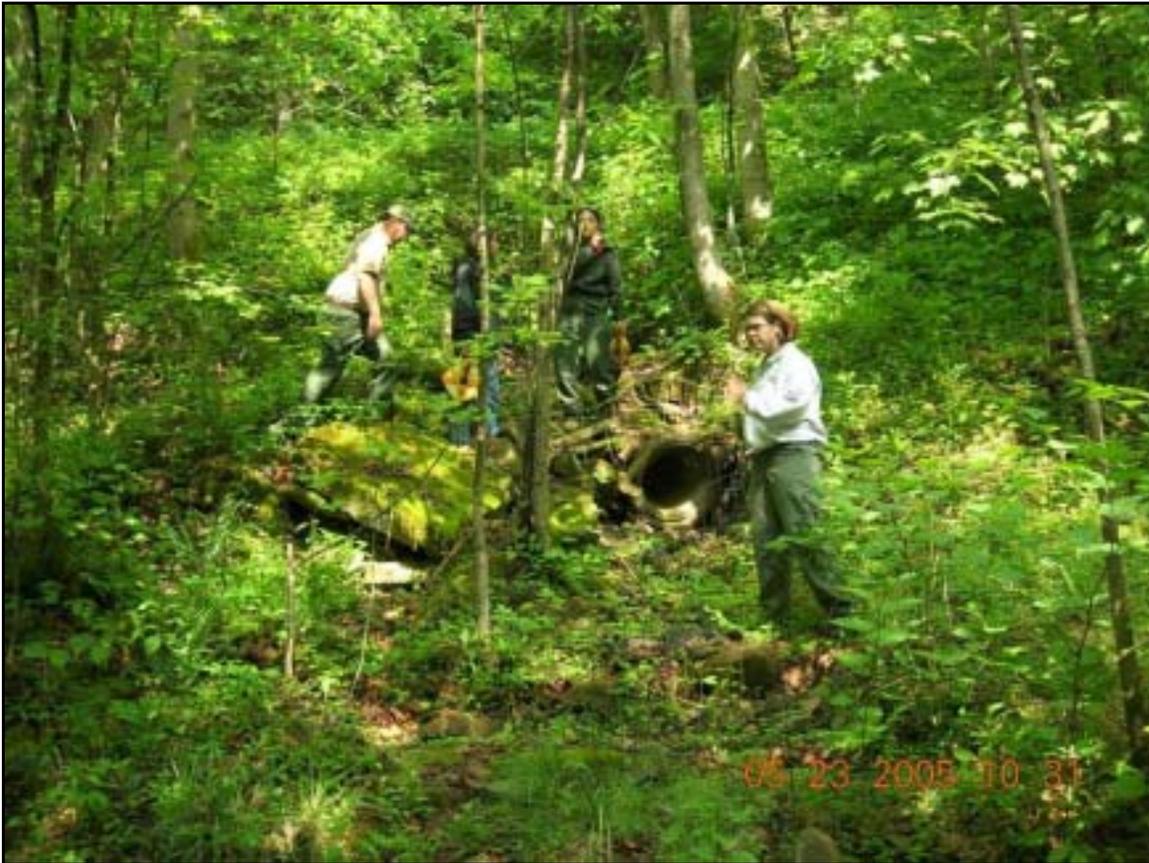
MC#2b

A dry, eroded culvert was observed just below Jones Hollow slip at river left.

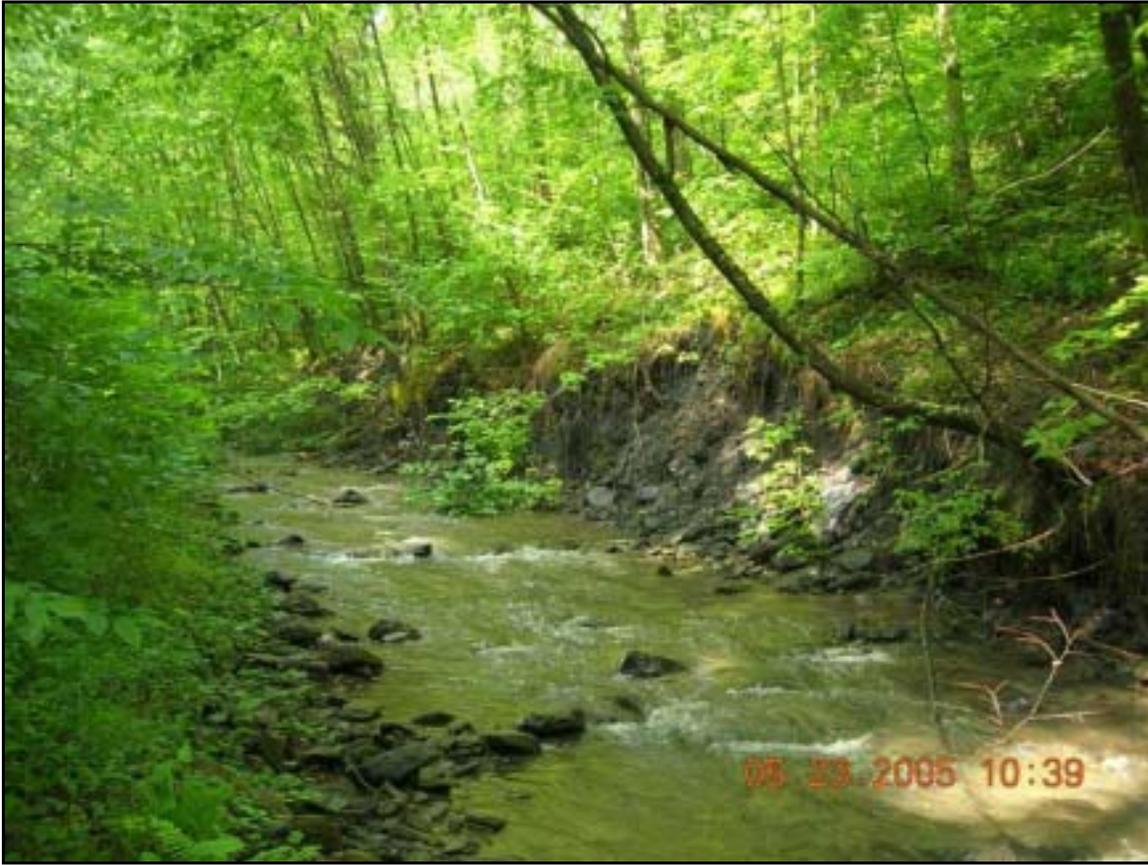
MC#3

Streambank erosion (107 ft) of low priority was observed at river left below a dry culvert. The eroded bank looks like refuse and road fill. There is an excellent floodplain at river right. One or two j-hook structures with a bankfull bench at river left could enhance the stability of the reach.

At 2X's maximum bankfull depth (in a riffle), the stream is still contained within an incised channel. The floodprone area is small (<30ft) resulting in an entrenchment ratio (ER) of 1.5 – 2.0. When entrenchment ratio decreases, stream stability dramatically decreases especially during a big flood. Thus, Morris Creek is an entrenched B channel, with unstable reaches that are G and F channels. The stable form of a G channel is a B.

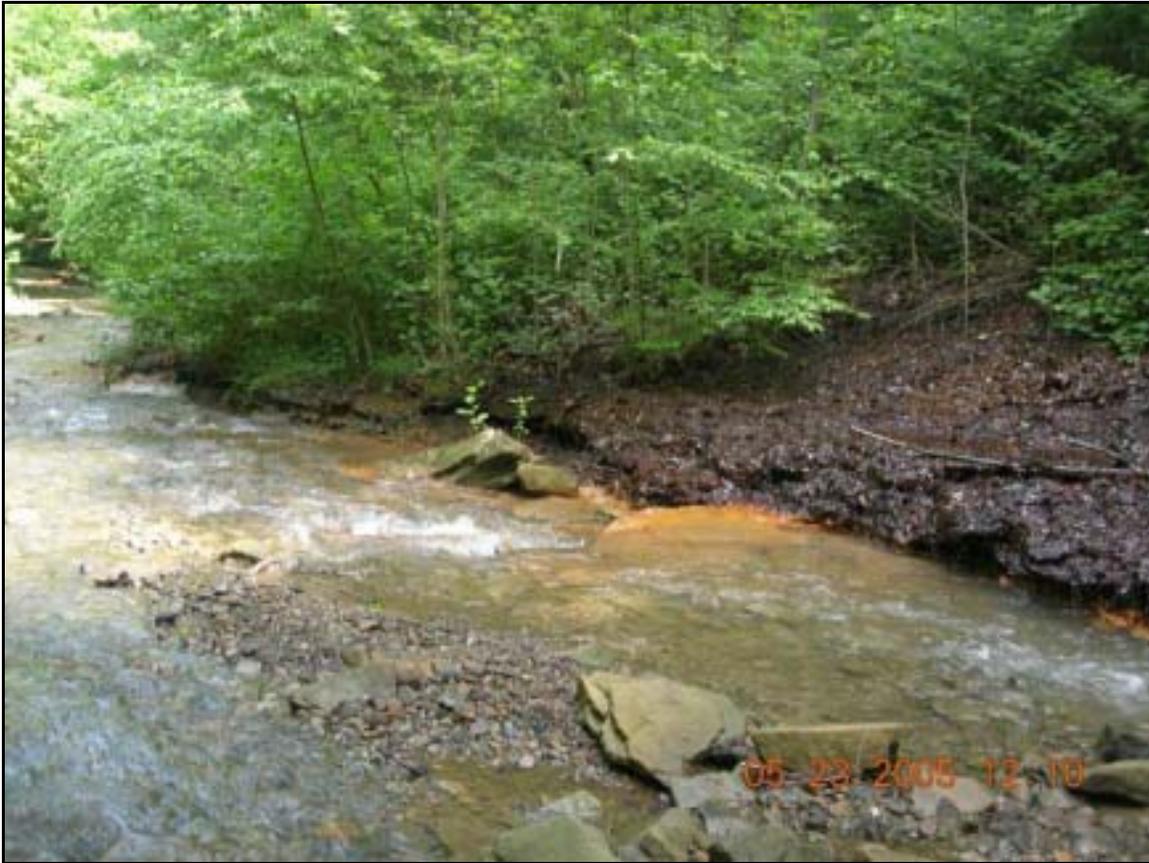
At this location an apparent change in W/D for the mainstem due to the development a long central bar. A culvert bridge impounds the bankfull flow and facilitates aggradation in the upstream reach. This sections measures 300 feet of instability due to a bridge grade control in slope and flood-prone width. Restoration could include channel realignment using two structures and retrofit two 'squashed' bankfull culverts at the bridge.

MC#4	Aggradation, pattern and slope problems due to bridge grade control on stream pattern and slope	300	Channel realignment, 4 structures, bankfull bench, bridge retrofit	moderate	\$80	\$24,000
MC#5	Aggradation, pattern, slope, and vegetation problems	76	Channel realignment, 3 structures, bankfull bench, increase floodprone width	low	\$40	\$3,040
MC#6	Aggradation, channel migration, and stream bank erosion	93	Reestablish W/D ration needed to acquire velocities that can transport the sediment load. Channel realignment, 2-3 structures.	low	\$50	\$4,650
MC#7	Landslide	40	Pull back escarpment of the landslide from above	low	\$40	\$1,600
MC#8	Confined channel with streambank erosion. Entrenchment ratio is < 1.5	146	Realign channel pattern, increase floodprone width, use structures to maintain W/D important for transporting and dissipating flood effects at bankfull stage or above.	high	\$70	\$10,220

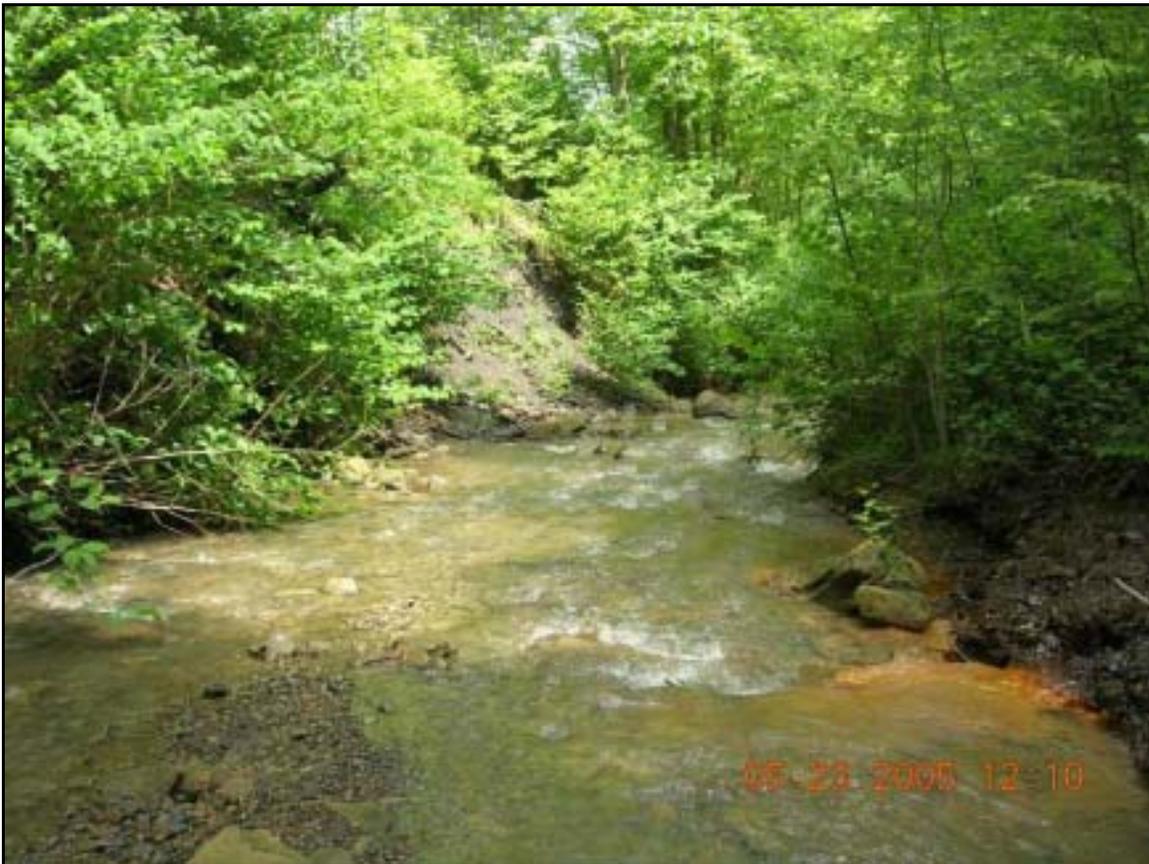
MC#5

At this location, a meander-chute-cut-off has resulted due to aggradation and central bar deposition. This aggradation has also influenced the erosion of the left bank. Within this reach, the stream wants to build in some pattern (sinuosity). Restoration could include channel pattern reshaping, 1- 3 structures with a floodplain bench and vegetation plan. Riparian vegetation is low through this section. The total length of instability is 76 ft.

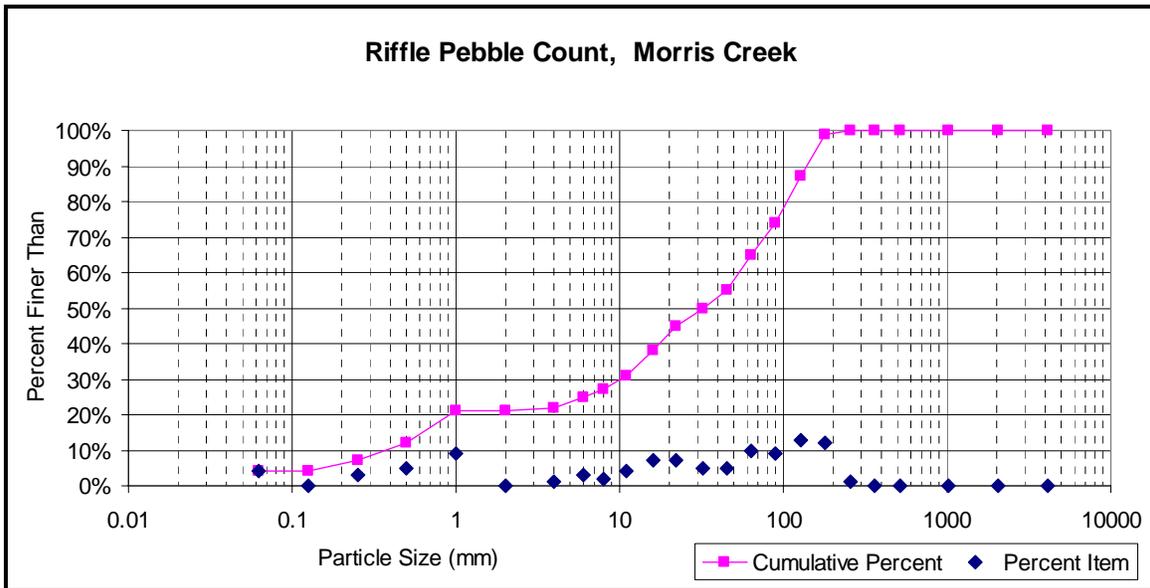
Figure 2: A riffle pebble count for Morris Creek just above the Waterfall.

Figure 2 illustrates a Riffle Pebble 100 Count for Morris Creek showing the D50 as 30mm (course gravel) particle size. Particle size from this pebble count is underestimated due to sampling more 'bankfull' particles skewing the distribution to include more sand and silt. Future pebble counts need to be accomplished upstream and downstream of this pebble count location for velocity and sediment entrainment calculations.

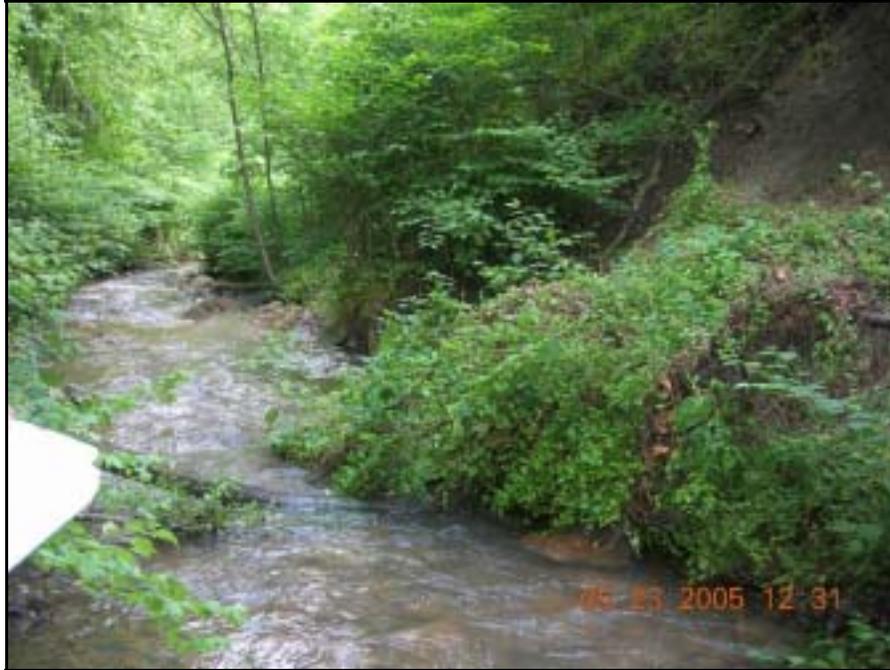
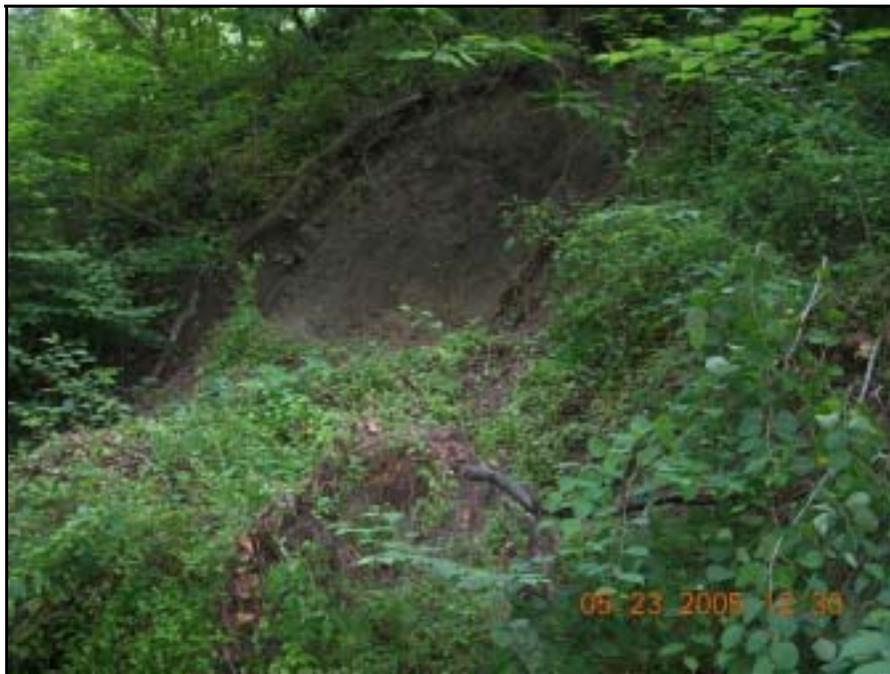
MC#7

At this location, a landslide slip has occurred at river right. The total length of the site is 40 ft. The top of the slip could be pulled back and hydro seeded. There is a 'natural' log-vein just above the slip (keep in place for restoration).

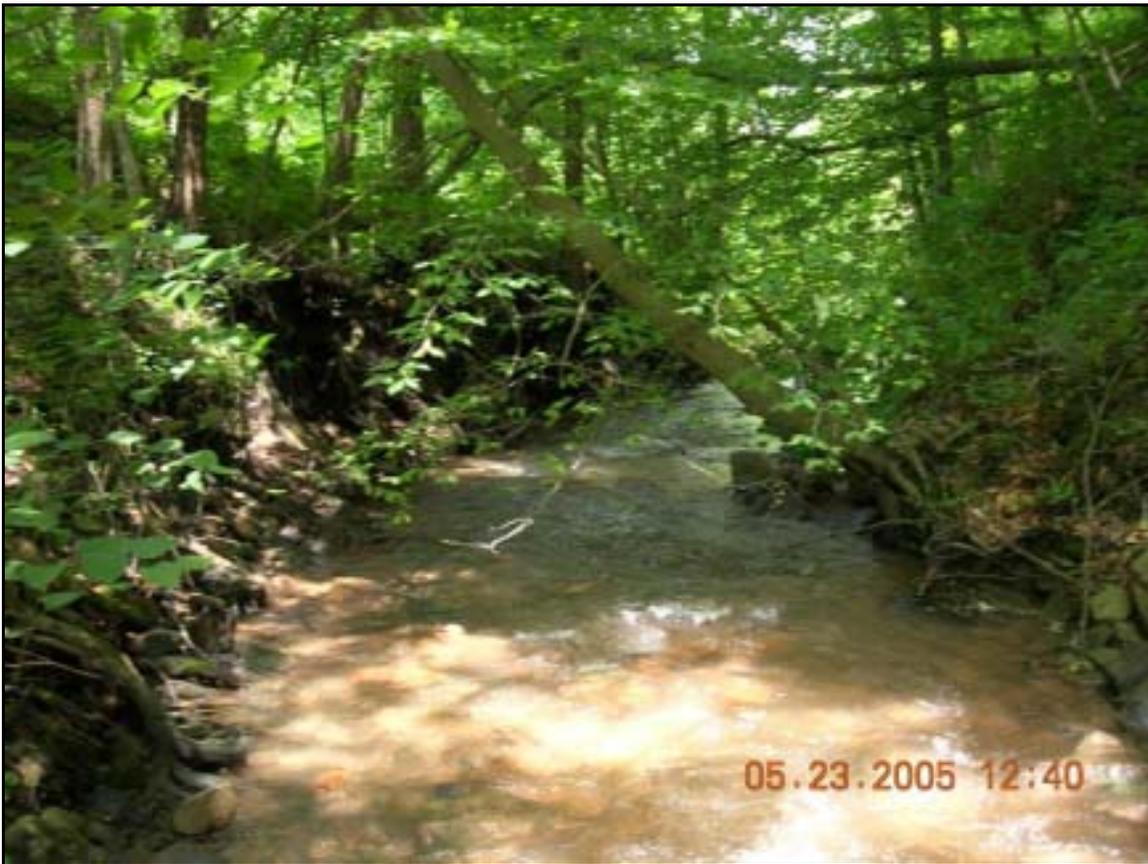
MC#8

This would be a high priority restoration location just above the AMD Lower Mainstem site. Stream bank erosion for 146 ft at river left leads into a small landslide at river right. This erosion and mass wasting is due to channel confinement to an unstable G stream-type with a low floodprone width (<30ft). During a big flood, shear stress would be very high through this reach. Restoration could include channel pattern realignment, 2 -3 structures, a bankfull bench, and a vegetated terrace. A terrace could be built just below 2x's maximum bankfull depth to reduce stream velocity during very large flood events. The excellent vegetation in the reach should be included as materials in the final restoration designs to help keep restoration costs low.

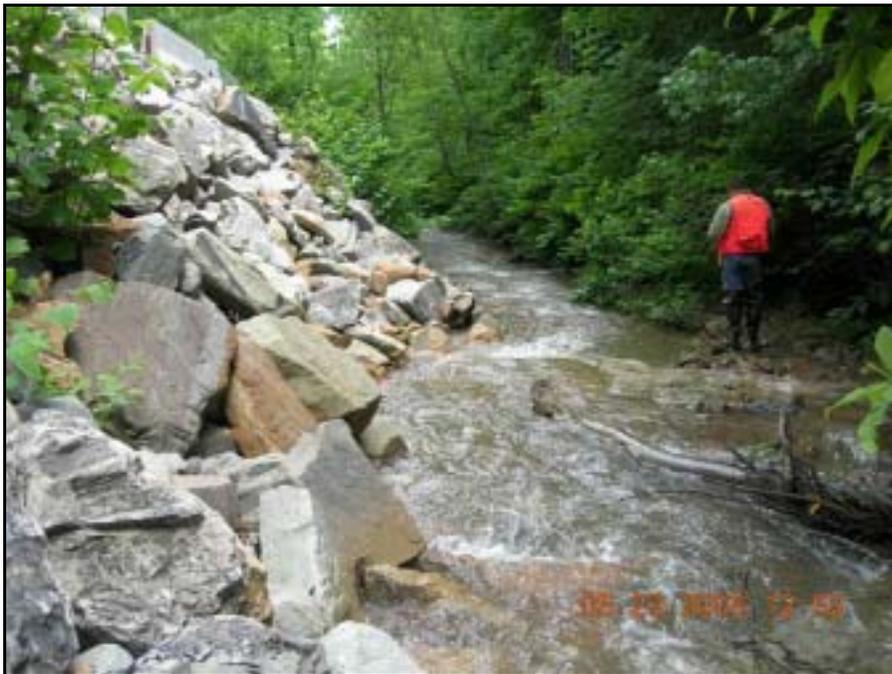
Just below MC#8 there is a riprap road section for ~200 ft at river left. This could be linked to the upstream erosion, or a tight, nick point in the stream valley.

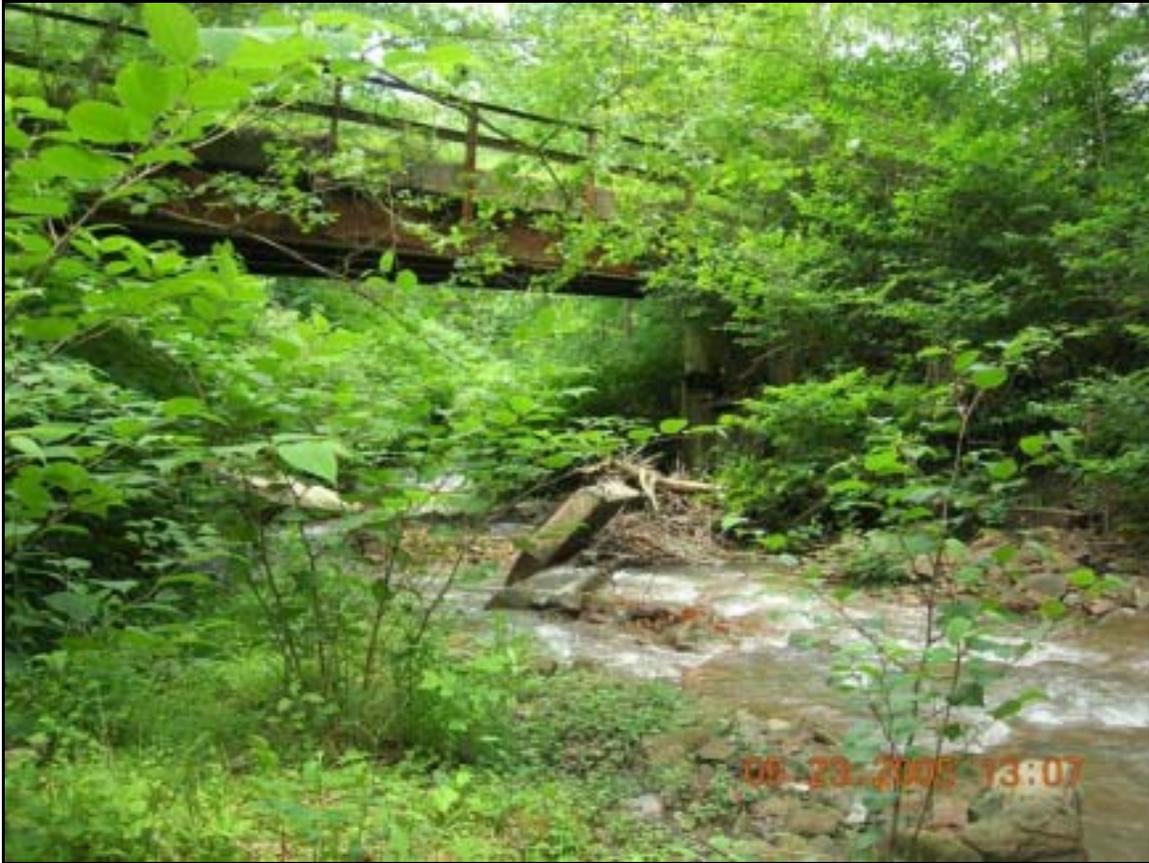
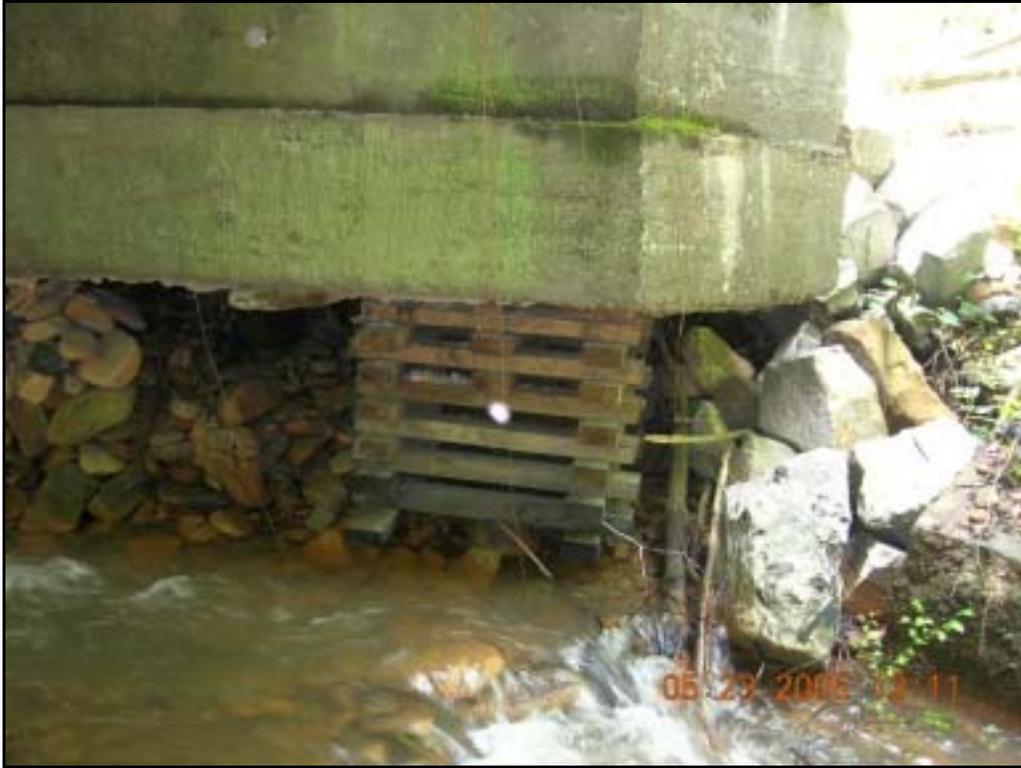
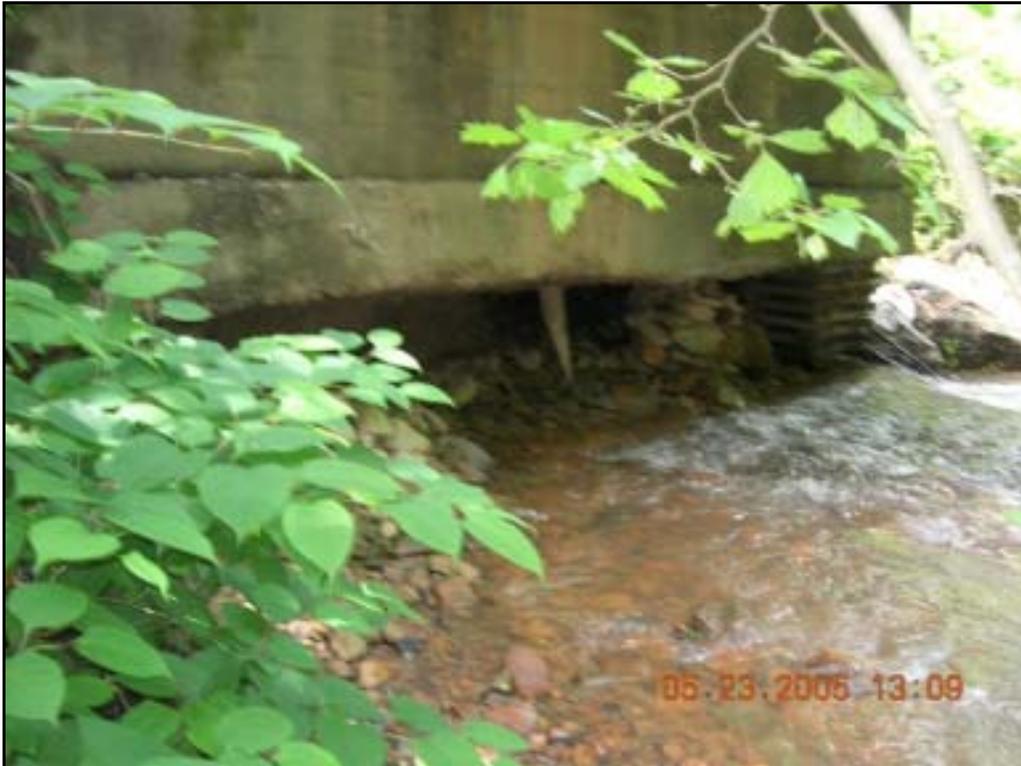
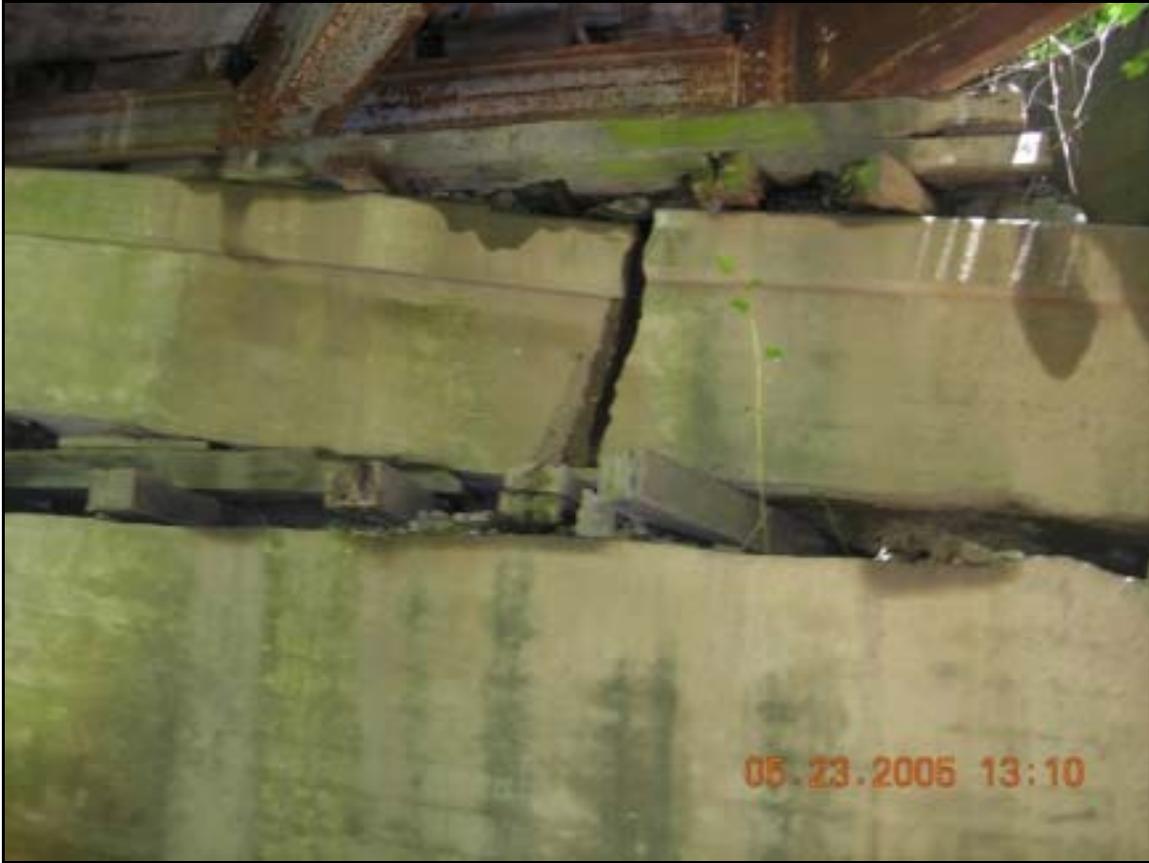
Bridge near Morris Creek Gate

At this bridge location there is erosion on both wing walls through the bridge. The bridge confines the floodprone area creating an unstable F stream type ($W_{bf} = 30$, $W_{fpa} = 40$). The W/D ratio in this area is 14. Restoration would include channel realignment; structures maintain W/D and dissipate energy near the bridge and route sediment through the bridge at bankfull flows and during large floods.

Bridge Near Morris Creek Gate	Poor eroded condition, Cannot dissipate energy above bankfull flows.	150	Replace bridge with appropriate design to transport sediment and dissipate flood effects	moderate	\$100	\$15,000
MC#9	Landslide and residential encroachment confines channel and decreases Entrenchment ratio (ER) increasing velocity and shear stress through the reach.	55	Work with landowner to provide to increase floodprone width. Use several structures (4) to build a stable B channel with correct W/D ratio.	moderate	\$100	\$5,500
MC#11	Residential Encroachment, change in W/D ration, channel and floodplain disconnection.	140	Reestablish W/D ration needed to acquire velocities that can transport the sediment load. Reconnect the channel to the floodplain at bankfull stage. Channel realignment for correct pattern using 2-3 structures.	moderate	\$100	\$14,000
MC#12	Residential encroachment confines channel and decreases Entrenchment ratio (ER) increasing velocity and shear stress through the reach.	75	Work with landowner to provide to increase floodprone width. Use several structures (4) to build a stable B channel with correct W/D ratio.	moderate	\$100	\$7,500

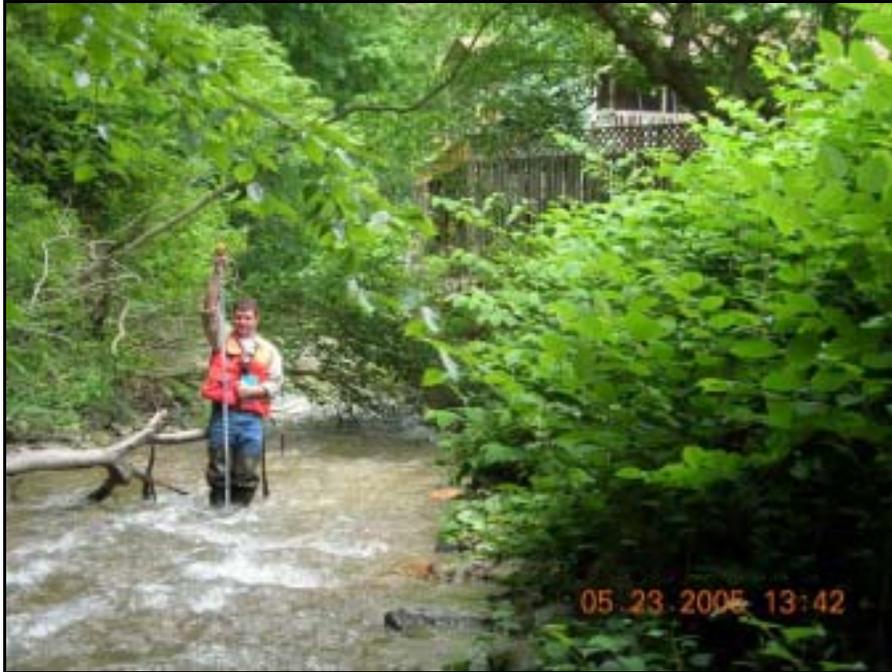
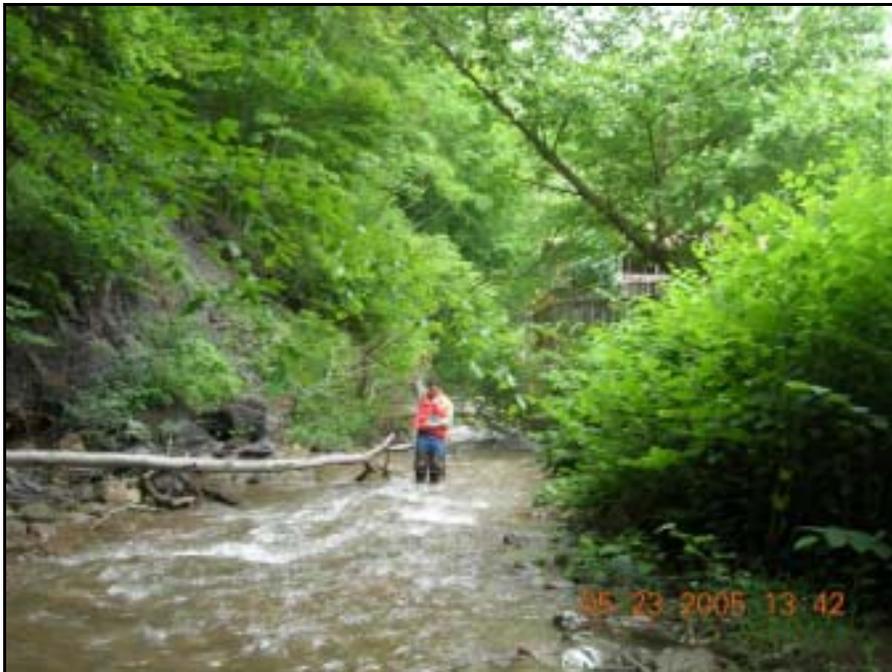
MC#9

This location has a landslide at river left. There is 'confining' residential encroachment up to the active stream channel. The entrenchment ratio is <1 . The encroachment at river right accelerates the water through the channel by working with the bedrock at river left. There is a long eroded stream bank toe at river left below the residential encroachment. This location is just above the most upstream WV Highways Bridge. The total length of instability is 55 ft.

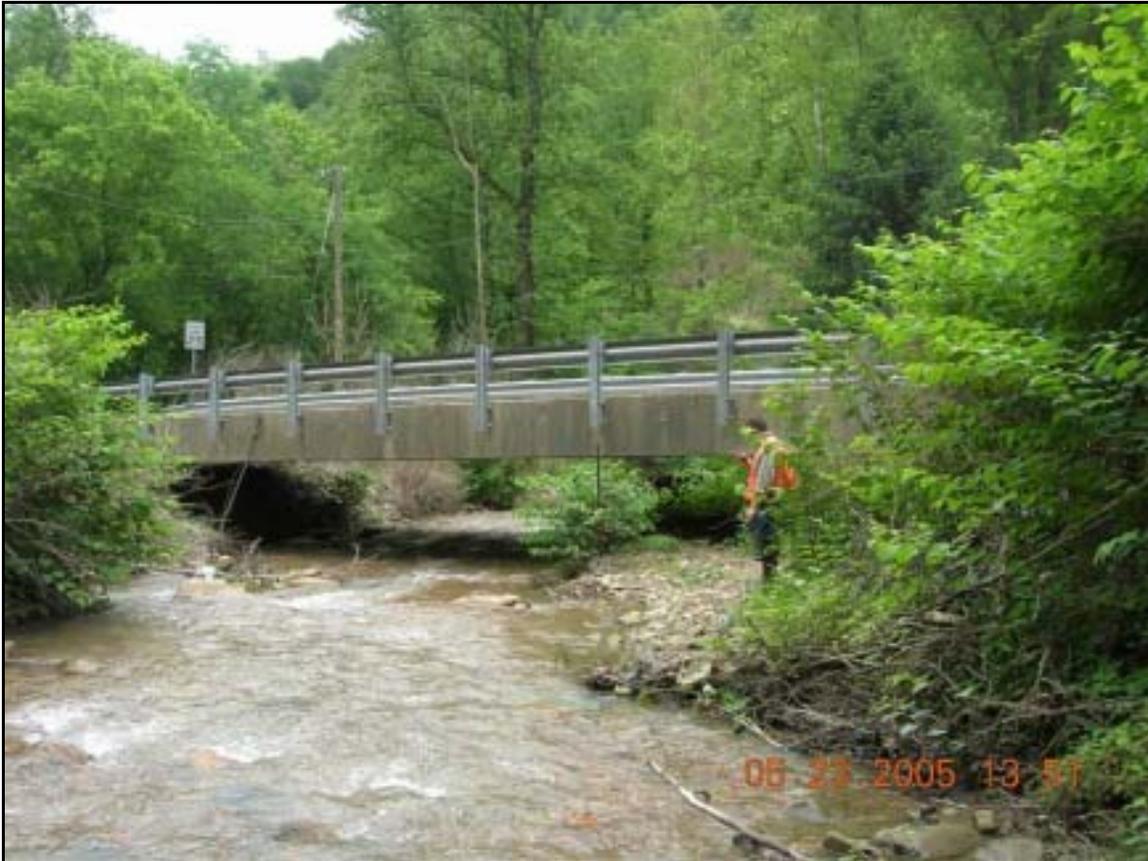
MC#10

This location is the most upstream WV Highways Bridge. This bridge spans the active floodplain allowing for the channels ability to route sediment at bankfull flows. Less frequent large floods could cause back water and erosion of bridge wing walls during the event. This design could be a model for future bridge construction in the watershed. Care should be taken to design bridges to drain the floodplain during large floods.

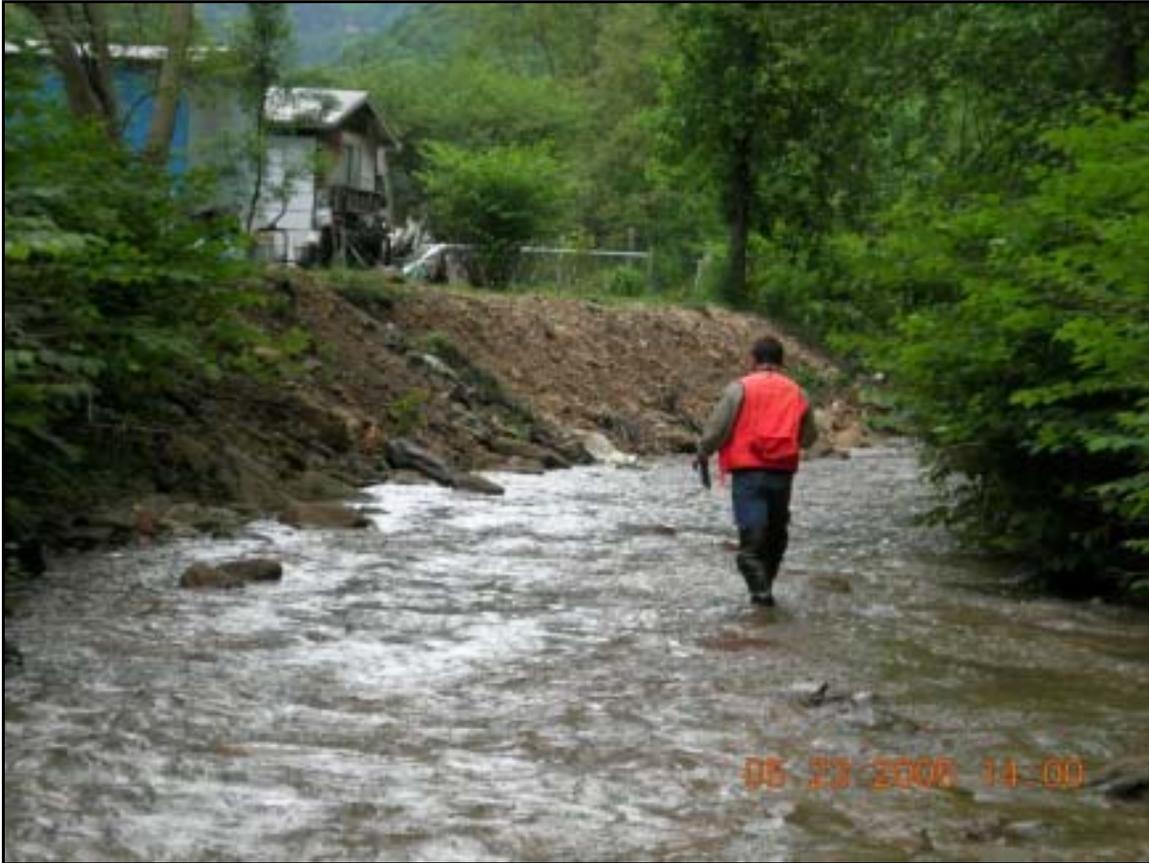
MC#11

This is a location of residential channel encroachment. W/D ratio increases to 14 through this reach resulting in a confined F stream type. Restoration would include 140 ft of channel and floodplain realignment with reestablishment of riparian vegetation. A vegetated terrace may also be a solution to assist during very large floods. Sycamore and willow were observed in the area.

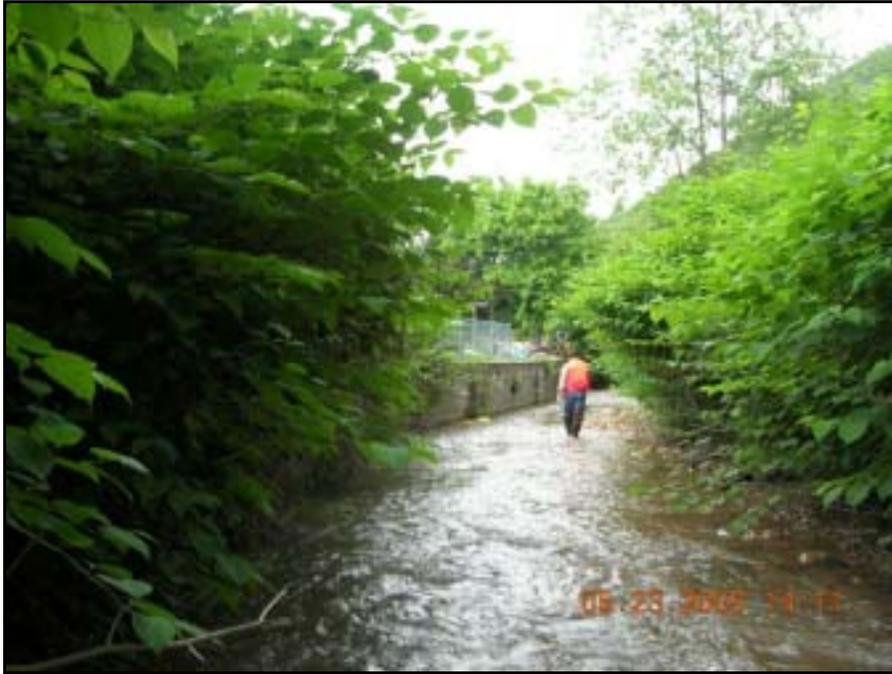
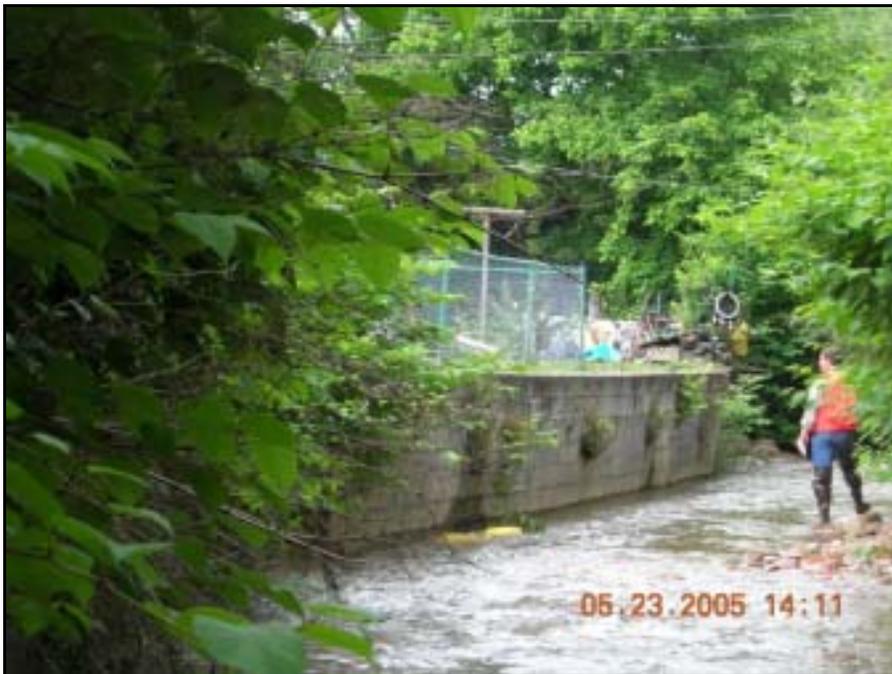
MC#12

This location is residential encroachment at river left just above private bridge. W/D ratio is < 12 , and the stream is a confined G. The total length of instability is 75 ft. The channel needs to be reconnected to a floodplain or bankfull bench. Two structures could also help realign channel and dissipate energy through the bridge below. A vegetated terrace may also assist in this reach for the large floods.

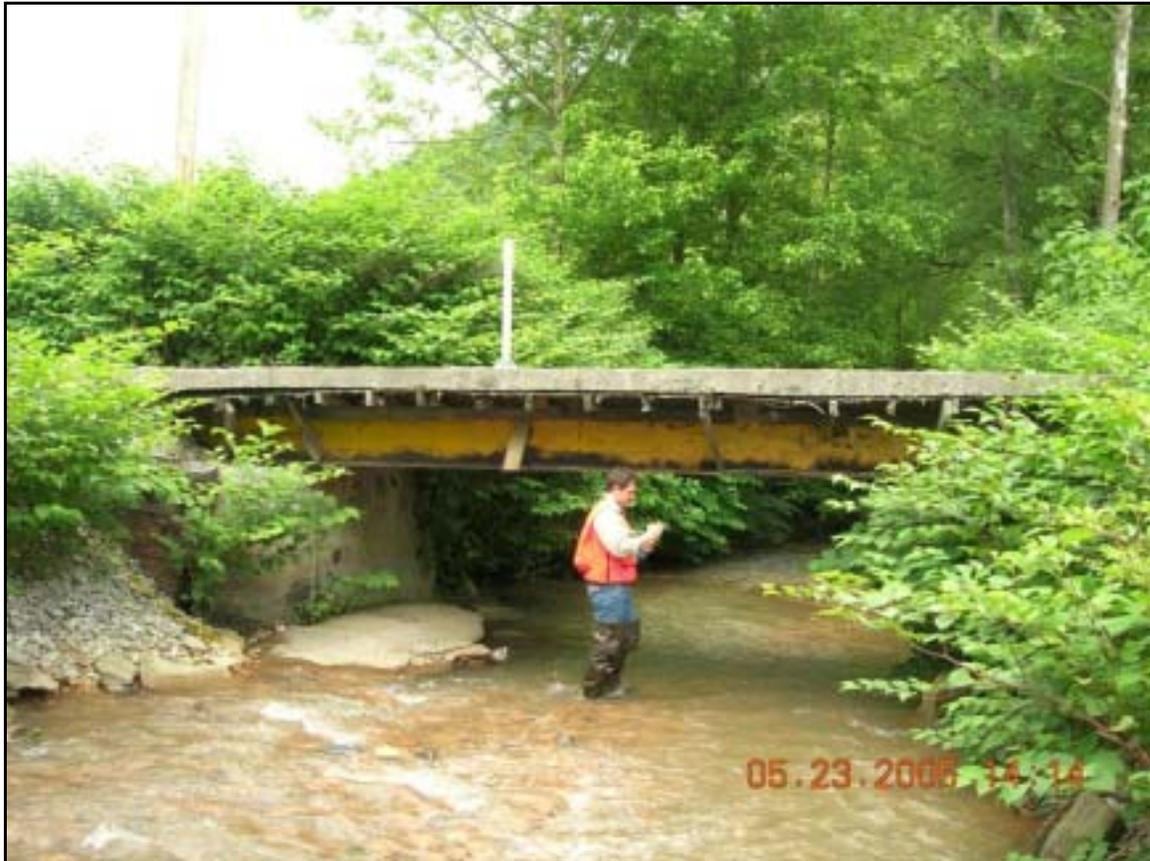
This bridge works for now, but should not be imitated for the long term. This bridge is showing signs of erosion, particularly around the wing wall foundations. This bridge does not dissipate energy at bankfull, nor would it handle the energy or transport the sediment during a big flood event.

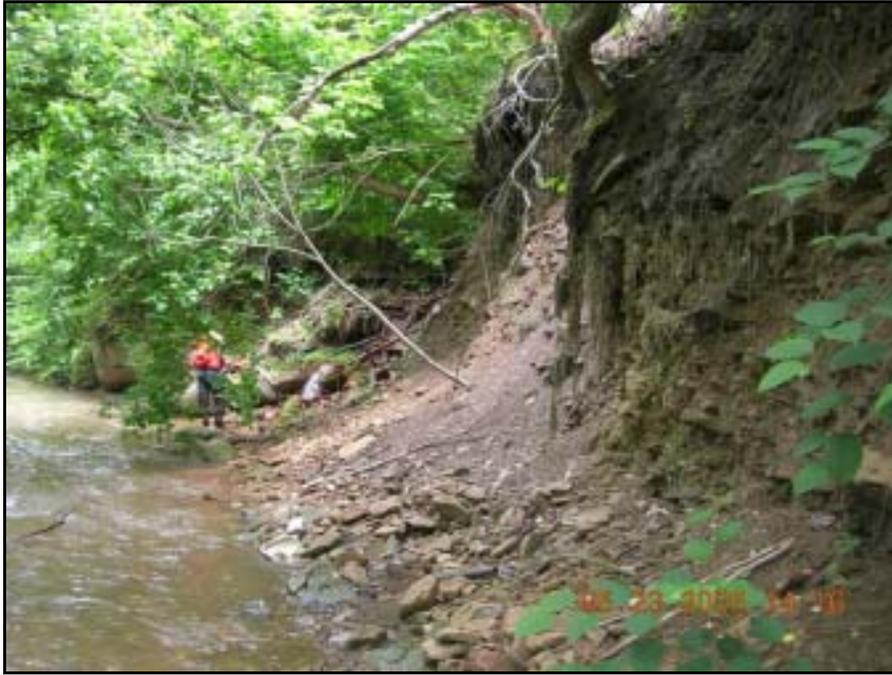
The confluence of Black Snake Hollow with Morris Creek is heavily eroded due to alluvial and colluvial processes (mass wasting). Stream bank erosion occurs on the river left downstream of the confluence. This would be a very difficult sediment source to stabilize.

Black Snake Hollow	Alluvial and colluvial processes with stream bank erosion. This area may produce a large amount of sediment and should be considered for any sediment reduction project in Morris Creek	500	Very difficult to slow or stop colluvial processes. Restore stream channel to transport the sediment load. Reduce sediment sources in the headwaters of Black Snake Hollow. A large area below this confluence needs channel reshaping, several structures, and appropriate W/D ratio.	moderate	\$100	\$50,000
MC#13	Rip-rap, channel floodplain disconnection, stream bank erosion	100	Reestablish W/D ration needed to acquire velocities that can transport the sediment load. Reconnect the channel to the floodplain at bankfull stage. Channel realignment for correct pattern using 2-3 structures. Work with landowner to provide to increase floodprone width.	moderate	\$70	\$7,000
MC#14	Dredging, over-widening, burning, aggradation	600	Build appropriate W/D, pattern, and profile using 4 - 5 structures. Work with landowner to provide to increase floodprone width. Setback burn, residential setbacks, reestablish riparian vegetation, develop transportation route.	high	\$70	\$42,000
