**Hydrologic Reconnaissance for Stream Stability
And Sediment Consequences
Morris Creek, West Virginia**

6/1/05

Prepared by:
Ryan Gaujot
Geologist
Canaan Valley Institute

In Partnership with:
Morris Creek Watershed Association

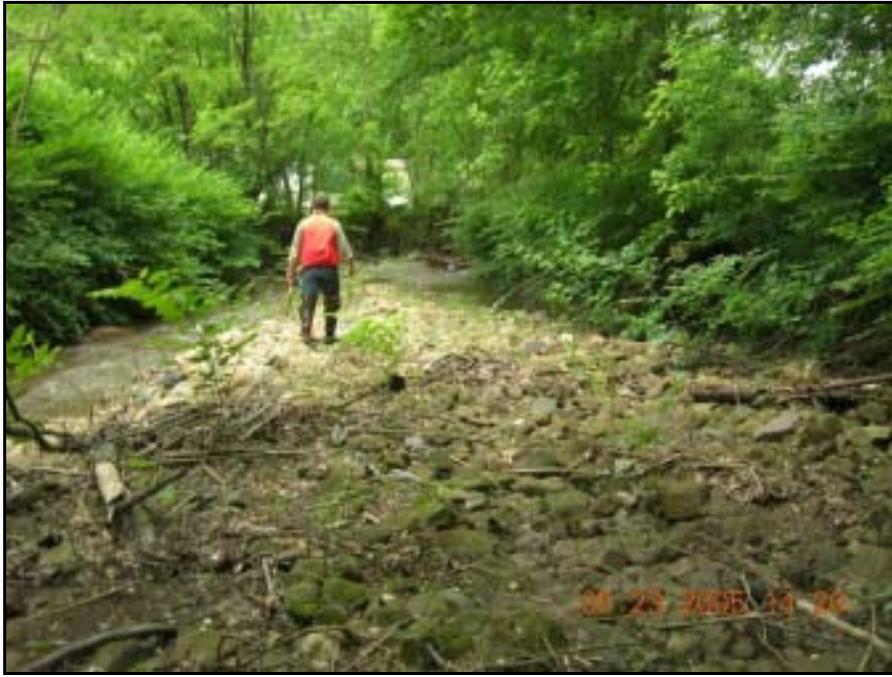
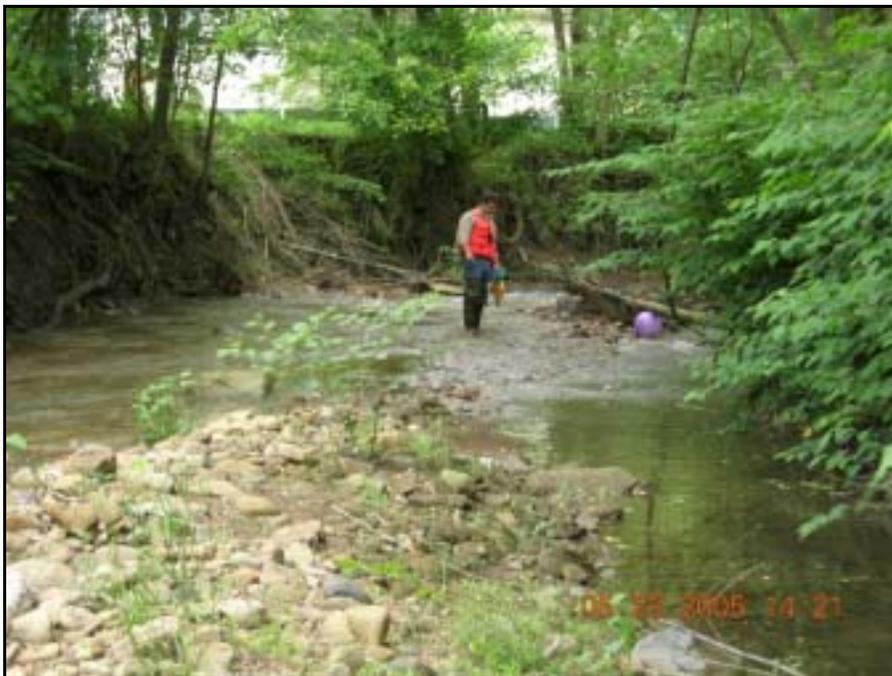
The channel is too wide through this reach to route sediment ($W_{bf} = 38$, $Dbf = 1.5$). The channel geometry in this reach results in low bankfull velocities, deposition of sediment, and erosion downstream river left.

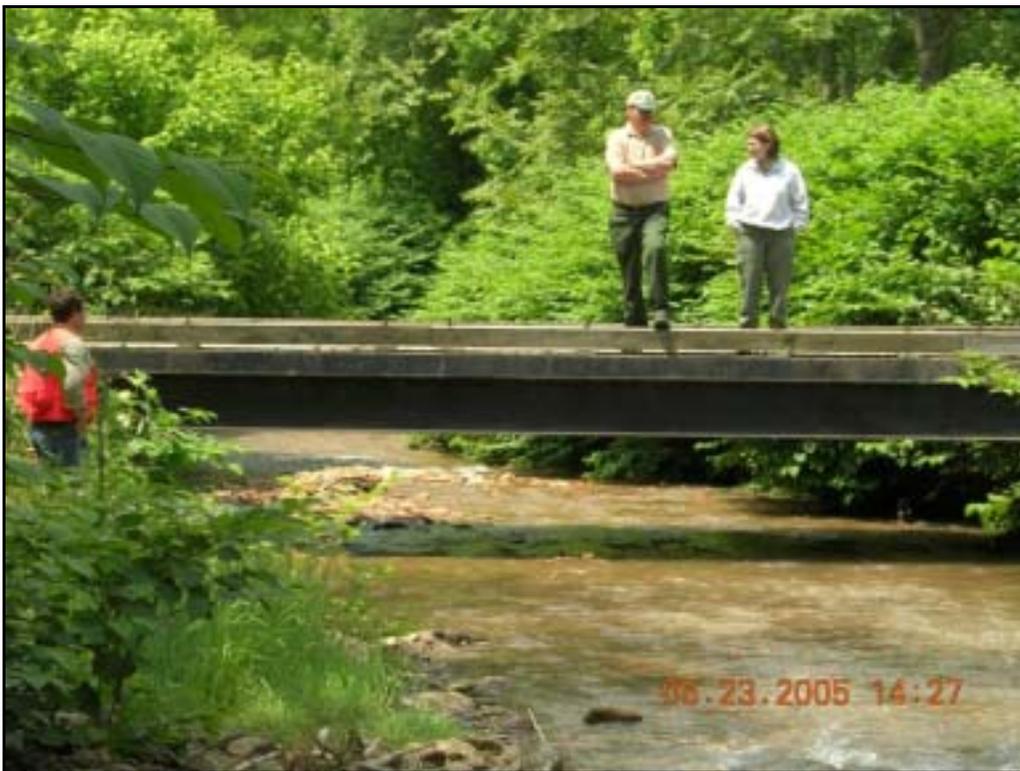
This bridge works for now, but should not be imitated. This bridge is showing signs of erosion, particularly around the wing wall foundations. This bridge does not dissipate energy at bankfull, nor would it handle the energy or transport the sediment during a big flood event.

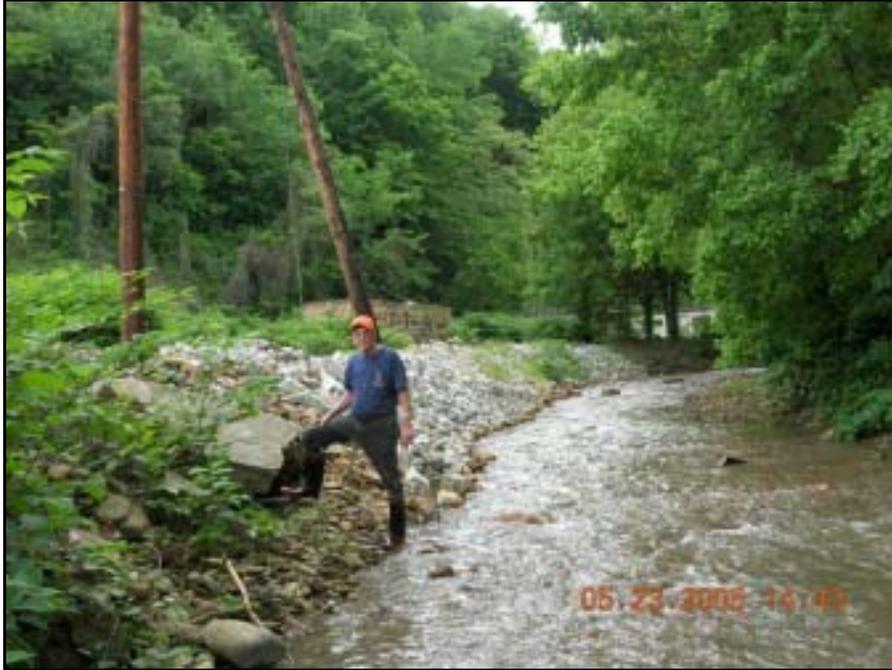
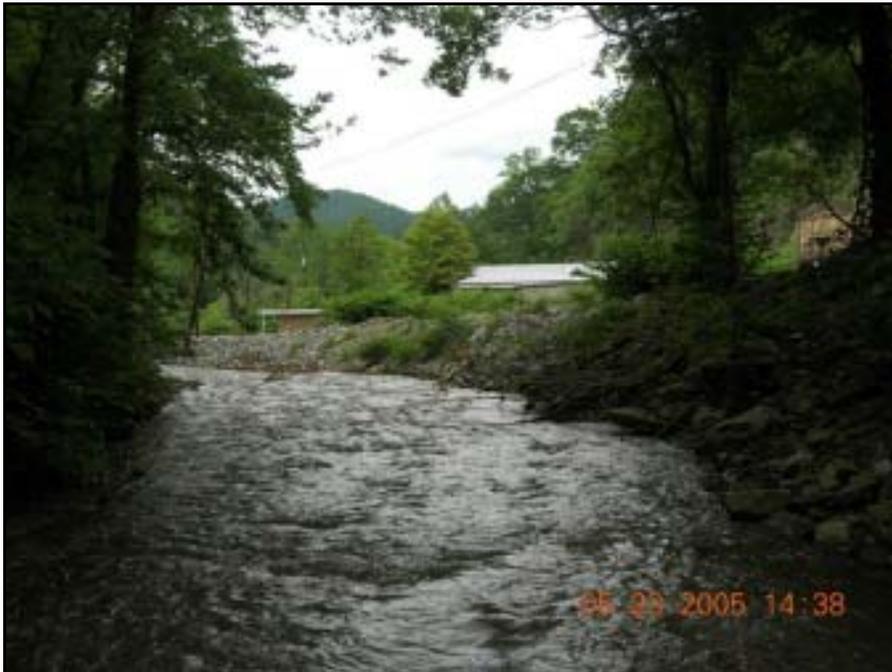
MC#13

This is a recently rip-rap section at river right of approximately 100 ft. This rock was put in place to armor the right bank from erosion and channel migration towards residential structures. The rip rap armor confines the stream channel at 2x's maximum depth resulting in an F stream type. This section should be combined with MC#14 below.

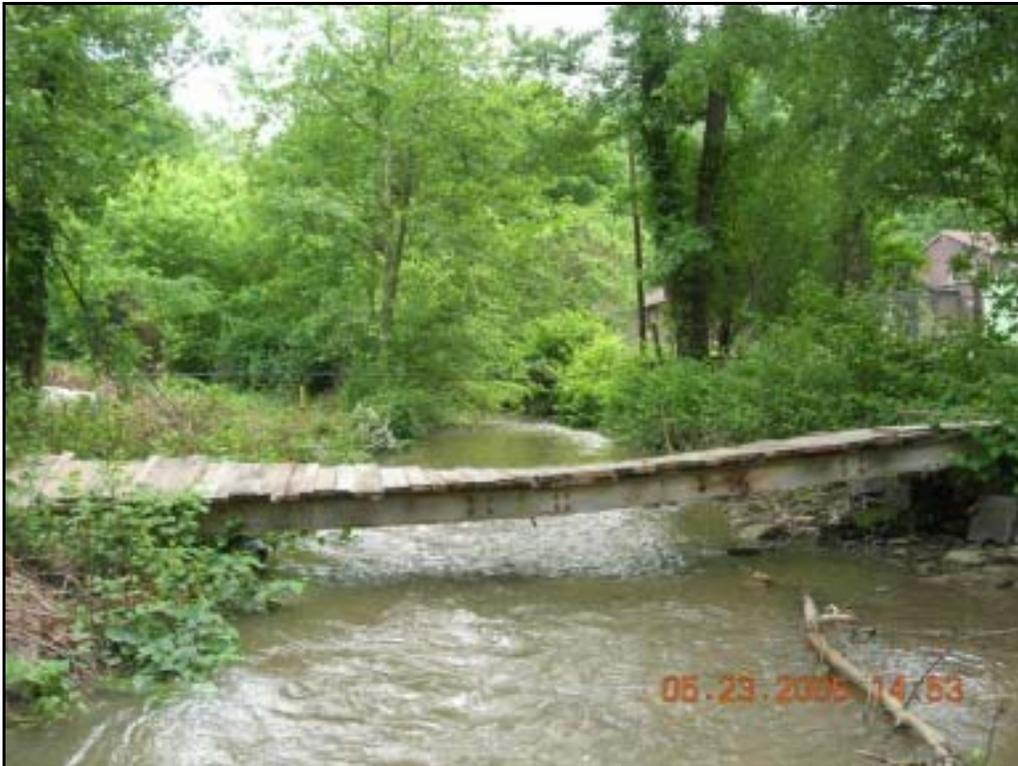
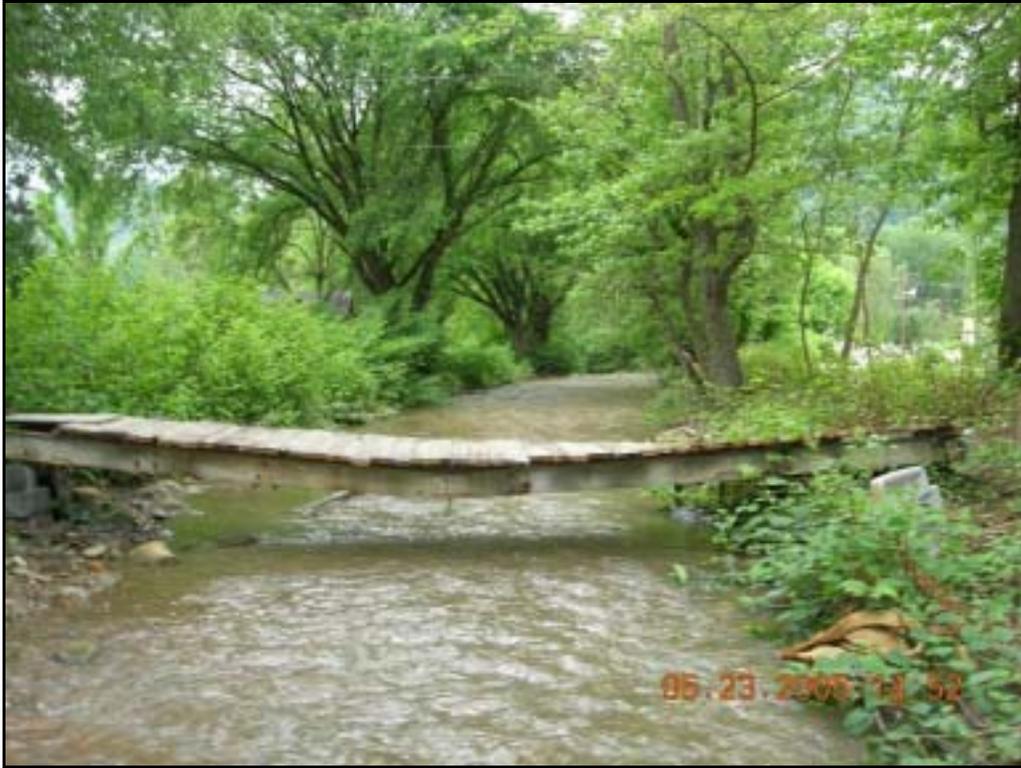
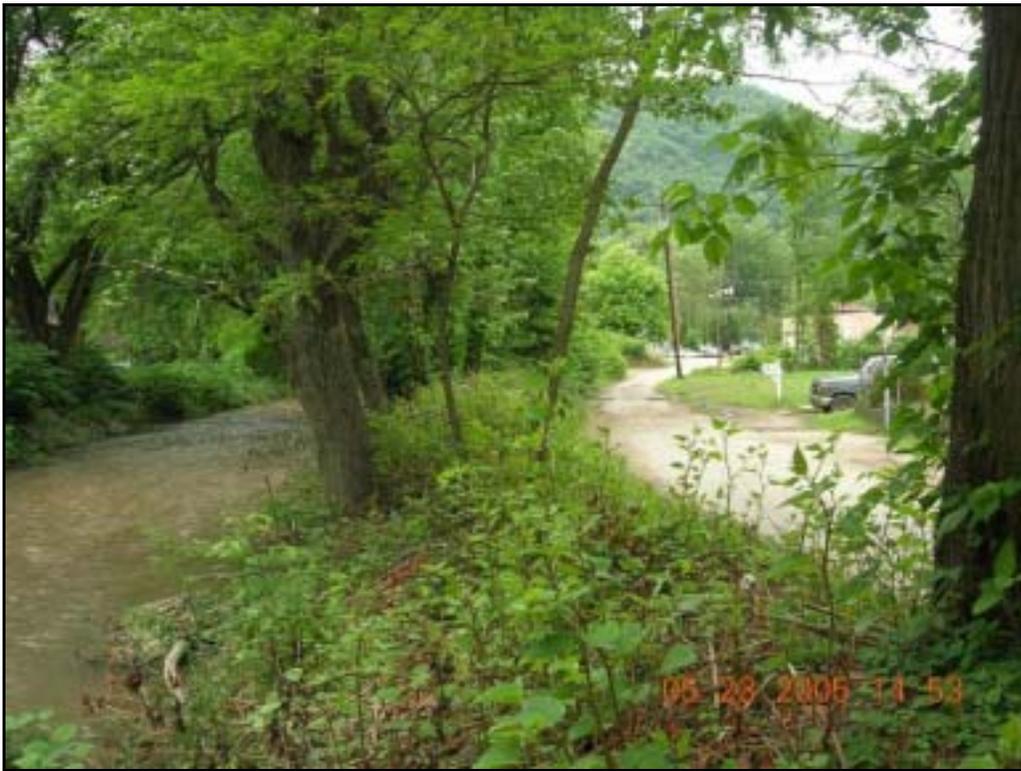
MC#14

This is a high priority location that has been apparently over-widened due to dredging and streamside burming of the Morris Creek mainstem channel. The section is extremely wide and shallow, resulting in lower flow velocities at bankfull. The reach needs a lower W/D to route sediment with higher stream velocity. Reestablishment of pattern using 2 – 4 structures should help dissipate energy and route flows during floods. The burms would have to be set back to provide for more floodprone area. A section of the Sanitary Sewer runs through this reach making channel work more difficult driving up design and construction costs. Some sewers are upwelling.

These measurements show a very different stream type (C or D) from what was been observed through most of the Morris Creek mainstem (B - G).
