West Virginia Department of Environmental Remediation  
Office of Environmental Remediation

VRP Project #: **15017**  
Brownfield Site: Yes  No   
Report Date: **02-24-2016**  
Page 1 of 2

**OFFICE OF ENVIRONMENTAL REMEDIATION**  
**VOLUNTARY REMEDIATION PROJECT**  
**SITE VISIT/INSPECTION REPORT**

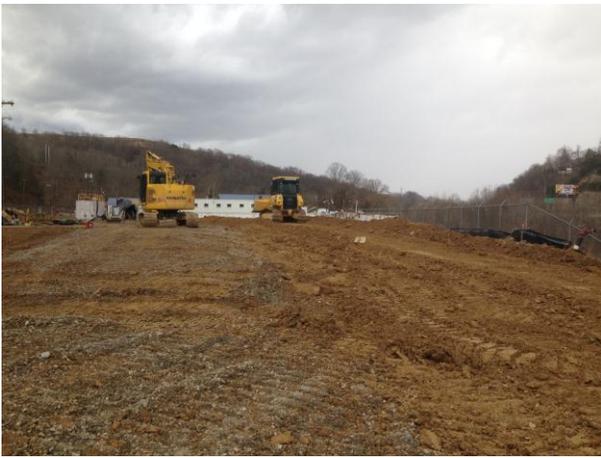
**Figure 1 – Soil levelling/grading work in Area 1B**

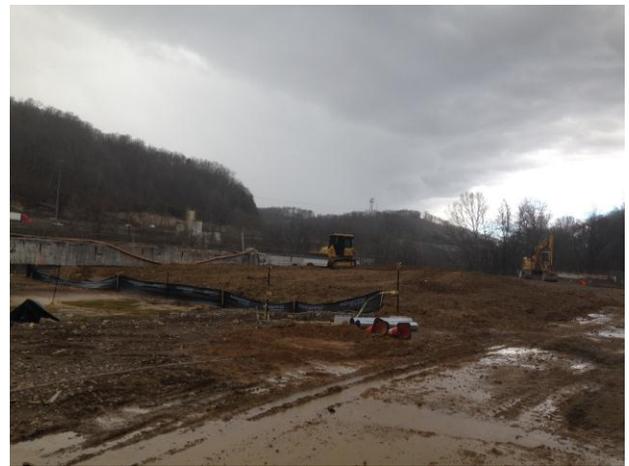
**Figure 4 – Soil levelling/grading work in Area 1B and 3.**

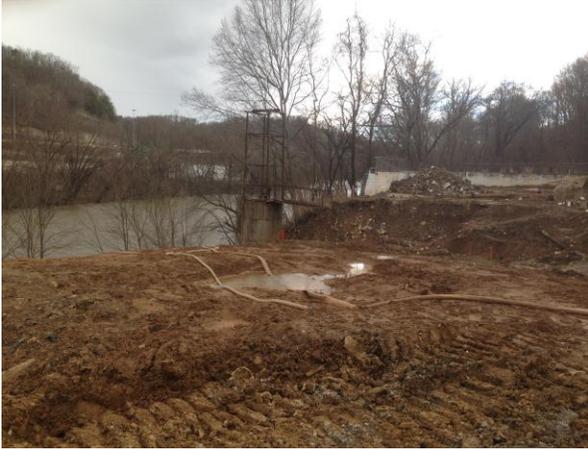
**Figure 2 – A look at Area 3 with water puddles developing at the top of the “ravine” where water is being collected.**

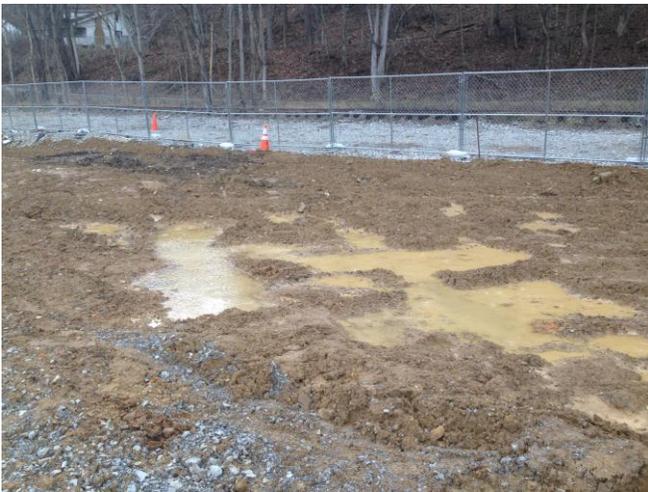
**Figure 3 – Section of the site east of Area 3 with more water puddles.**

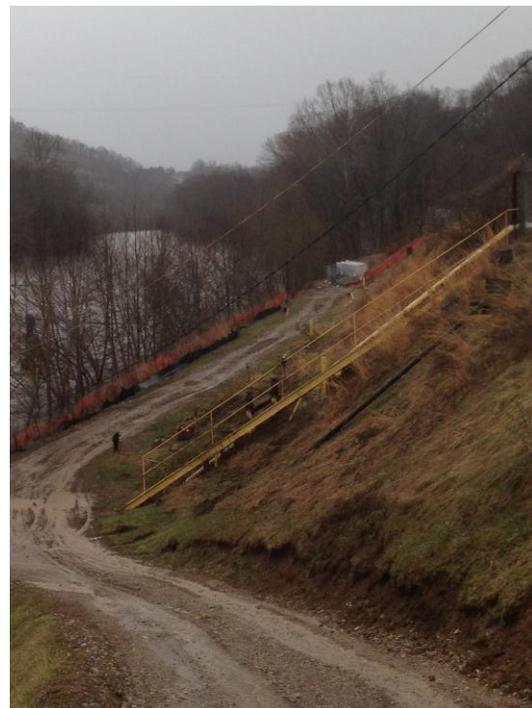
**Figure 6 - A view of the lower trace area by Elk River from the gate. Elk River water level was high but still several feet below the level of the sumps.**
