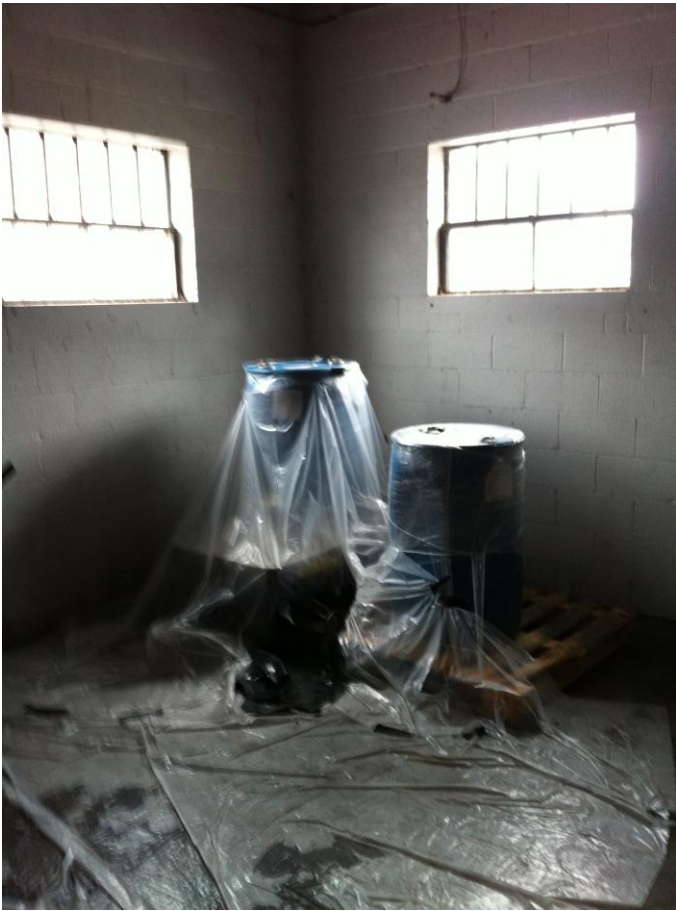
1. Two locked drums of MCHM still present in the office building.
2. Oil pit/hydraulic lift area in garage.
3. Pipe leading down to stormwater outfall at southern end of site.
4. PVC pipe leading down to manhole.
5. Barge dock area on lower bench (note rising water level in Elk River).

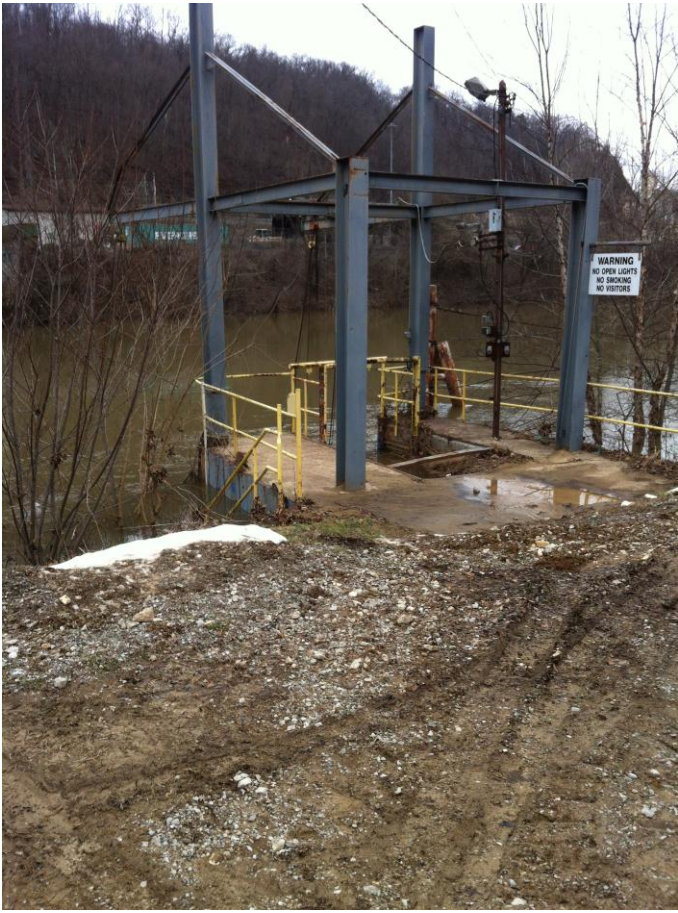
5.

Drove over to excavation Areas 3&4 so that Mr. Jones could observe these areas and take GIS readings. Also drove down to lower bench of site (collection trench area) for additional GIS readings. Water level in the Elk River is almost up to the bottom of the collection trench. Also walked to southern end of the site to investigate stormwater outfall areas.
