VRP Project #: **15017**
Brownfield Site: Yes No
Report Date: **5-2-16**
Page **1** of **6**

OFFICE OF ENVIRONMENTAL REMEDIATION
VOLUNTARY REMEDIATION PROJECT
SITE VISIT/INSPECTION REPORT

FACILITY: Freedom Industries				STREET ADDRESS: 1015 Barlow Drive							
CITY: Charleston				COUNTY: Kanawha				PHONE: ()			
DATE OF VISIT: March 25, 2016				TIME IN: ~2:00 pm				TIME OUT: ~ 4:30 pm

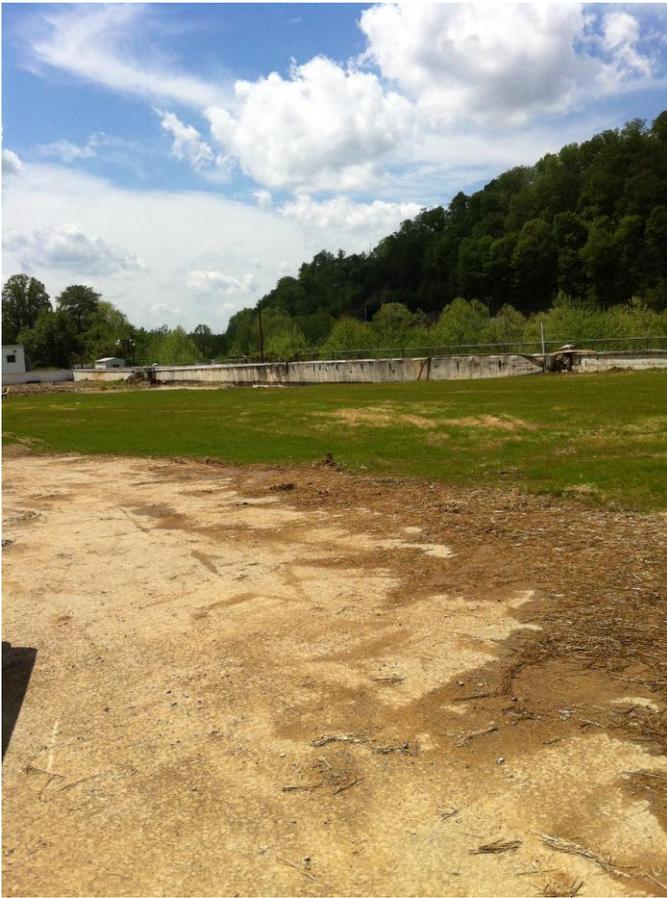
1. Grass growth in former excavation Area #1, looking southwest.
2. Grass growth on excess soil mound - looking north.
3. Grass growth in former excavation Area #3.

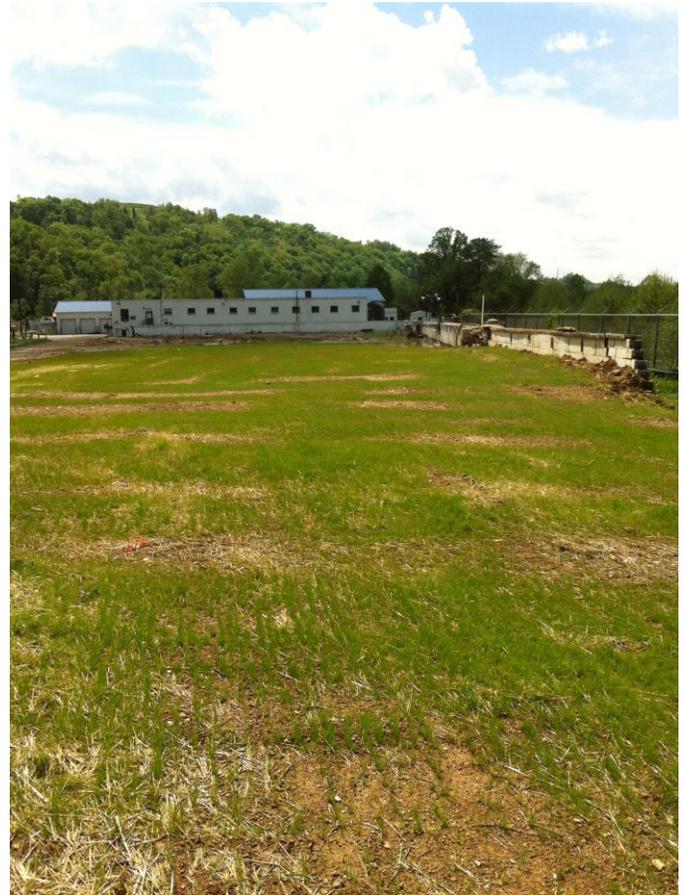
4. Grass growth in former excavation Areas 1, 2 & 3, looking south towards office building.
5. Coconut straw matting and grass growth on slope (former excavation Area #4) above concrete buttress.

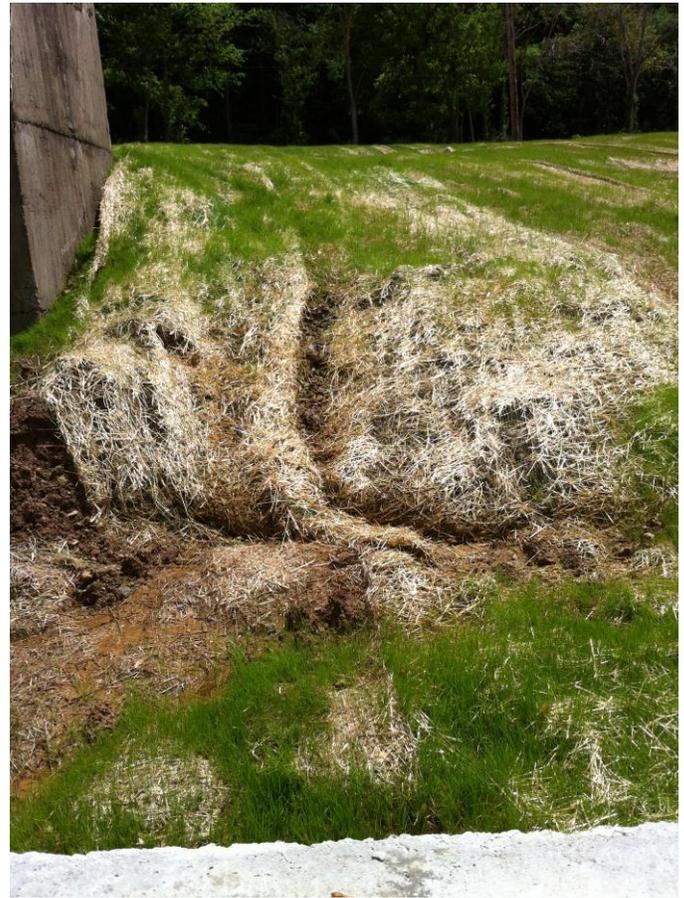
Drove north to northern entrance of site. Observed good grass growth in former excavation area 1 driving to north gate. Got out of truck and walked to edge of slope - good grass growth in former excavation areas 2 and 3. Also good growth on soil mound - this is excess soil left over from the grading of the slope. Got back into truck and drove down to lower bench of site (collection trench area). River is up today, but still 10' below collection trench and concrete buttress. Good grass growth on slope. Coconut matting is doing good job of holding clay cap in place for the most part. Noticed several areas where water is still seeping out of the slope to the surface, despite the french drain installation. Noticed area near the concrete pump structure where it appears some slippage of soil has occurred, but this is very minor. Water is also pooling at the base of the slope behind the concrete buttress. No MCHM odor noticeable. No evidence of seeps on the river bank below the buttress. No evidence that buttress has moved at all. No evidence of seeps on the river bank below the additional retention trench that was installed with the french drain system. All in all, it appears the slope and cap is holding well. Drove back up to upper levels to northern end of site and top of slope. Good grass growth on upper slope and northern end of site. Gas company still has not replaced damaged gas line valve. Evidence of some drainage to surface on upper slope also.

6. Grass growth on slope - looking east.
7. Active seep and evidence of some sloughing of clay cap in area near concrete pump structure.
8. Concrete buttress and grass growth below, looking south.

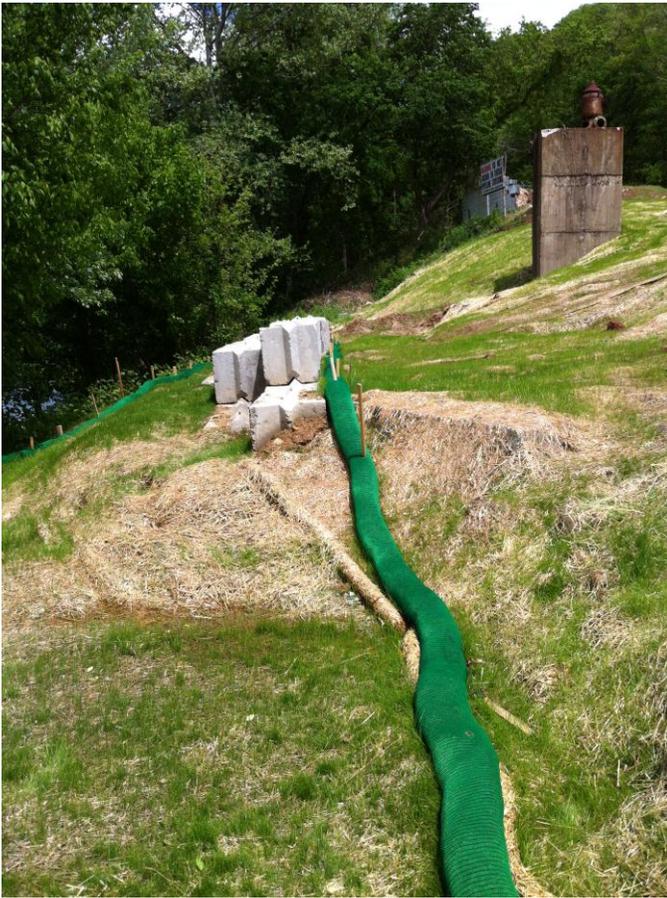
9. Grass growth on lower (trench) level, looking north.
10. View of river bank below concrete buttress and retention trench.
11. View of upper slope area (former excavation Areas 3&4) - looking southwest..

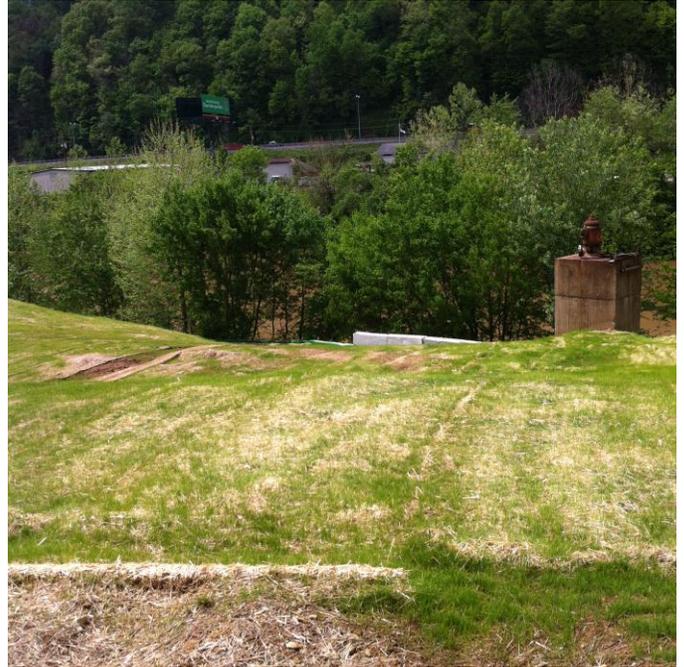
12. View of slope and concrete buttress - lookoing west towards Elk River.
13. View of upper slope & damaged gas line area - looking northwest towards Elk River.
