**CONSENT ORDER
ISSUED UNDER THE
WATER POLLUTION CONTROL ACT
WEST VIRGINIA CODE, CHAPTER 22, ARTICLE 11**

TO: HG Energy LLC
Attn: Matthew McGuire
5260 Dupont Rd.
Parkersburg, WV 26101

DATE: February 11, 2015

ORDER NO.: 8199

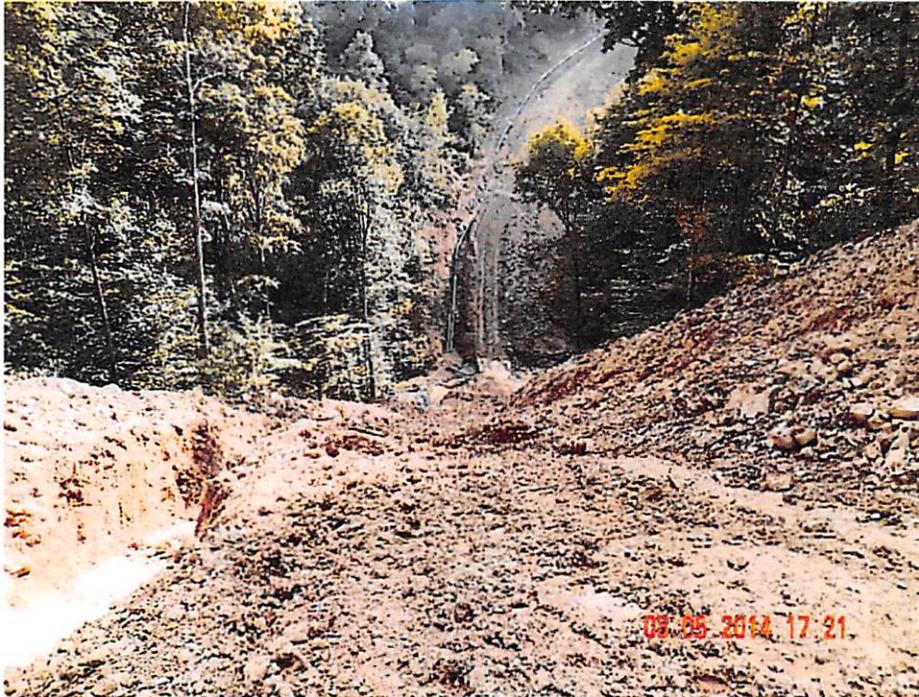
DSCN1460: Overview of ROW. Pipeline on far side of ROW slid down trench.

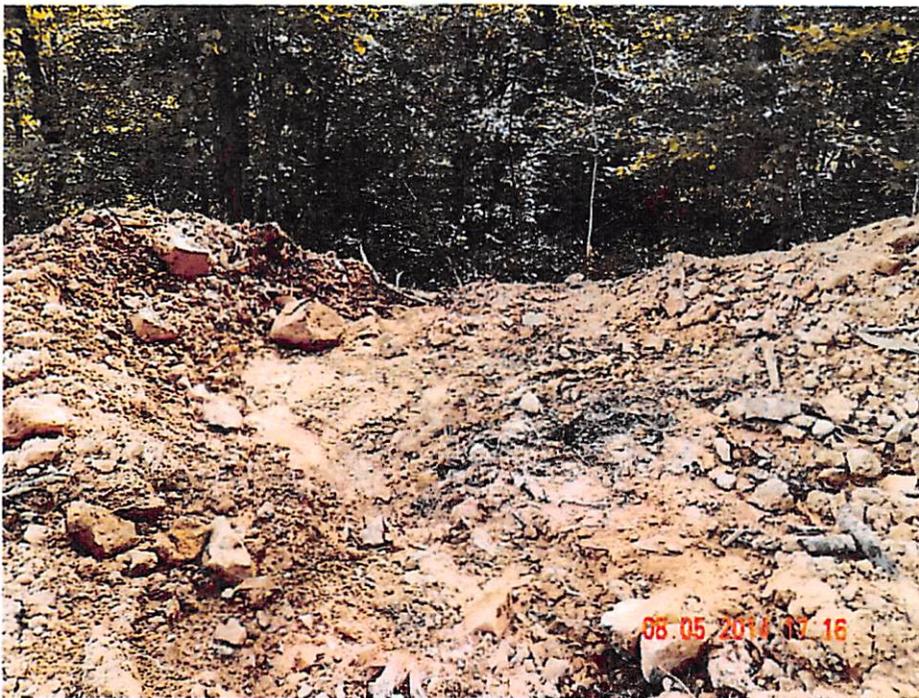
- iv. Failed to conduct inspection of BMPs every seven (7) calendar days or within twenty-four (24) hours of a rain event.
 - v. Failed to provide outlet protection for all waterbars.

DSCN1455: Waterbar without outlet protection as indicated by approved SWPPP.

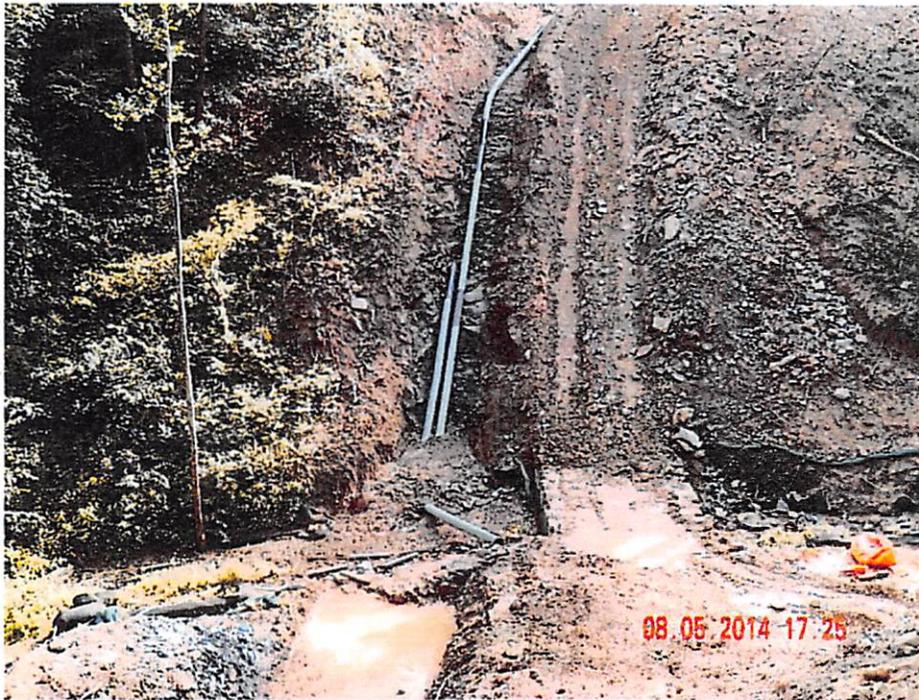
- c. 47CSR11 Section 2.2.a.-HG Energy failed to immediately report a spill. Specifically, sumps installed on HG Energy's right of way failed, allowing sediment, rock, Best Management Practices (BMPs) and other debris to enter into a UT of Fourmile Run.

DSCN1461: Failed sumps. Stream filled with sediment, rock, BMP, cribbing, piping and sandbags.

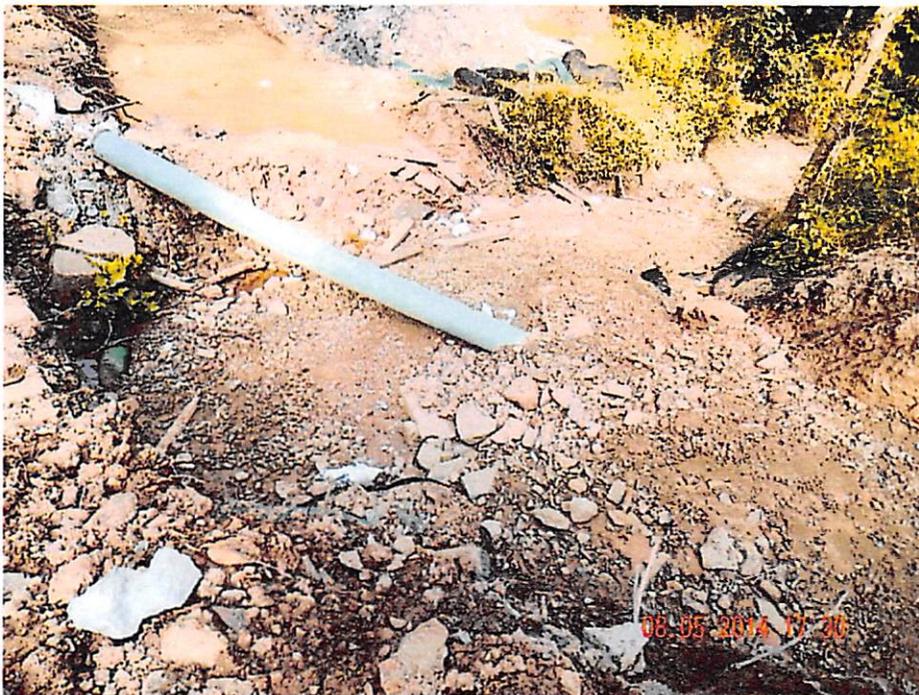
DSCN1471: Alternative view of photo DSCN1461.

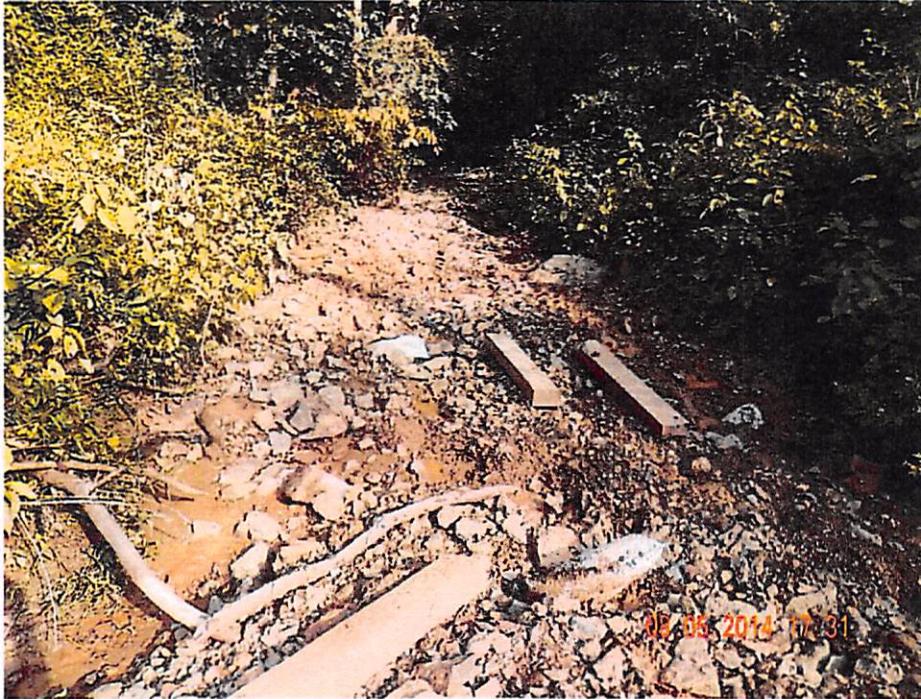
DSCN1473: Downstream of ROW. Stream filled with sediment, rock, cribbing and sandbags. Material is approximately six inches deep in this area.

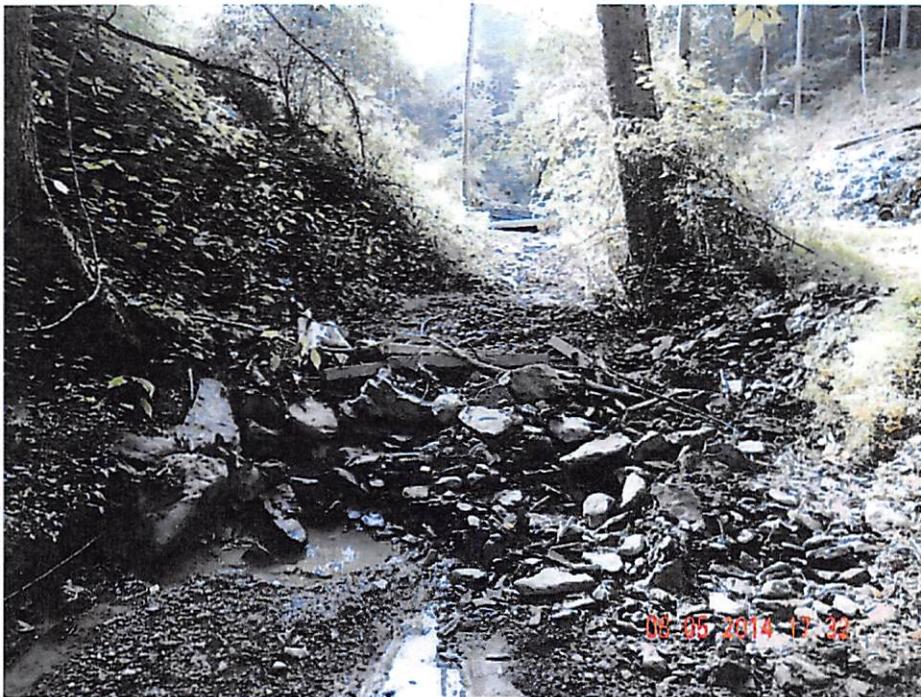
DSCN1474: Downstream looking up stream toward ROW. Most of the heavy debris and material ended here.

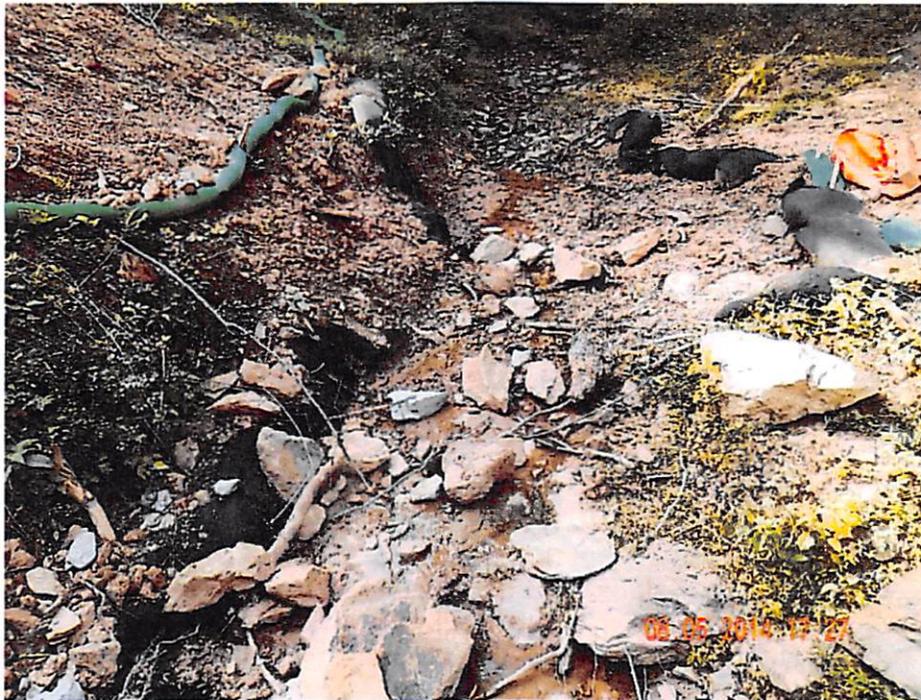
DSCN1464: ROW on upstream side of trench. Stream filled with sediment and rock. BMPs in stream.
Compromised BMPs.

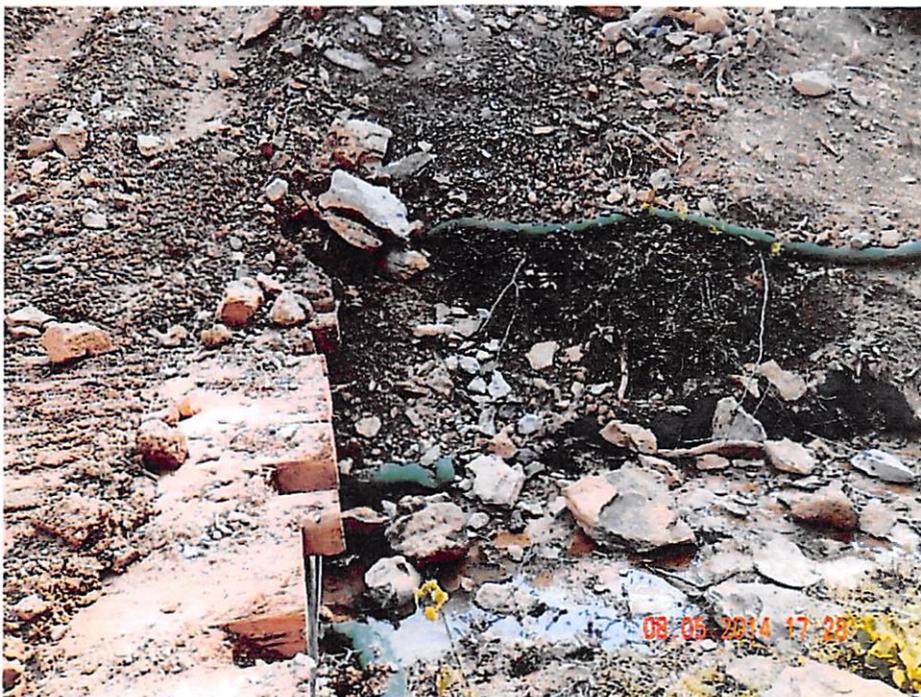
- iv. Wattles protecting a UT of Fourmile Run were overtopping and/or compromised.
 - v. A timber mat bridge allowed sediment to fall between timber mats and into the stream.

DSCN1466: Timber mat bridge not keyed in allowing sediment to enter stream.

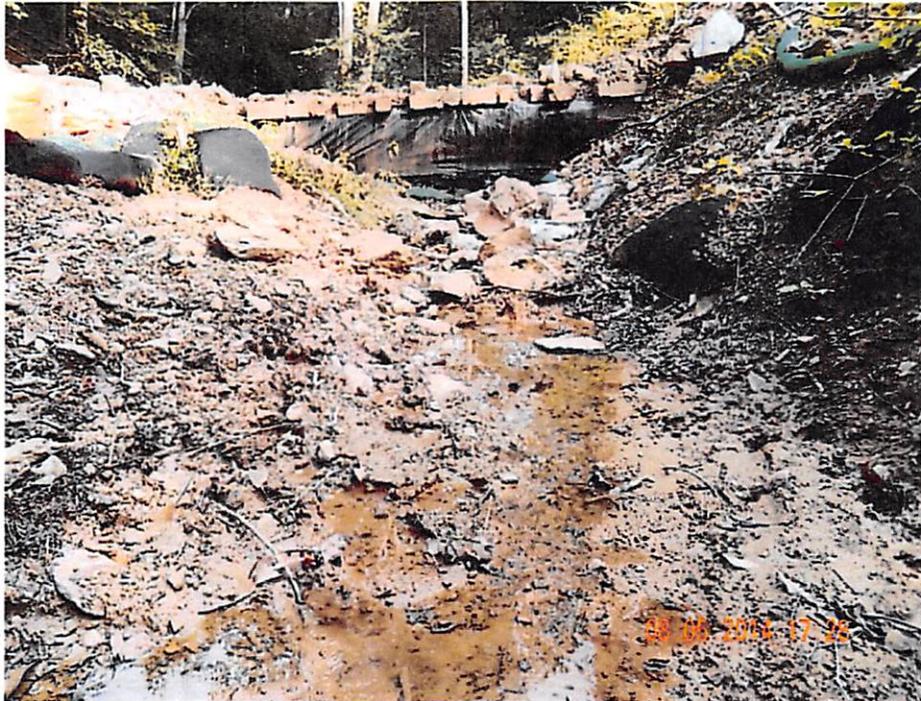
DSCN1469: Photo taken upstream of ROW looking downstream. Stream filled.

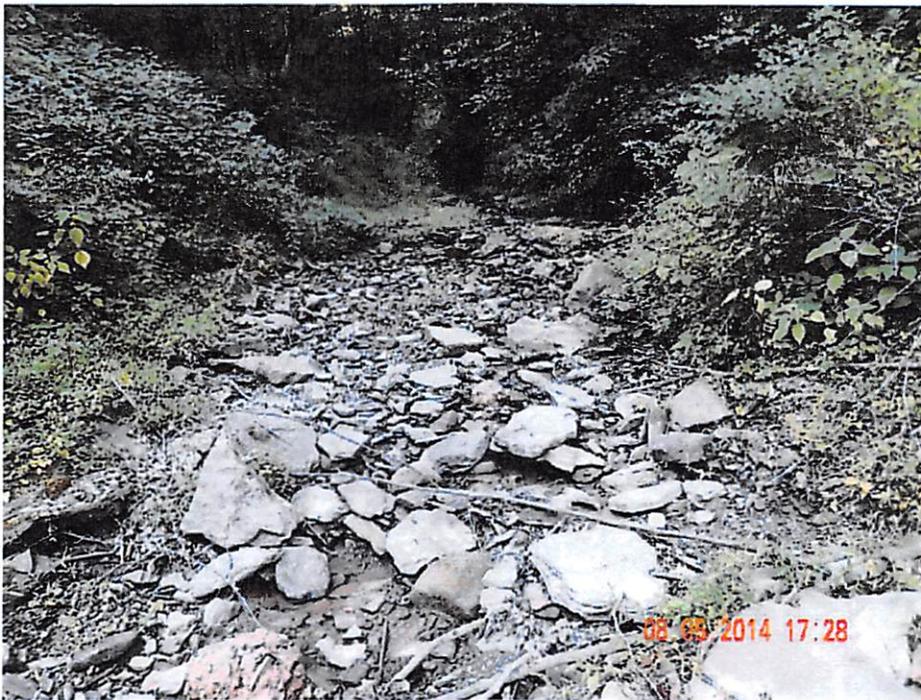
DSCN1467: Taken from same position as photo DSCN1469 looking upstream from ROW.

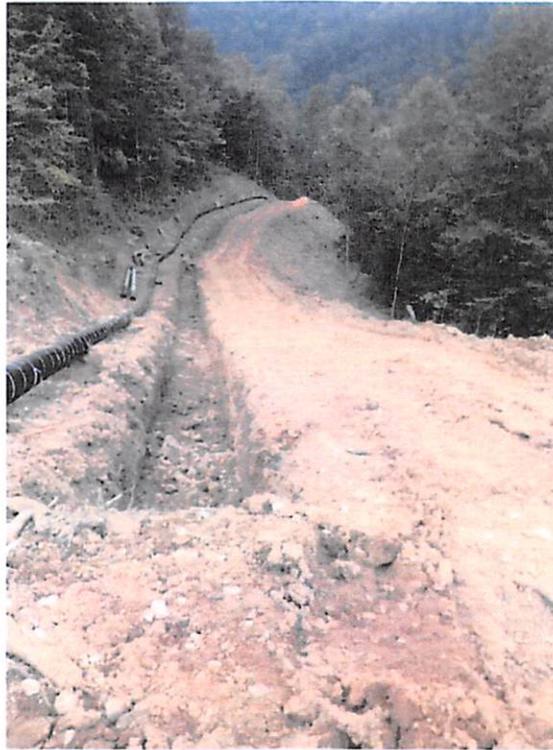
IMG_0503: Pipeline ROW with open trench.

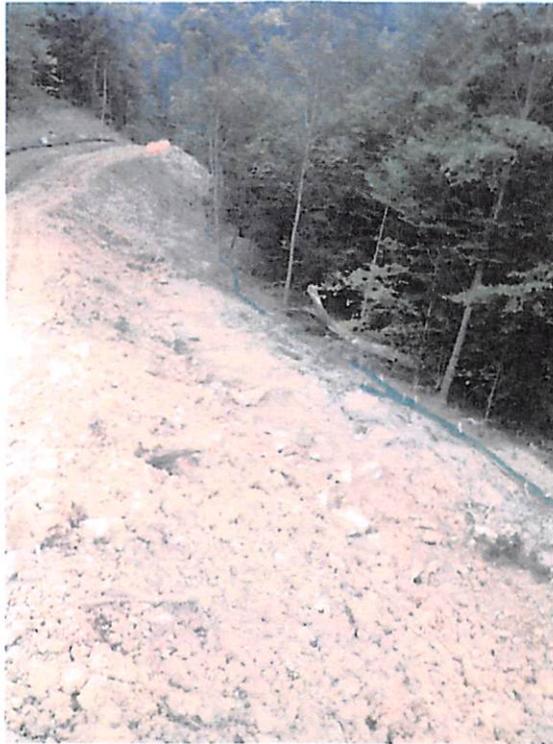
- i. Replaced the approved 24" wattles with 8" wattles.
 - ii. Failed to install the required waterbars.
 - iii. Failed to properly key in timber mat bridges.

IMG_504: Wattles are not the right size. SWPPP indicated 24" for this area. Wattles not placed as indicated on SWPPP.

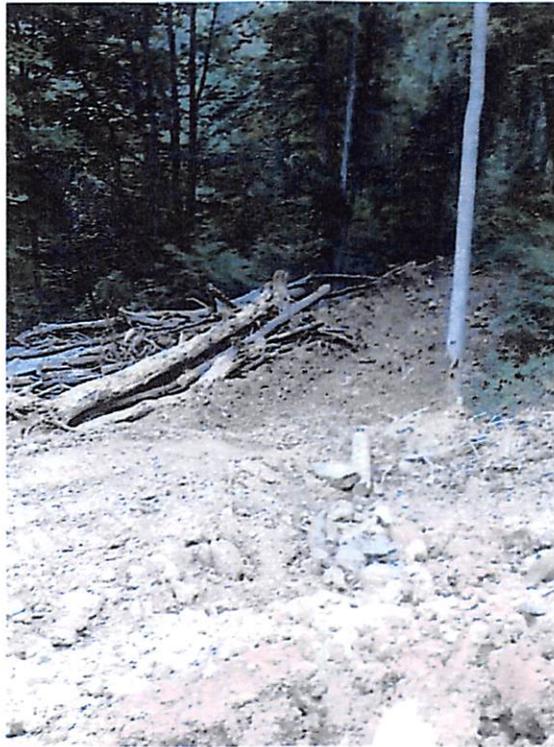
IMG_510: Disturbed area outside of LOD. Photo taken standing on working downslope side of ROW looking right.

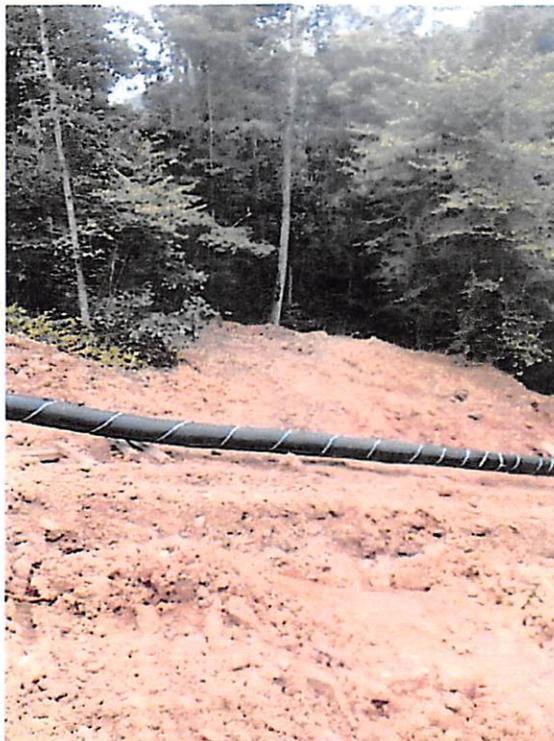
IMG_511: Disturbed area outside of LOD. Taken from same position as photo IMG_510 looking left.

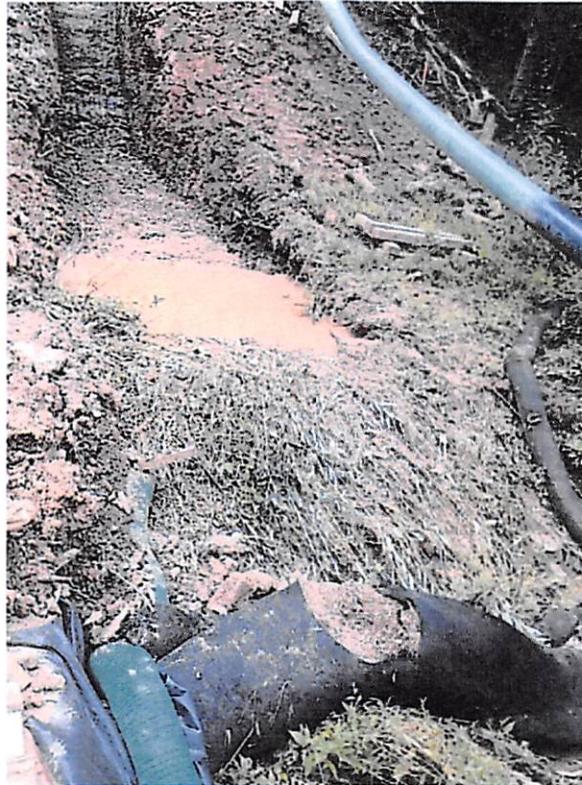
IMG_518: Unmaintained sump. Sump bypass compromising wattles.

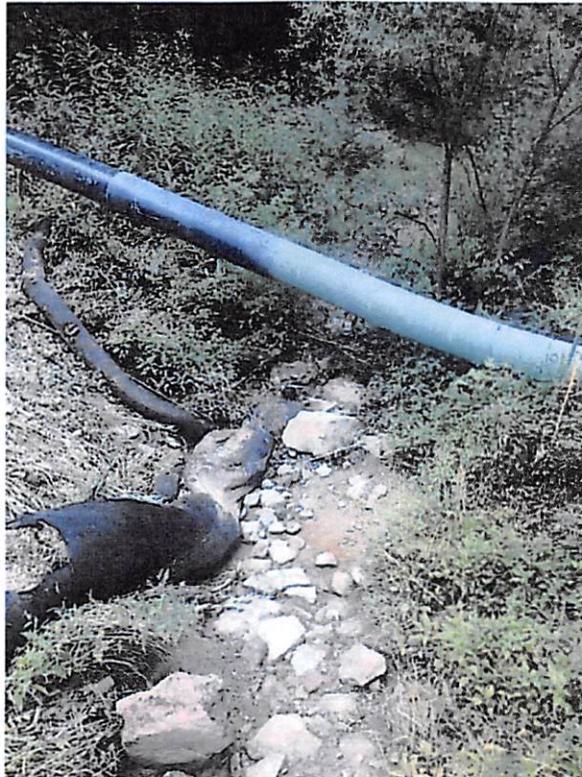
IMG_516: Wattles, sediment and rock in stream from sump bypass in photo IMG_518.

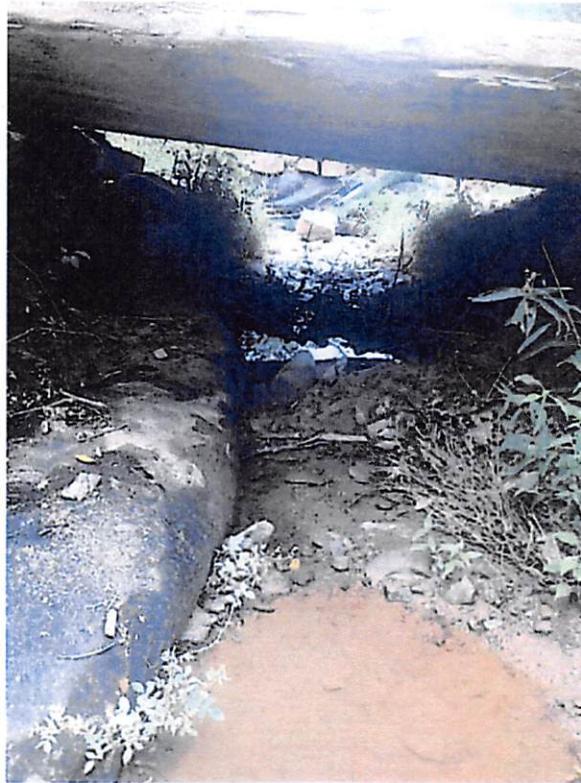
IMG_525: Sediment and wattle in stream under timber mat bridge without geotech.

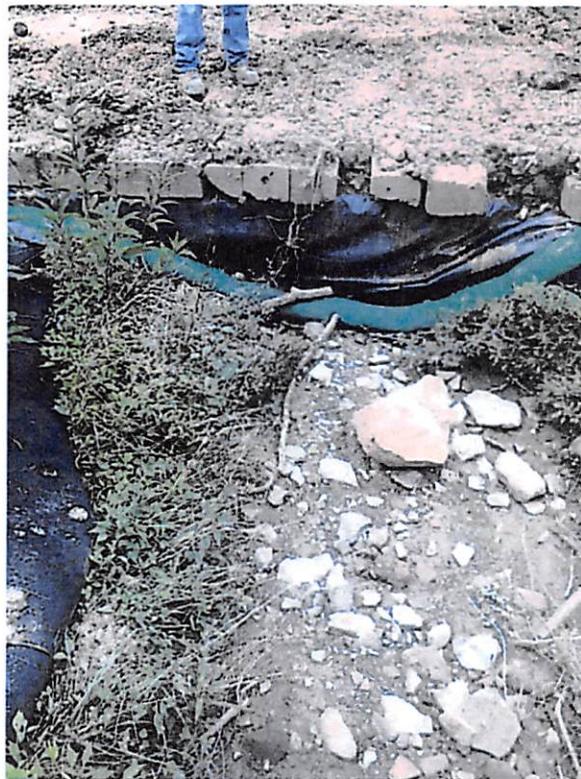
IMG_529: Wattles in stream.

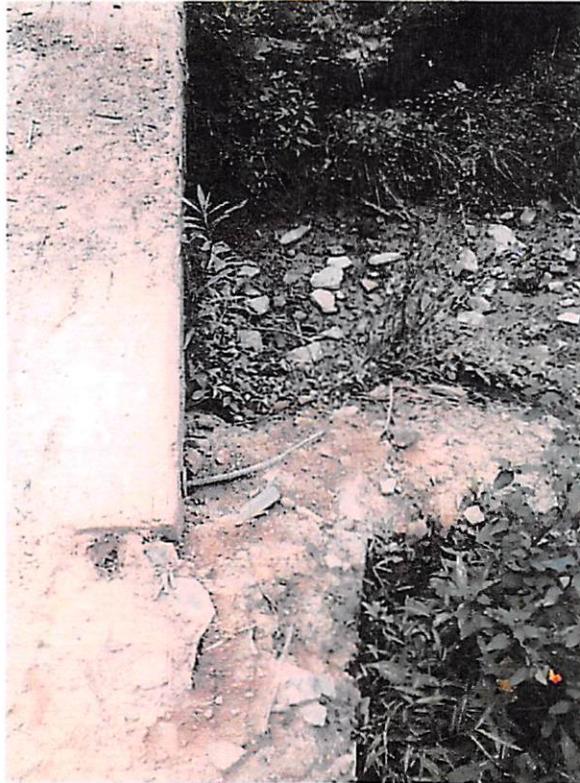
IMG_530: Sediment entering stream where timber mat bridge is not keyed in.

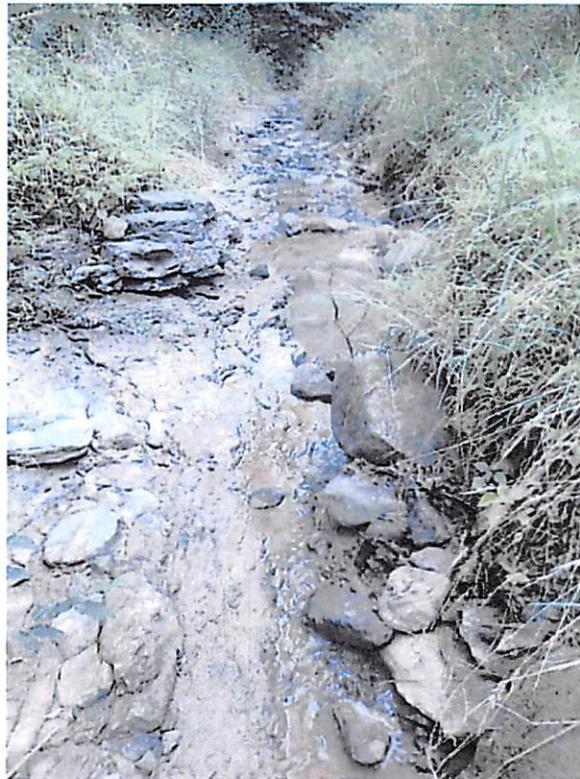
- a. 47CSR2 Section 3.2.b-HG Energy caused conditions not allowable in waters of the State. Specifically, sediment deposits originating from HG Energy's right of way were blocking Garrison Fork at the right of way and downstream of the right of way.

IMG_521: Downstream. Sediment deposits on rocks and in stream.

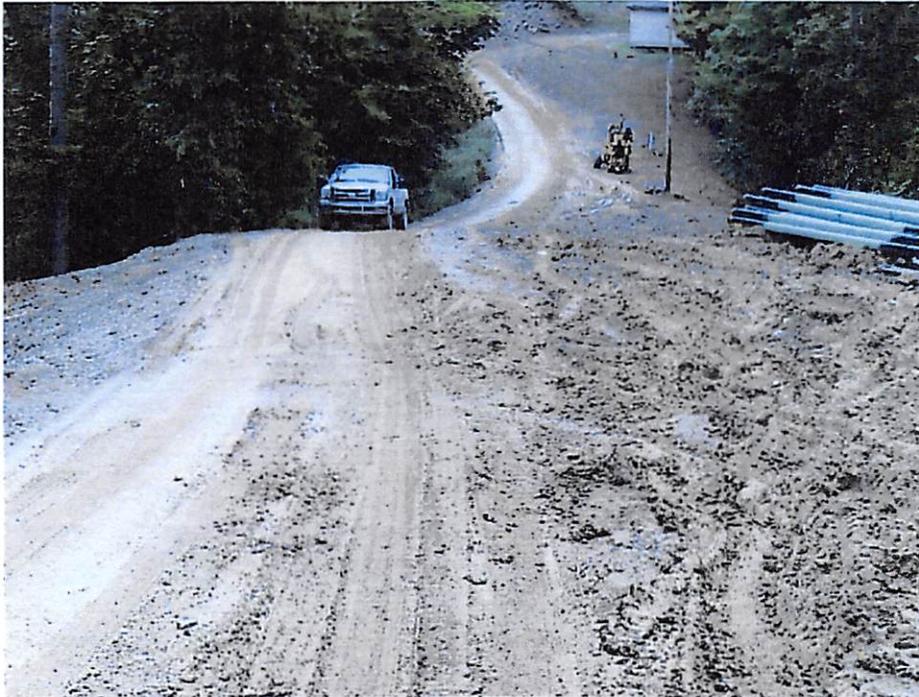
- d. Section G.4.c-HG Energy failed to modify its permit to include all disturbed area. Specifically, a section of pipeline being installed along Hoyt Rd. for more than 2,400 feet west of the permitted right of way was outside the limits of disturbance.

DSCN1525: Pipeline being installed along Hoyt Rd. off permitted limits of disturbance. Excessive mud on Hoyt Rd.

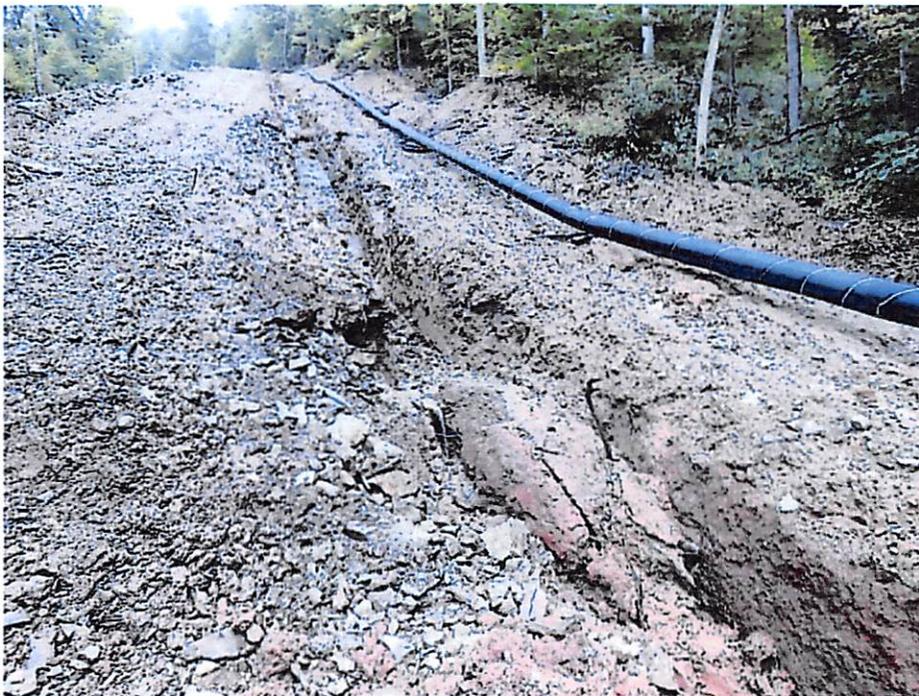
- iv. Excessive mud was on Hoyt Rd.
 - v. The walls of the trench were collapsing and, in conjunction with ground water and surface water infiltration, were creating mud flows.

DSCN1534: One of several areas where trench is collapsing.

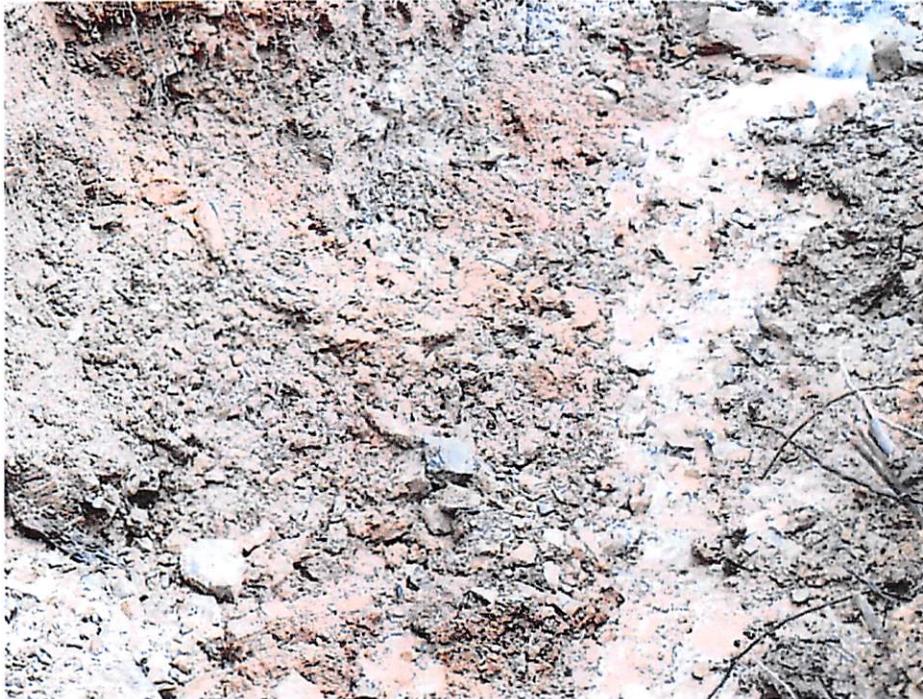
DSCN1530: Groundwater and surface water infiltration flowing in trench.

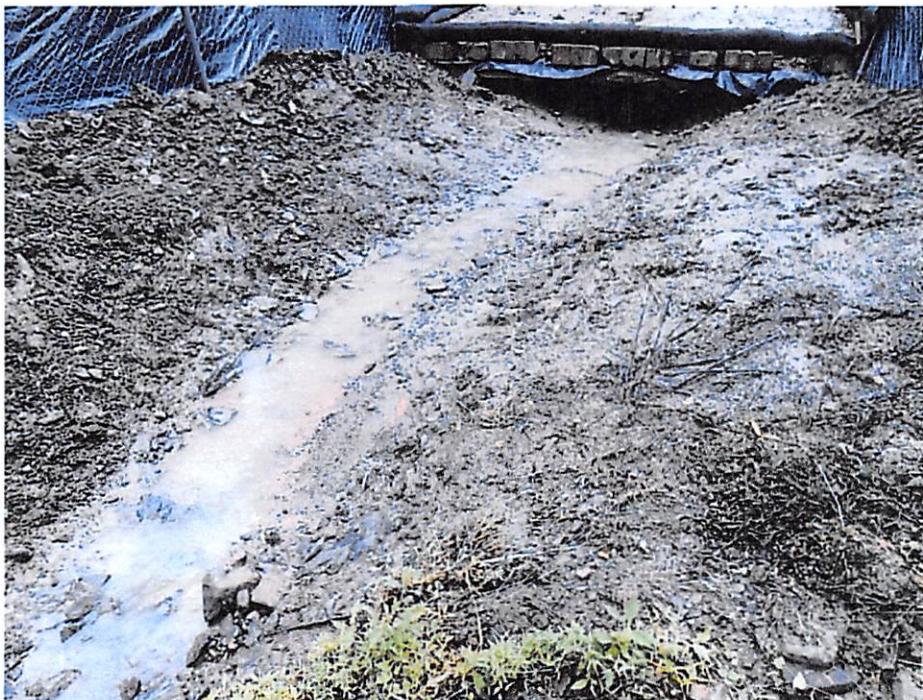
DSCN1536: Stream banks not stabilized.

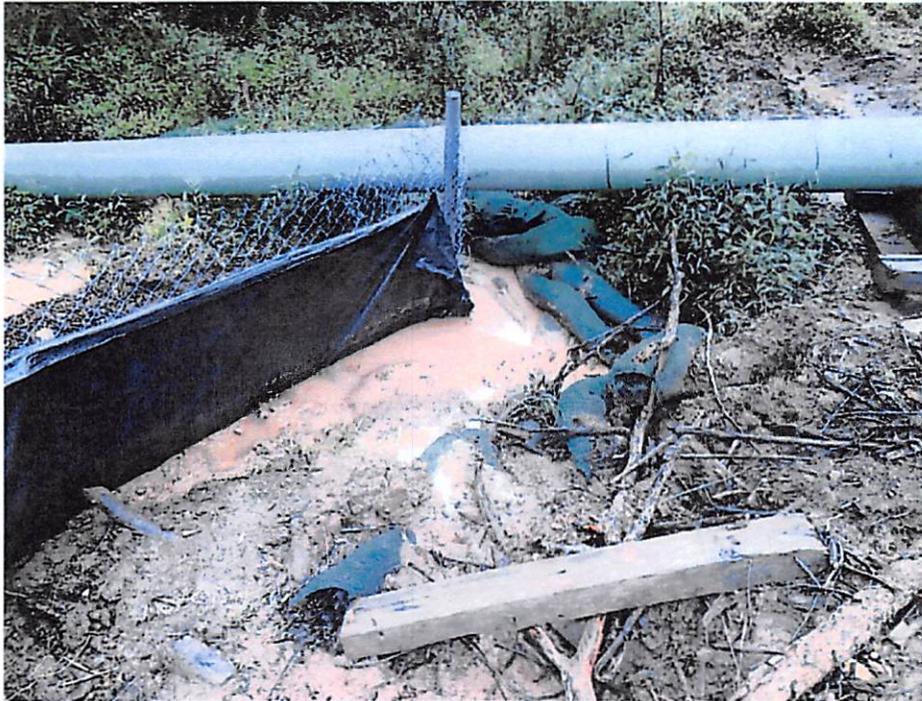
DSCN1537: Sediment laden water bypassing super silt fence.

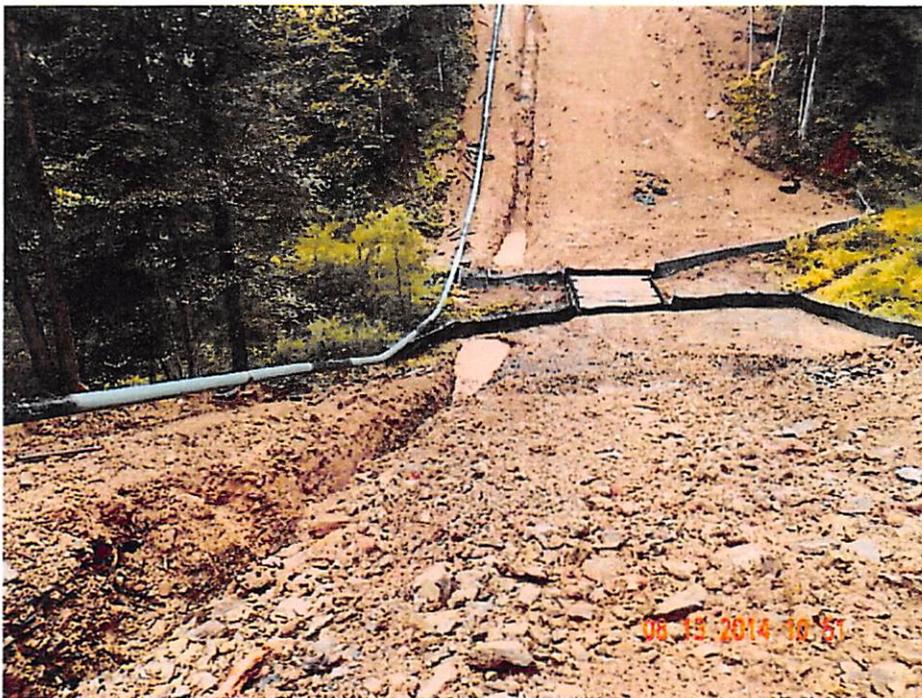
DSCN1488: Trench sumps full and overflowing.

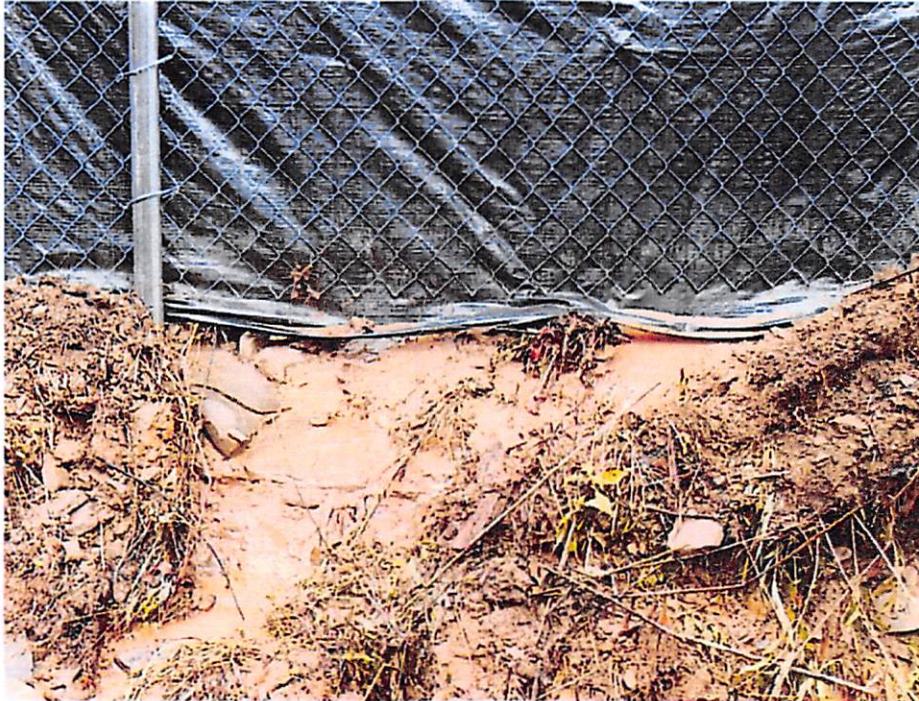
DSCN1538: Silt fence not keyed in allowing for sediment laden water to pass. Photo taken from stream side.

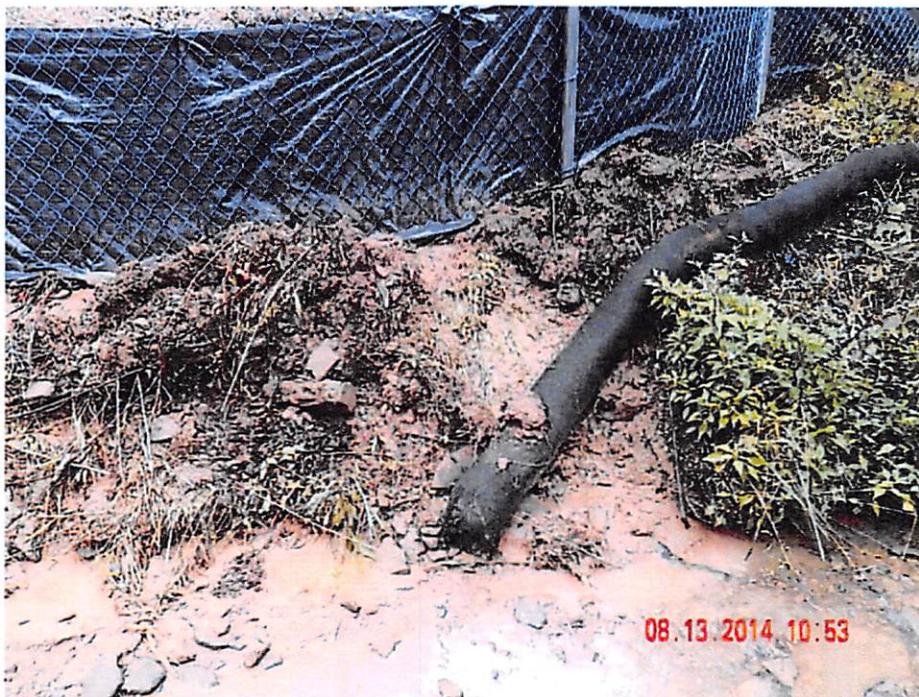
- c. 47CSR2 Section 3.2.a-HG Energy caused conditions not allowable in waters of the State. Specifically, sediment laden water originating from HG Energy's pipeline project was entering into Garrison Fork, creating a visible plume of settleable solids at the right of way and downstream.

DSCN1490: Sediment laden water entering Garrison Fork. Photo is same area as photo DSCN1538.

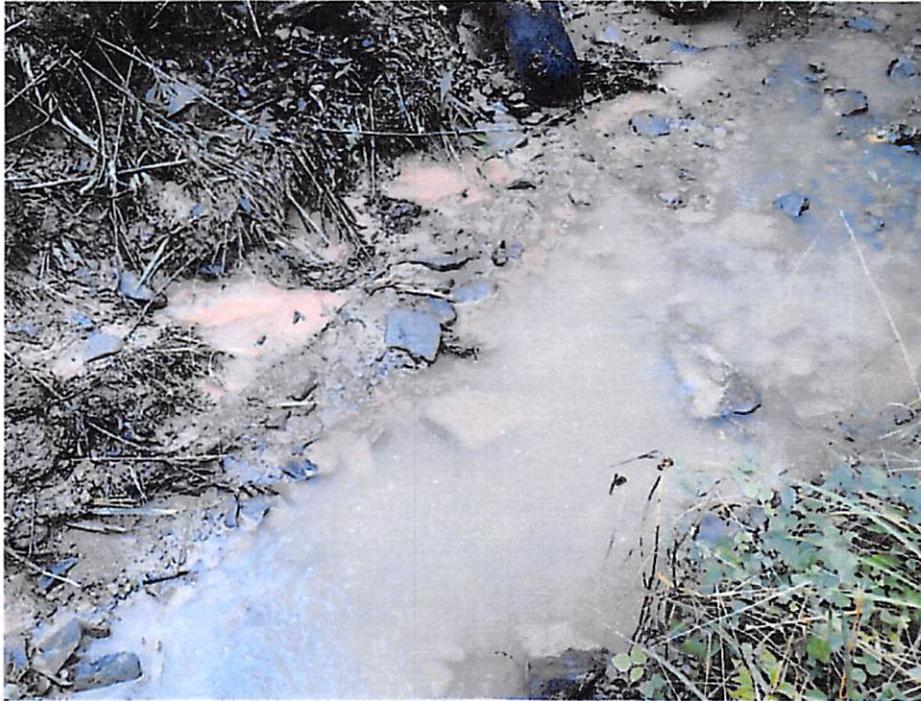
DSCN1539: Conditions not allowable in Garrison Fork.

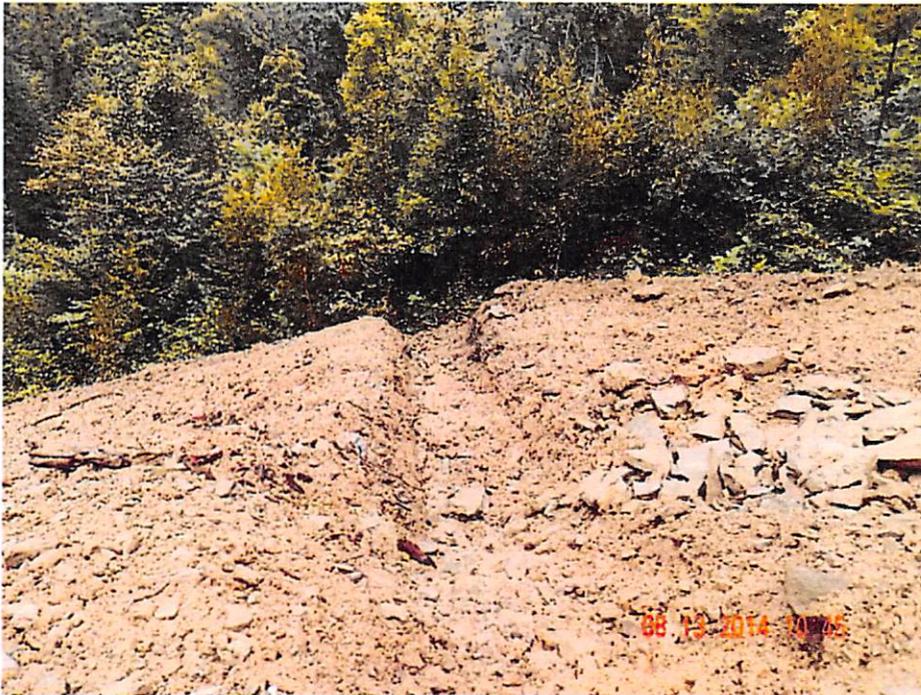
DSCN1486: Waterbar not installed properly. No outlet protection.

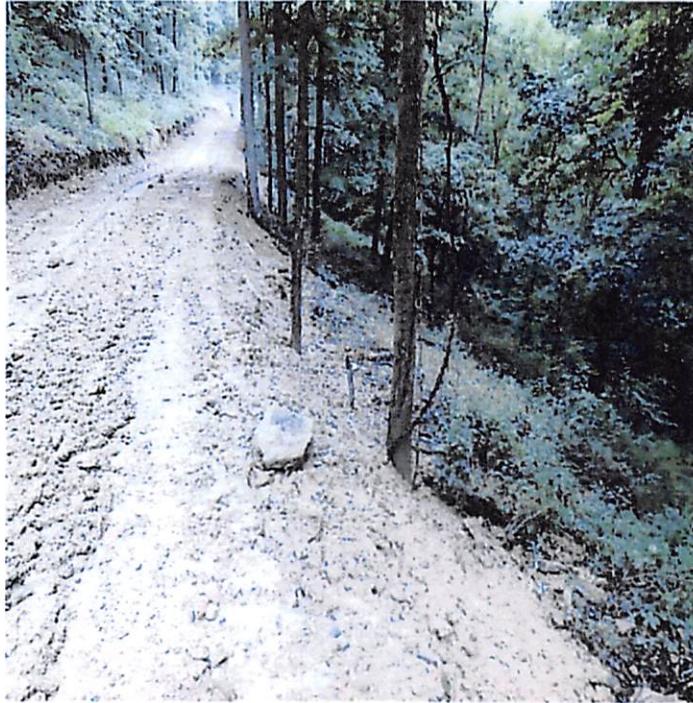
DSCN1560: Haul road without silt fence as required by SWPPP.

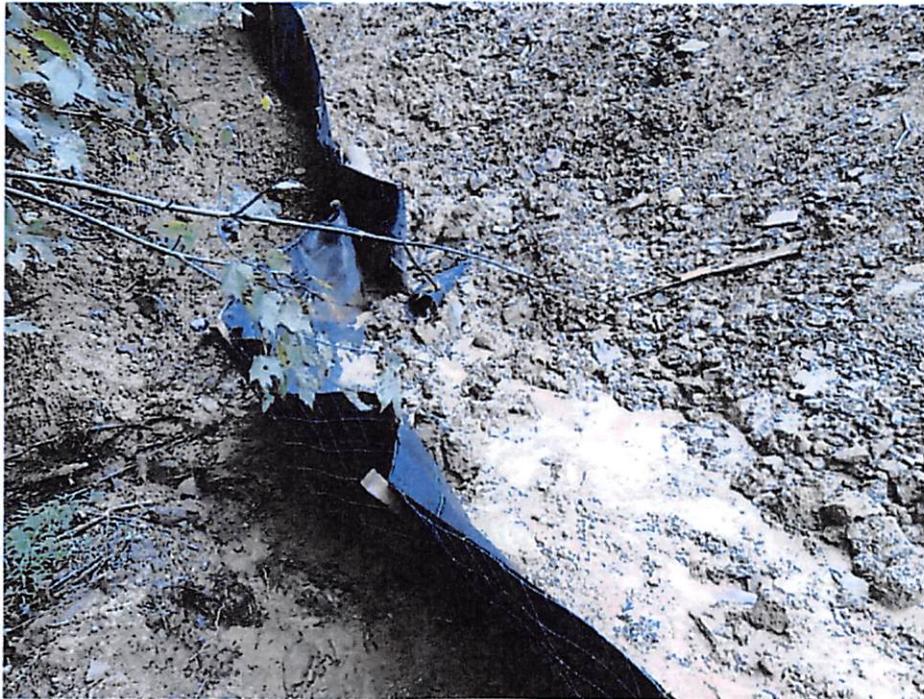
DSCN1567: Silt fence not being maintained allowing for sediment to leave site.

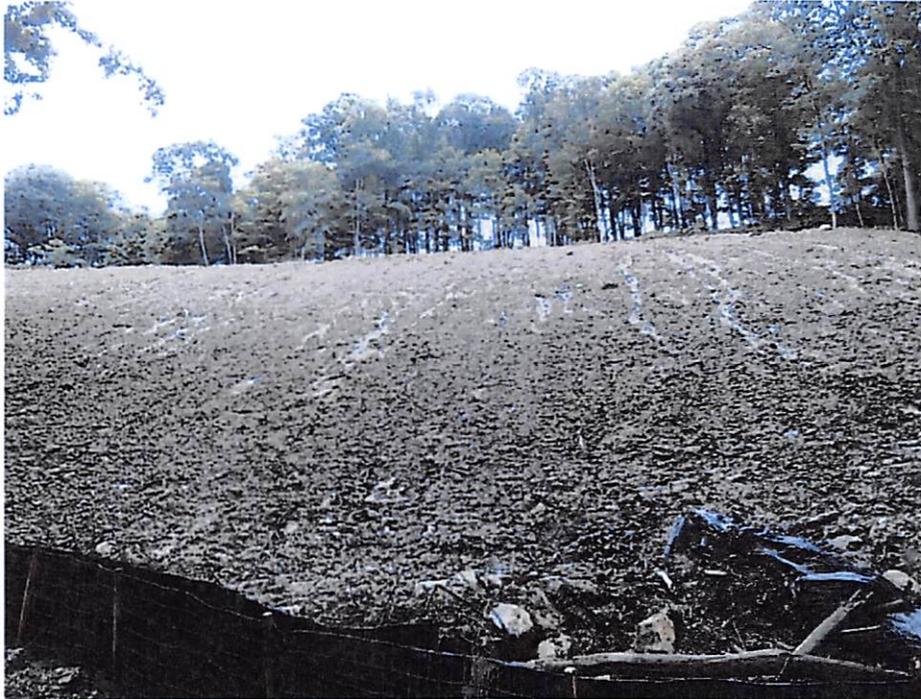
DSCN1577: Erosion rills on face of fill slope.

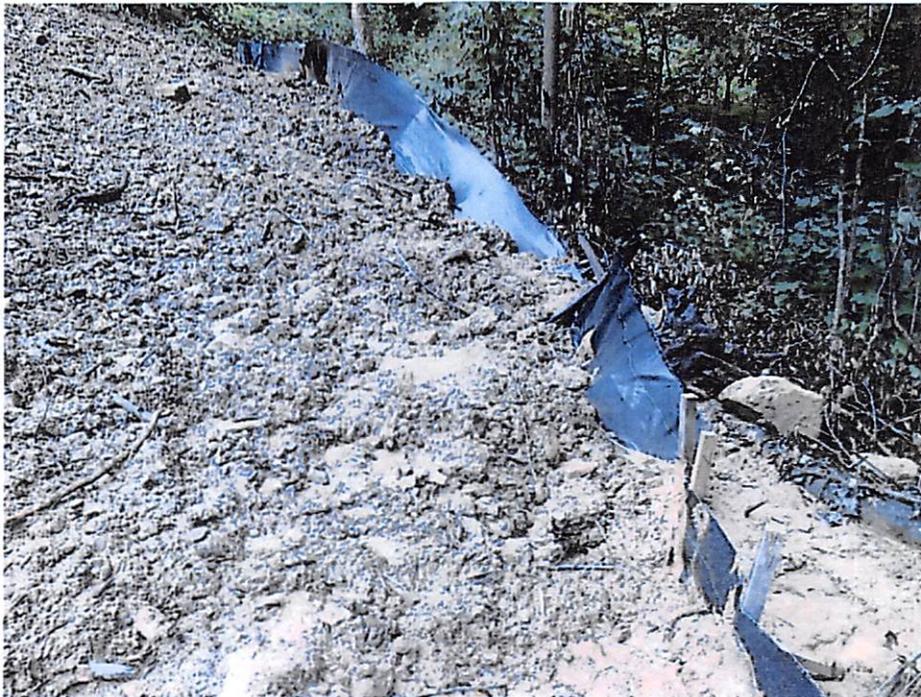
DSCN1583: Silt fence not being maintained. Sediment leaving the site.

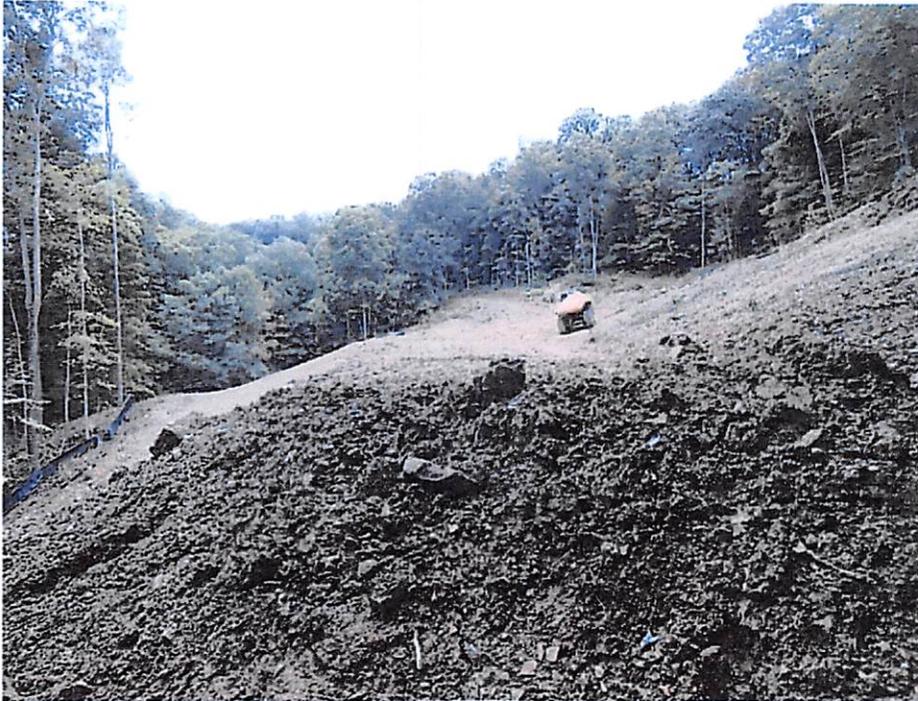
DSCN1586: Site overview. Diversions and sumps have not been installed.

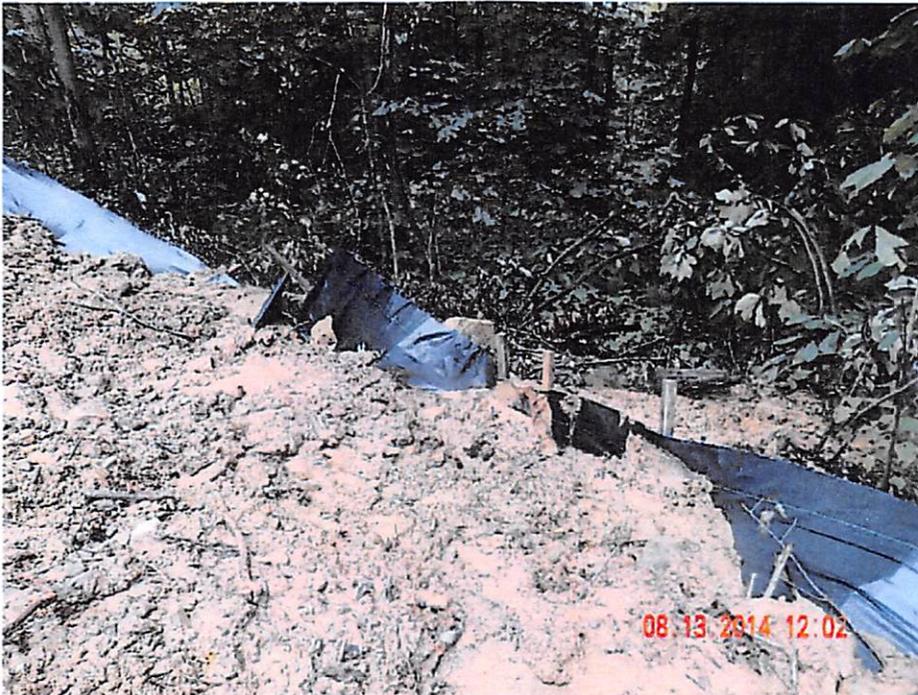
DSCN1513: Silt fence not being maintained. Sediment leaving site.

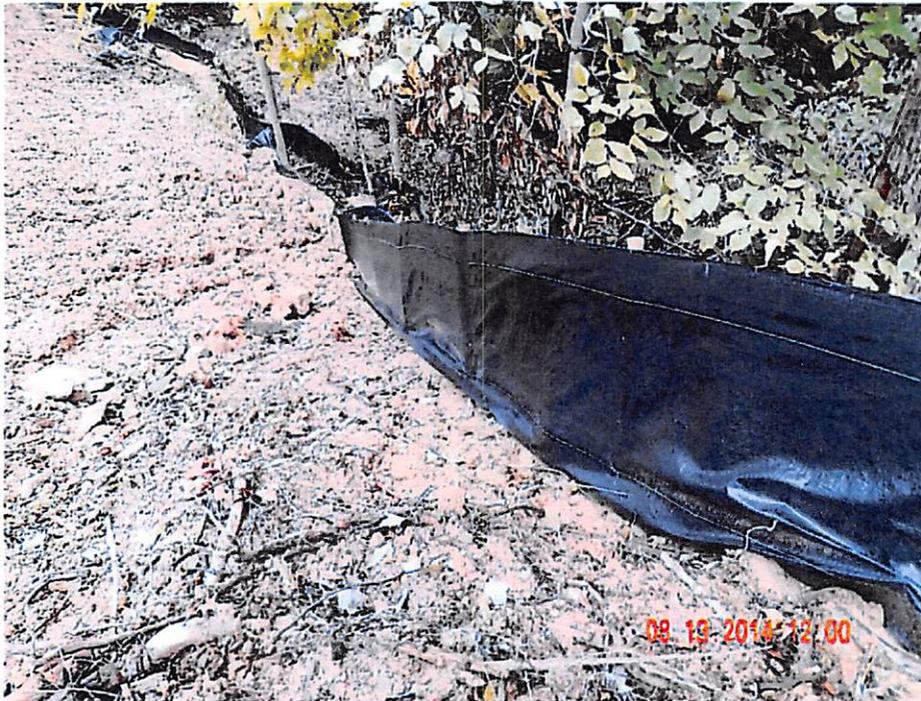
DSCN1507: Silt fence not keyed in.
