**CONSENT ORDER
ISSUED UNDER THE
WATER POLLUTION CONTROL ACT
WEST VIRGINIA CODE, CHAPTER 22, ARTICLE 11**

TO: HG Energy LLC
Attn: Matthew McGuire
5260 Dupont Rd.
Parkersburg, WV 26101

DATE: February 11, 2015

ORDER NO.: 8199

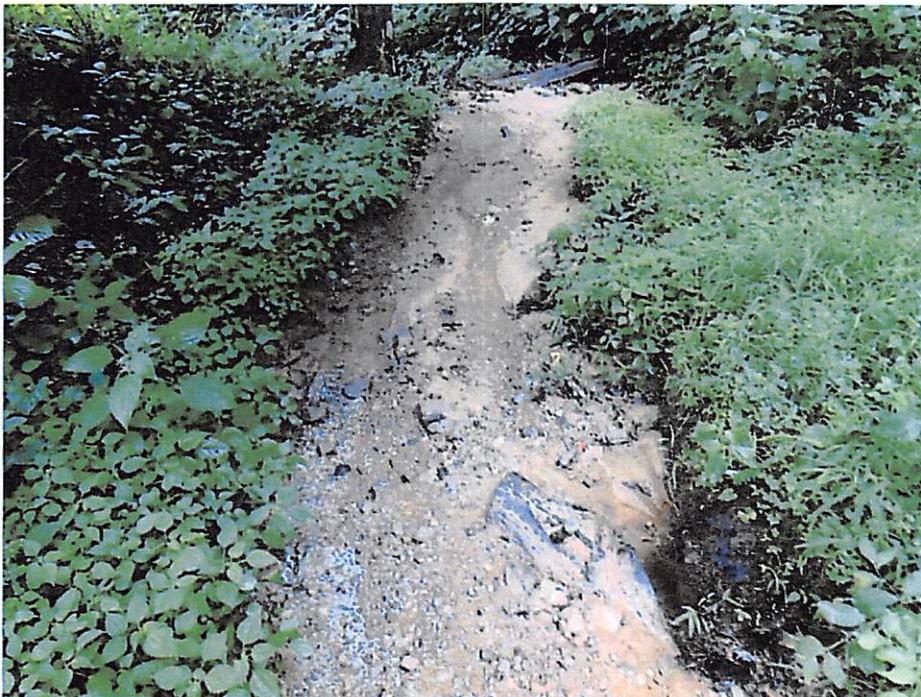
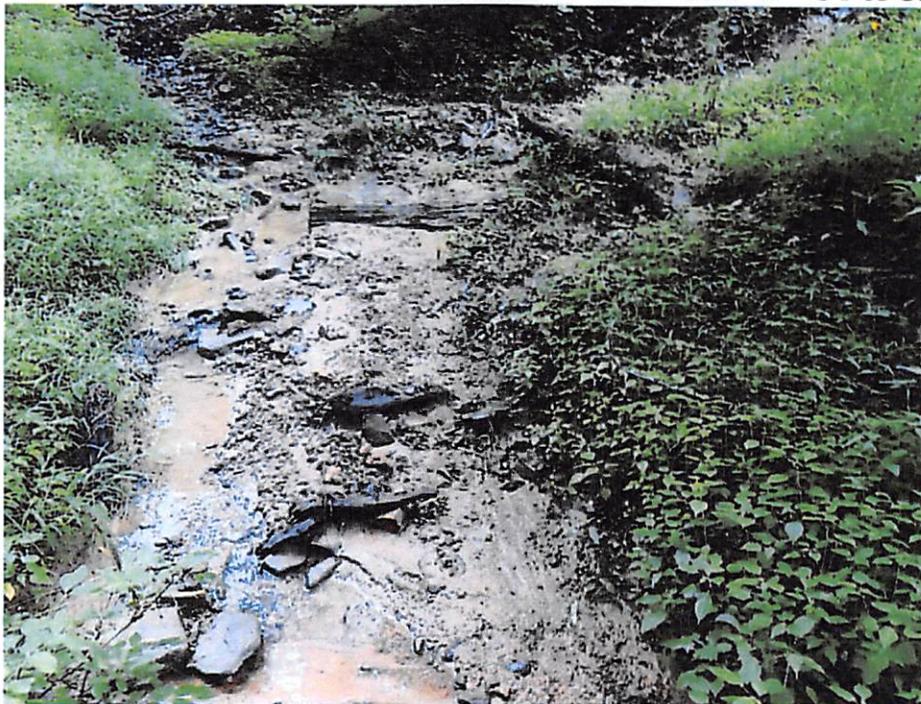
- a. 47CSR2 Section 3.2.b- HG Energy caused conditions not allowable in waters of the State. Specifically, sediment deposits originating from HG Energy's Fill Area project were observed in a UT of Garrison Fork.
- b. Section G.4.e.2.A.ii.f-HG Energy failed to protect fill slopes by using measures to divert runoff away from the fill slopes to conveyance measures such as pipe slope drains or stable channels.
- c. Section B-HG Energy failed to comply with the approved SWPPP. Specifically, sediment and erosion control devices were not in place.
- d. Section D.1-HG Energy failed to at all times properly operate and maintain all facilities and systems of treatment and control. Specifically, silt fence was not installed properly, and several areas were knocked over, torn, and/or partially buried.

DSCN1570: Sediment deposits in UT of Garrison Fork.

DSCN1572: Sediment deposits in UT of Garrison Fork.
