West Virginia Department of Environmental Protection
Division of Water and Waste Management
Environmental Enforcement

Fly Ash Dam/Landfill Condition Evaluation

November 2009

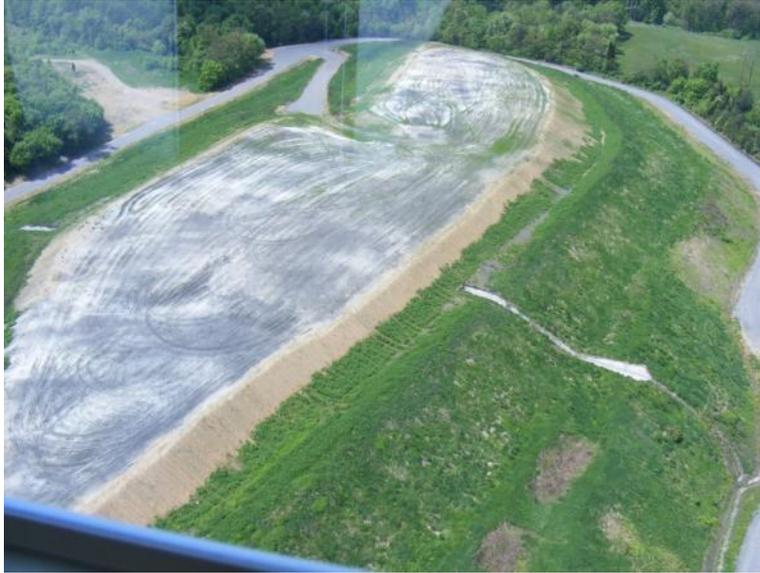
R. Paul Smith Landfill - Old Cell - 5/12/09

Inspection Summary: Minor erosion was observed on uncovered waste material in both the existing and the new cell (currently in a construction phase). Permittee states seeding for revegetation will be completed once the weather is suitable.

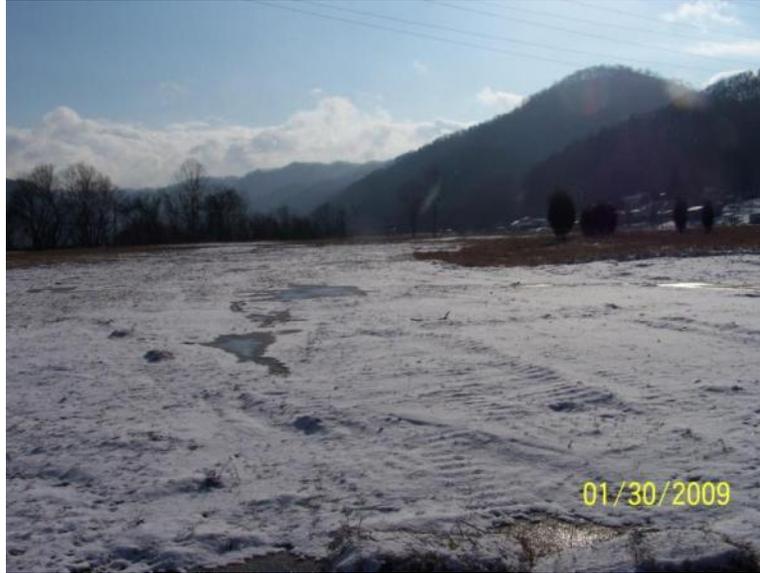
Deepwater Landfill – 1/30/09

Inspection Summary: This facility has been closed for a number of years and is currently enrolled in the Brownfield program with the WVDEP Office of Environmental Remediation (OER). The landfill has a storm water management system comprised of several vegetated swales that flow to drop inlets throughout the site. The drop inlets discharge via two under drains to the Kanawha River. Both discharges were clear, and no evidence of the ash material was observed in the discharge channels. Some minor pooling of water on the top of the landfill was observed. This appears to be due to partial obstruction of the drop inlet structures and snow

cover that may have slowed drainage through the swales. A small slip was noted on the out slope of the fill about halfway along the landfill, approximately 100 yards from the Kanawha River. WVDEP DWWM Permit Section records indicate that this slip was first observed in 1998, and has shown no signs of movement since its discovery. Medium sized woody vegetation was observed throughout the slip area, and the slip appears to be stabilized.

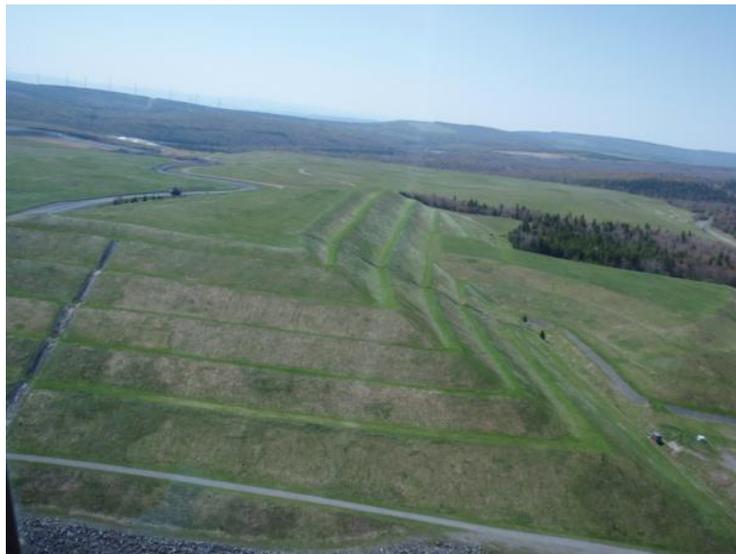
Mt. Storm - Closed Ash facility – 5/12/09

Inspection Summary: Facility appears to be well maintained. Well established grass cover.

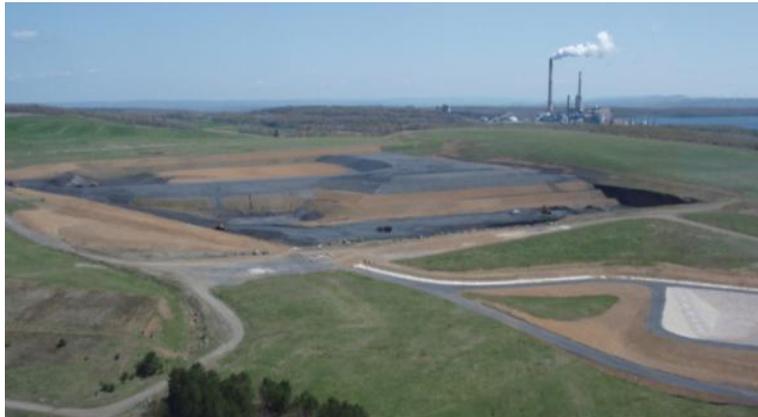
Mt. Storm - Active Ash Landfill – 5/12/09

Inspection Summary: Facility appears to be well operated and maintained. Well established grass cover. Leachate discharges to Consol mine.

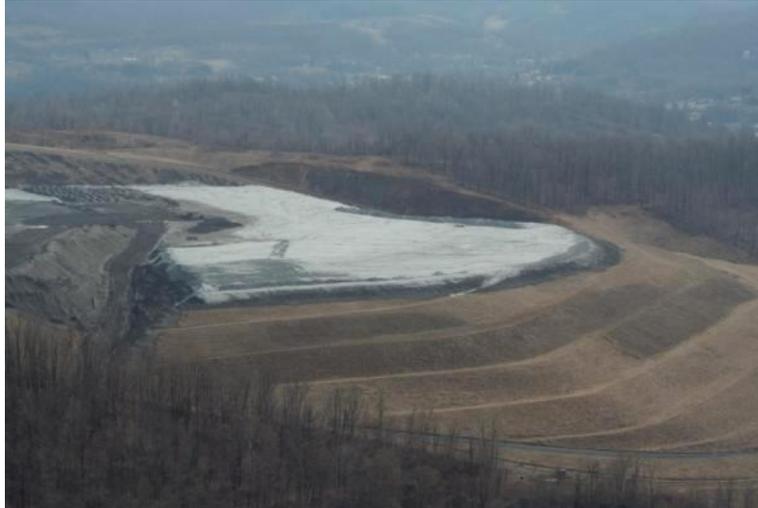
Harrison Ash Disposal Site - 2/11/09

Inspection Summary: Landfill slopes are stable with positive drainage noted throughout. No noticeable slips or bulges. The vegetation on the landfill was good. Stormwater diversion away from the landfill is controlled with diversion ditches and in good condition in areas inspected. One small area in Cell No. 3 has erosion where water broke over the bank and eroded the slope somewhat. The breach has been repaired and the erosion on the slopes will need to be repaired. One small area near the toe of the new cell has some erosion that has undermined the concrete drainage ditches. The water causing this erosion is diverted. No. 1 sediment pond impoundment appears to be in good condition; no slips, bulges or seepage noted. The wetland treatment system appears to be in good condition this date, good vegetation throughout the system. Outlet 016 has a sediment pond for treatment. Outlet 012 does not.

Warning Issued: Immediately direct water bypassing treatment at outlet 016 and flowing to outlet 012 back into outlet 016. Address minor erosion noted in the landfill when weather allows.

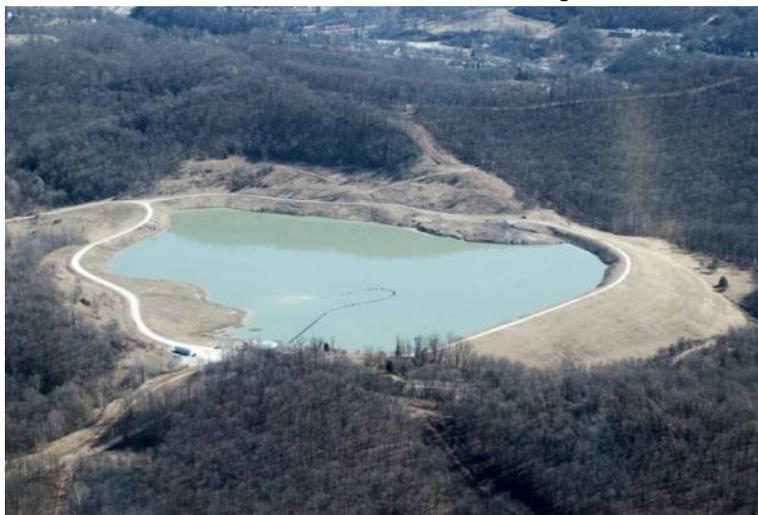
Holz Impoundment – 2/17/09

Inspection Summary: This impoundment receives wastes from the South Charleston plant's water filtration unit, power house (fly ash and bottom ash) and sludge from the City of South Charleston's wastewater treatment plant. This impoundment has no direct discharge. Overflow is piped to the City of South Charleston wastewater treatment plant. No deficiencies were noted.

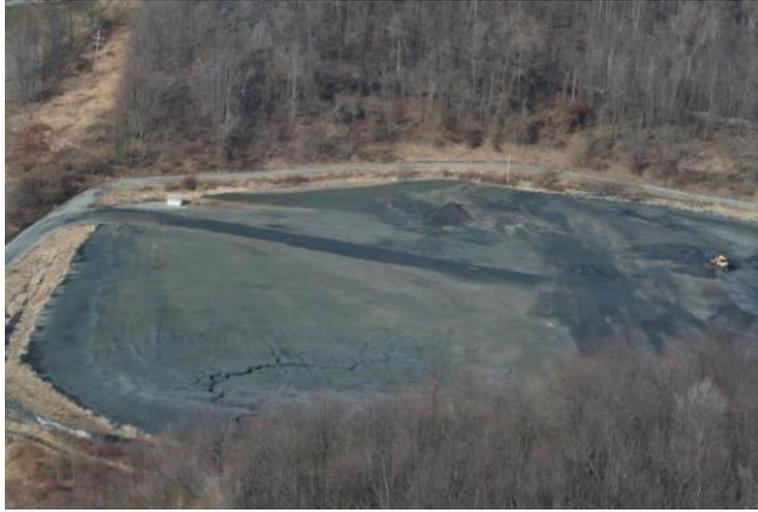
Rivesville New Ash Site – 2/11/09

Inspection Summary: There were no noticeable slips around the perimeter of the landfill. The bank of the pond that collects leachate and storm water from landfill appeared to be adequately vegetated and stabilized. There were fissures on the surface of the landfill from storm water run-off. Rock check dams were present in the ditch that conveyed storm water to the pond to collect sediment. The monitoring wells observed had concrete aprons, a locked cap and were properly

labeled. There has not been much activity at the site. Discharge Monitoring Reports (DMRs) were reviewed for January through April 2009. The reports were accurate and complete.

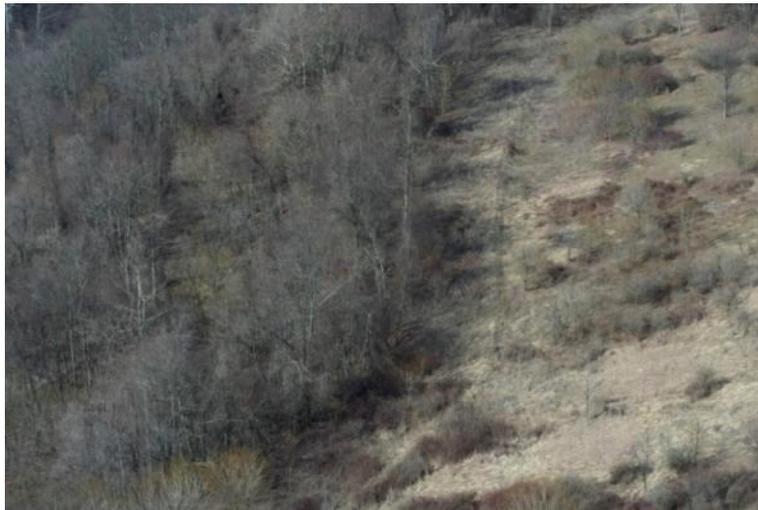
Rivesville Closed Ash Site - 2/11/09

Inspection Summary: Landfill has been closed for many years. No slips observed. Slopes covered with vegetative growth and trees. No storm water outlets.

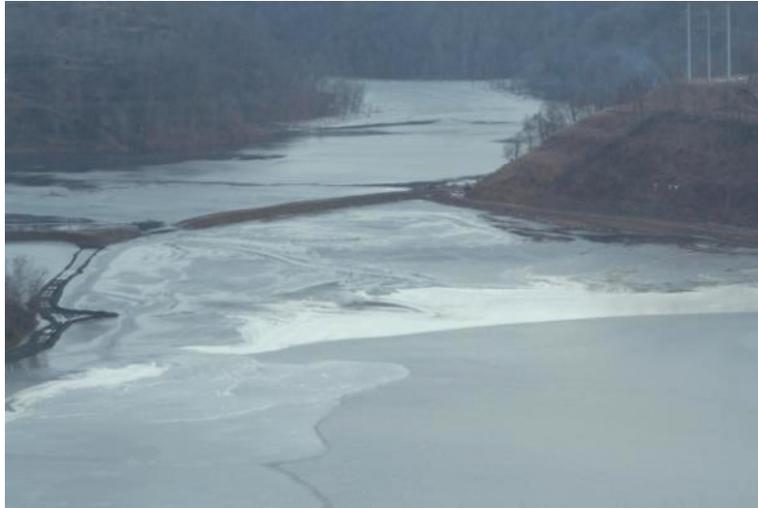
American Electric Power – Conner Run Impoundment – 2/11/09

Inspection Summary: The impoundment receives fly ash slurry from outfalls 104(AEP Mitchell Plant) and 204(AEP Kammer Plant) and coal mining waste from outfall 304(Consol McElroy Mine). The waste is pumped to the back of the impoundment by booster stations at the top of the hill near the saddle dam. All monitoring wells were observed and found to be in excellent condition, very well installed and maintained. Installation logs were reviewed and appeared to be satisfactory. Field logs for sampling were reviewed for sampling procedures and found to be satisfactory. They contained all data relevant to meeting permit Sec. C.21 requirements. DMRs were reviewed and spot checked against lab reports for 4th quarter 2008 and 1st quarter 2009 and found to be accurate and complete. Statistical analyses have been conducted on MWH1, MWU3, MWL3. MWU1 has reached the required ten samples and statistical analysis will be completed on the next report. Statistical Significant Increases (SSI) were found on MWH1 for temperature, SO₄, Zn, and Na. No other SSIs were found. Exceedances have been reported for As at MWH1, MWU3, and MWL3. An exceedance for Sb was reported at MWL3. The 2008 Annual Report shows waste received to be 440,665 tons from Mitchell, 42,555 from Kammer and 672,000 tons from Consol. The AEP operating record was reviewed and appeared satisfactory. An issue exists with an abandoned well, MWL1(4/06, collapsed screen), see fig. 6. Mr. Limes submitted the requested abandonment log, but it appears after review and site visit that it does not meet the requirements set forth in 47CSR60.19.2.3.

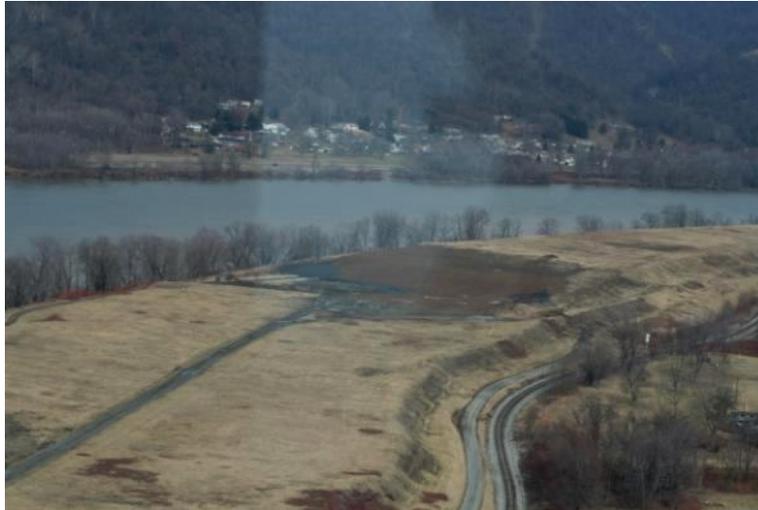
PPG Ash Landfill – 2/11/09

Inspection Summary: Produced fly ash is not currently being disposed of on site. Material is being taken to a fill in Ohio. Working face of fill has been partially capped. Work needs to be completed with exposed area stabilized, seeded and mulched. There is some evidence of animal burrows in the fill. Those areas need to be repaired and the animals trapped and relocated if possible.

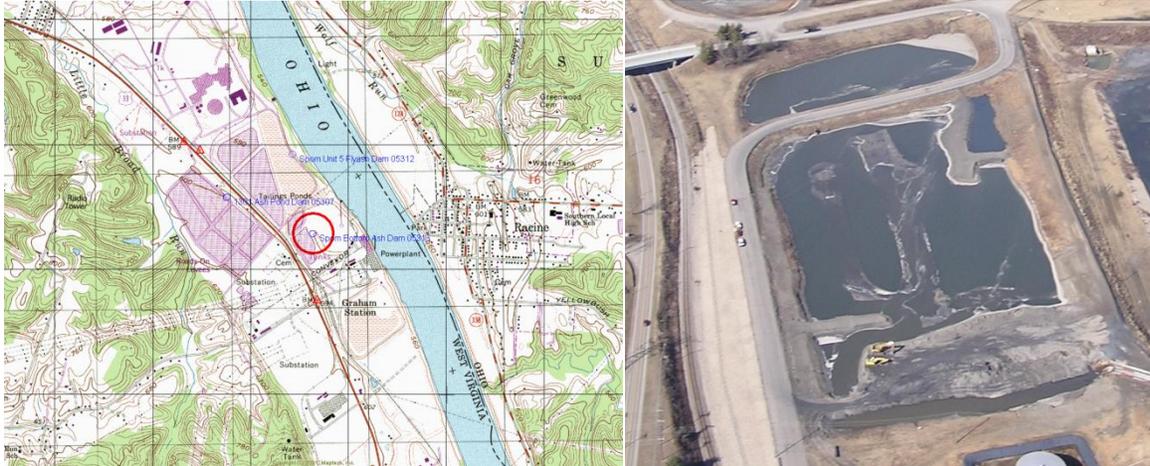
Sporn Bottom Ash Dam, Mason County, ID # 05313

A buttress of bottom ash exists on the upstream face of the embankment. Factors of safety less than required under the Dam Safety Rule were calculated in the bottom ash buttress in and under the water of the reservoir on the upstream slope of the embankments. No inadequate factors of safety were calculated that affected the overall integrity of the embankment. The bottom ash material, while apparently unstable by itself, provides weight against the existing dike material and apparently prevents slippage of the upstream slope under a number of conditions. The downstream slopes appear to meet or exceed Dam Safety Rule stability requirements. Therefore, the dam generally meets or exceeds the Dam Safety Rule stability requirements.

1. Monitor wave erosion.
2. Cut/remove vegetation.
3. Repair erosion gullies.

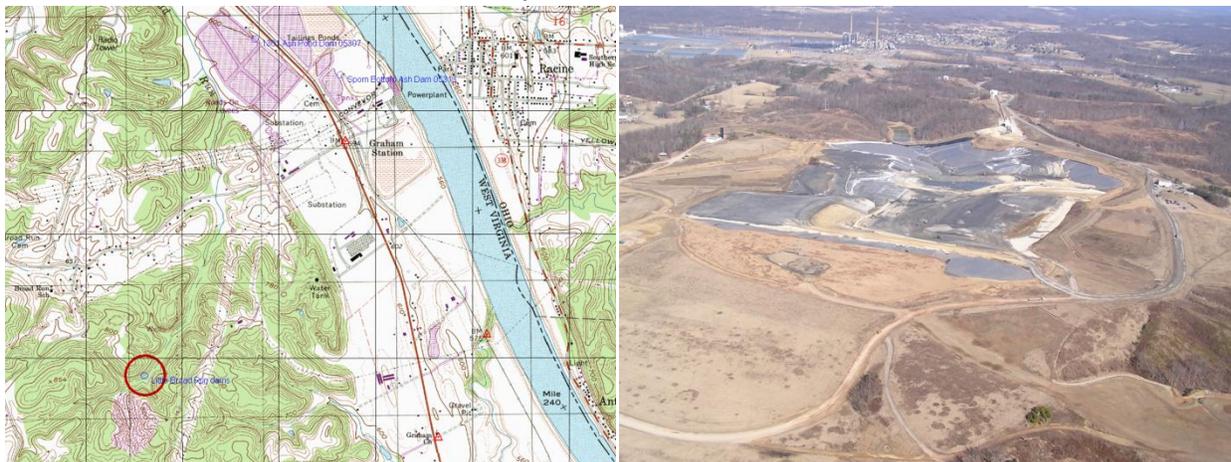
Little Broad Run Dams, Mason County, ID # 05319 & 05320

1. No spillway exists except for drainage through the landfill liner and one pump.
2. The embankments consist of highly erodible fly ash materials without apparent connection to natural ground foundation. No vegetation exists to stabilize the fly ash from erosion.
3. No emergency spillway or means to discharge the Dam Safety Rule design storm exists.
4. Downstream hazard potential appears to be high - loss of life is likely if the dams were to fail.

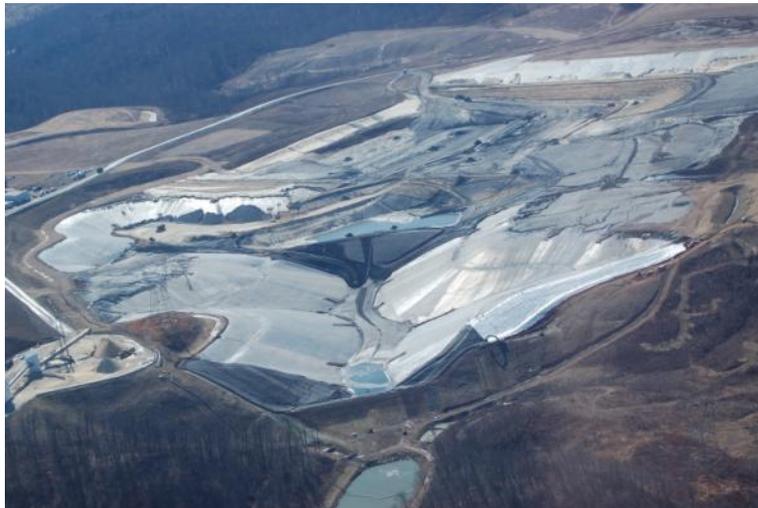
Little Broad Run Landfill – 2/17/09

Inspection Summary: 2/17/09 Large areas of the synthetic liner are uncovered and exposed. Slipping waste material, ponding water and erosion gullies all indicate that the collection system is not working properly. One liner tear was observed during the inspection and, according to the permittee; others have been noted and patched in the recent past.

Solids have accumulated in the leachate holding pond. Dredged solids adjacent to pond need to be removed. At the time of inspection measures were being taken to remove the solids in the pump sump area. Storm water outfalls 004 and 016 had significantly high results for both TSS and Total Recoverable Iron reported on the DMRs for the first and second half of 2008. Roadway above outlet 026 needs to be re-graded and stabilized. Gypsum offload area has inadequate drop inlet protection and conveyor system needs controls to prevent gypsum spillage onto ground. Several erosion gullies on site need to be corrected and stabilized. Storm-water from south side perimeter diversion ditch going into landfill cell #7. Rock armoring needs to be extended up right groin ditch of dike at cell #7. Access road on north side of cell #7 has not been stabilized and contributing sediment laden water to storm-water ponds. Coal combustion by-

products (CCB) being tracked on the haul road, washed off with process water, and discharged at a storm-water outfall. Several portions of the clay borrow area and the dike at cell #7 need to be revegetated. Too many cells open at one time creating potential for emergency situations and conditions that are extremely hard to manage. Large quantities of CCB are slipping and eroding within the landfill. As a result there is potential for impounded storm water and CCB material to destabilize and breach the dike between cell #6A and #6B. Also, as a result, large sections of the synthetic liner are exposed to equipment activity and the elements. No measures in place to control windblown gypsum dust at radial stack-out area.

5/29/09 Synthetic liner has been reinforced in problem areas. Chimney drains being regularly maintained for silting over. Ponding in Cell 7 being pumped out, restored dike and improved drainage in impounded area at Cell 6A. Leachate pond clean and free of solids. Intermediate cover being applied at Area #5. Diversion (on southeast side of Cell 7) still allowing storm water into Cell 7. Roadside diversion opposite leachate collection pond (north of outfall #026) needs to be maintained for solids/silt removal. Access road (northwest of Cell 7) not stabilized and contributing muddy water to Sediment Pond #1 (upper). Sediment and erosion controls need to be established along haul road in area draining to outfall #004. Placement and compaction *much improved from last inspection*, no large scale erosion or signs of material slippage. Still too much area open at once. Gypsum stackout area *much improved* with equipment and load-out technique modifications.

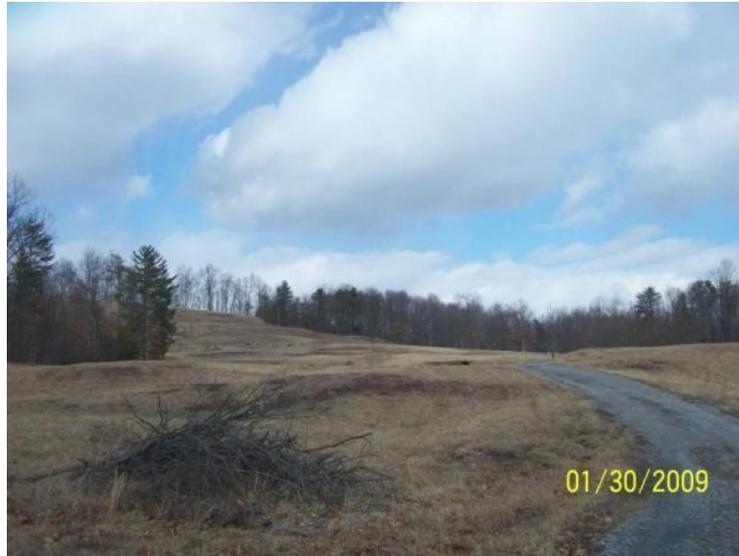
Adair Run Landfill - Area of Future Landfill – 1/30/09

Inspection Summary: This facility has not started. A portion of the area covered by the landfill permit is being utilized as a borrow area for a landfill in Virginia. The disturbed area for the borrow project is currently permitted under a General Permit for Stormwater associated Construction Activities.

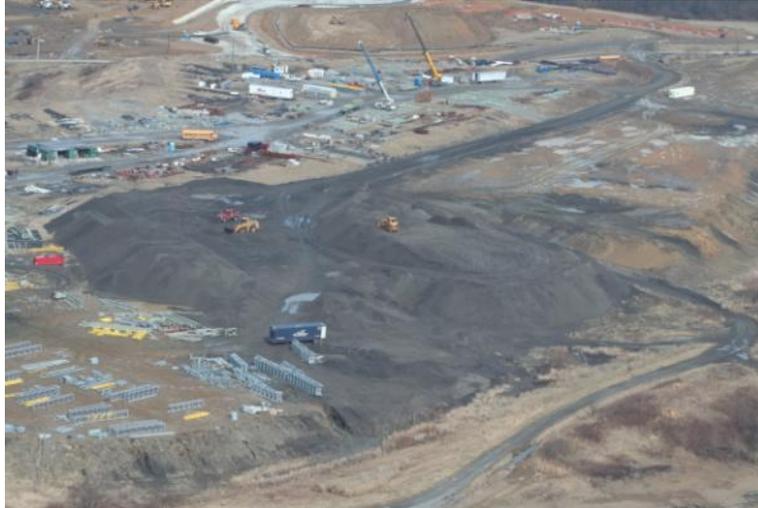
Fort Martin Ash Site – 2/11/09

Inspection Summary: No noticeable slips around the perimeter of the landfill. The banks of the four ponds that collect leachate and storm water from the landfill appeared to be adequately vegetated and stabilized. Lift stations that collect and pump pond effluent to the cooling tower appeared to be operating satisfactorily. The monitoring wells observed had concrete aprons, a locked cap, and were properly identified. A large pile of bottom ash is being stored on top of the landfill, the bottom ash will be used during construction of the leachate monitoring system for the new landfill across the road. Sampling data for the monitoring wells was satisfactory.

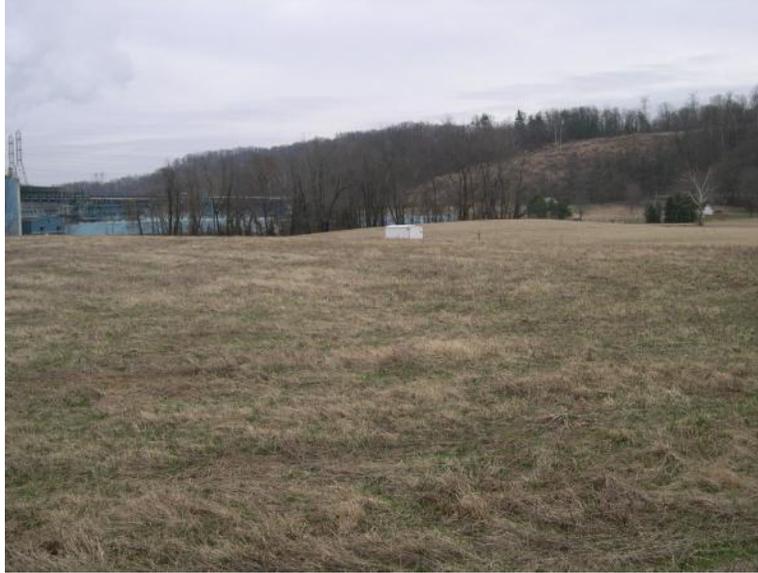
Cytec - Willow Island Flyash Impoundment – 2/19/09

Inspection Summary: This facility is no longer being utilized. The impoundment was used for the disposal of material generated by the facility's coal fired boilers. In 2005 the facility changed to natural gas as their fuel source. Permittee reports that closure plans are being developed for the impoundment. Groundwater monitoring is still being conducted, but no active filling is occurring.

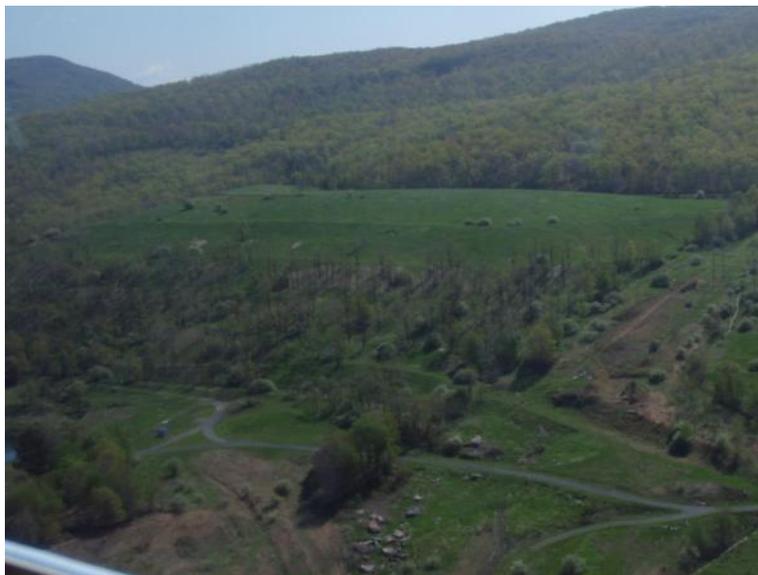
Albright Power Station - Closed Ash Cell - 5/12/09

Inspection Summary: Significant amount of woody growth and trees are present on the lower slopes and terraces of the fill, otherwise facility appears to be well maintained. Grass cover is well established.

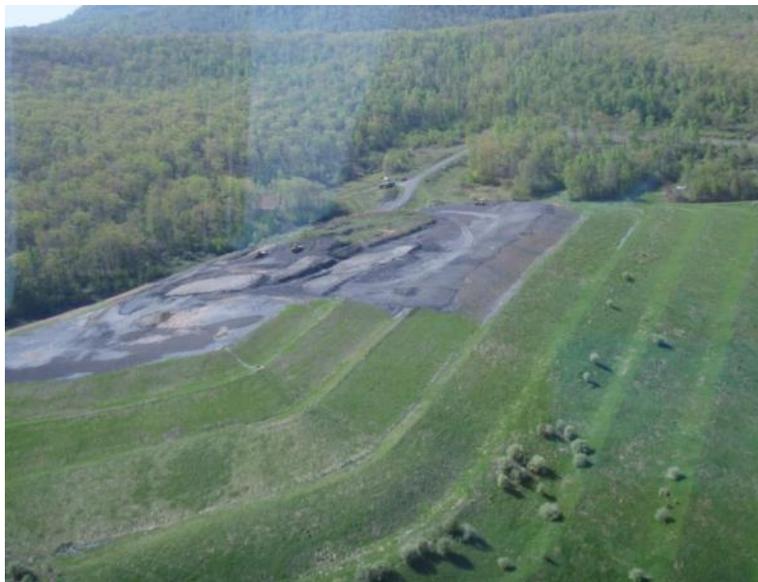
Albright Power Station - Active Ash Cell – 5/12/09

Inspection Summary: Some small woody growth on slopes and terraces, otherwise the facility appears to be well maintained and well operated. Grass cover is well established. Outlet 003 had four selenium excursions from September 2008 to April 2009.

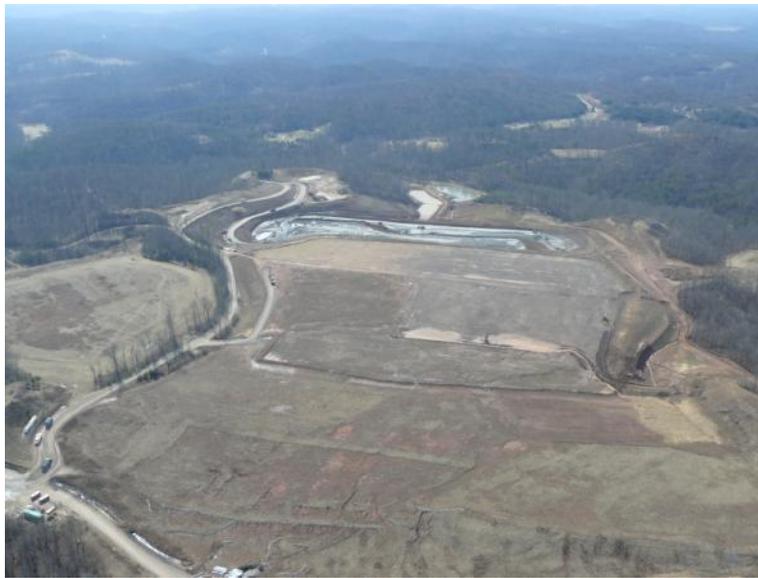
Quarrier Landfill – 2/17/09

Inspection Summary: Clean water diversion leading to outfall 011 has been routed to storm water pond, thus increasing the number of acres drained without increasing the pond's capacity. Unstabilized roadway runoff diverted directly to outfall 010 creating sediment deposits in the ditch line leading to the stream. Inadequate sediment / erosion controls and practices, insufficient revegetation. Fly ash deposits deposits in wetland area on both sides of haul road.

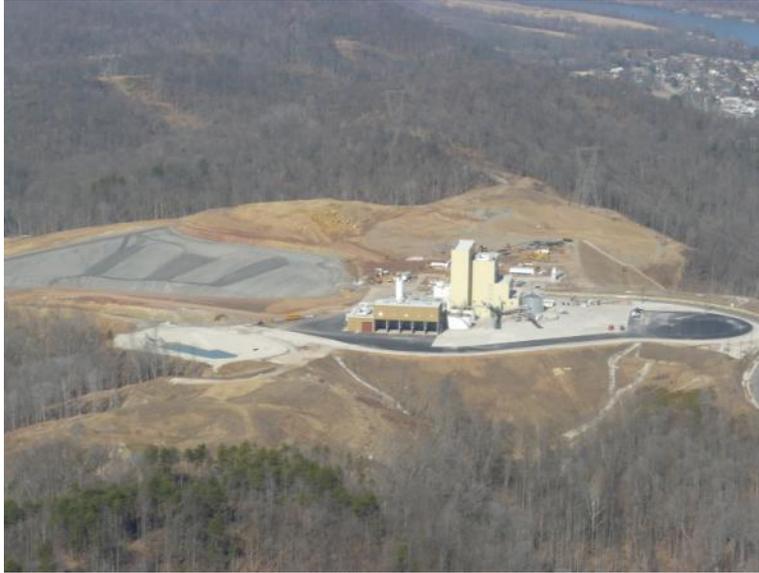
John E. Amos Landfill – 2/17/09

Inspection Summary: Landfill not yet active at time of inspection. Expected to become active in April. Extensive areas of disturbed, unstabilized soil.
