Lost River 319 #2

FY07 Final Report

NPS 1246 AM1
[02070003](#)

Lost River 319 Incremental Reporting (LR2)
April 2011- December 2011

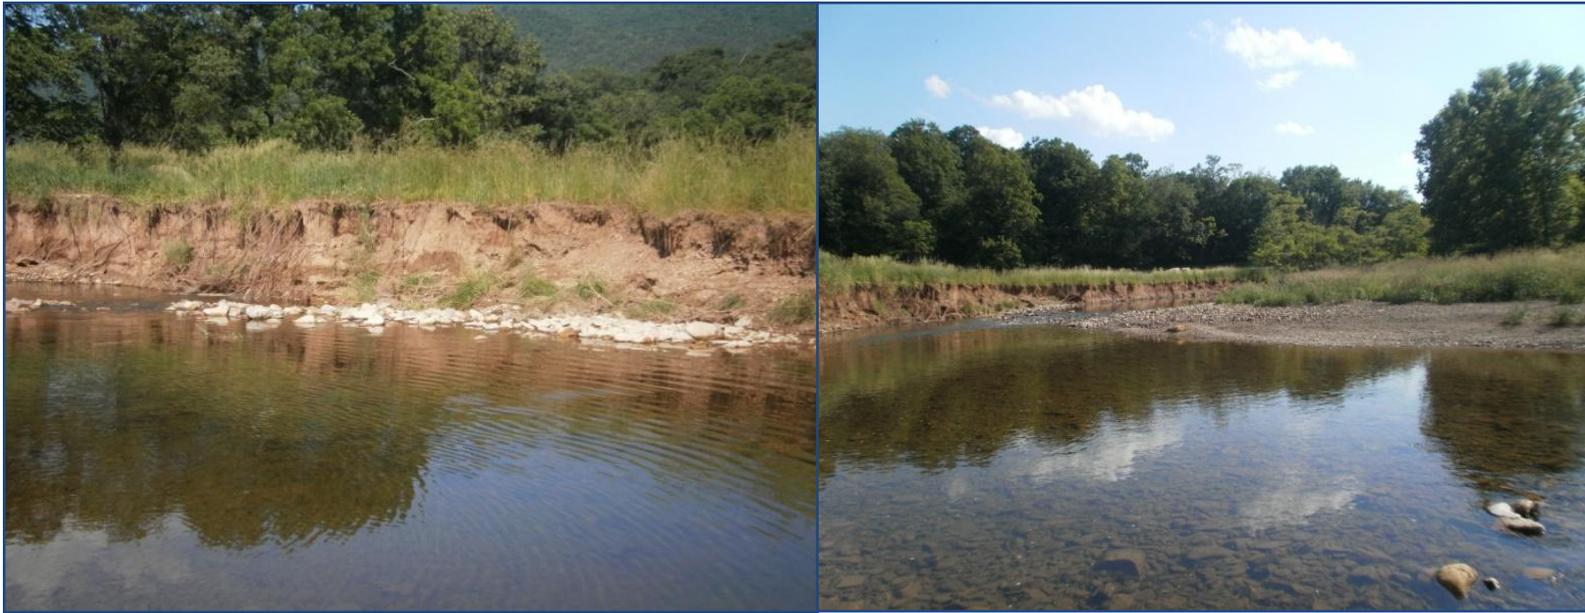
Fanlser Stream Enhancement and Bank Stabilization Project

The Fansler site is located within the Lost River Watershed approximately 1 mile south of Mathias, WV. The total project reach is **1,621 feet**. The original site condition was characterized by significant active erosion caused by hoof shearing and agricultural land loss. The site was chosen as a priority based upon the current cropping situation and the livestock access during winter months.

Pre-Construction photos show the severe erosion issues

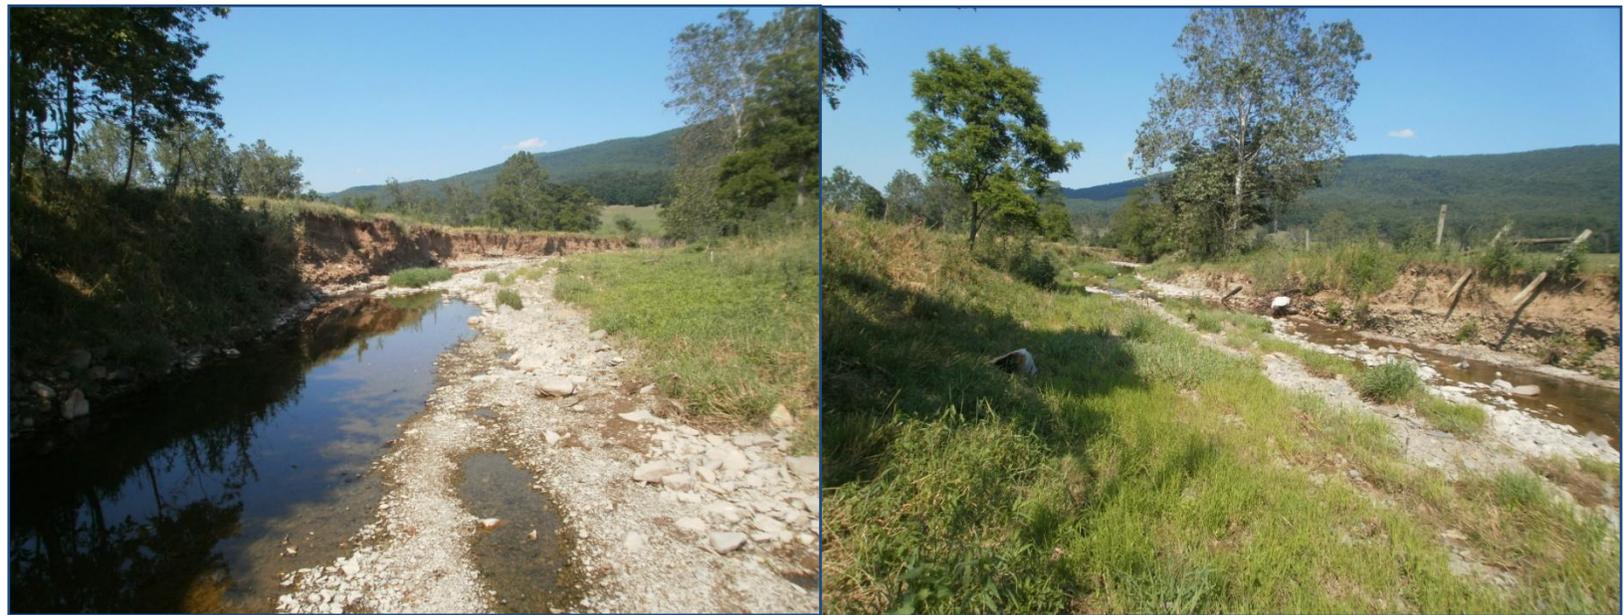
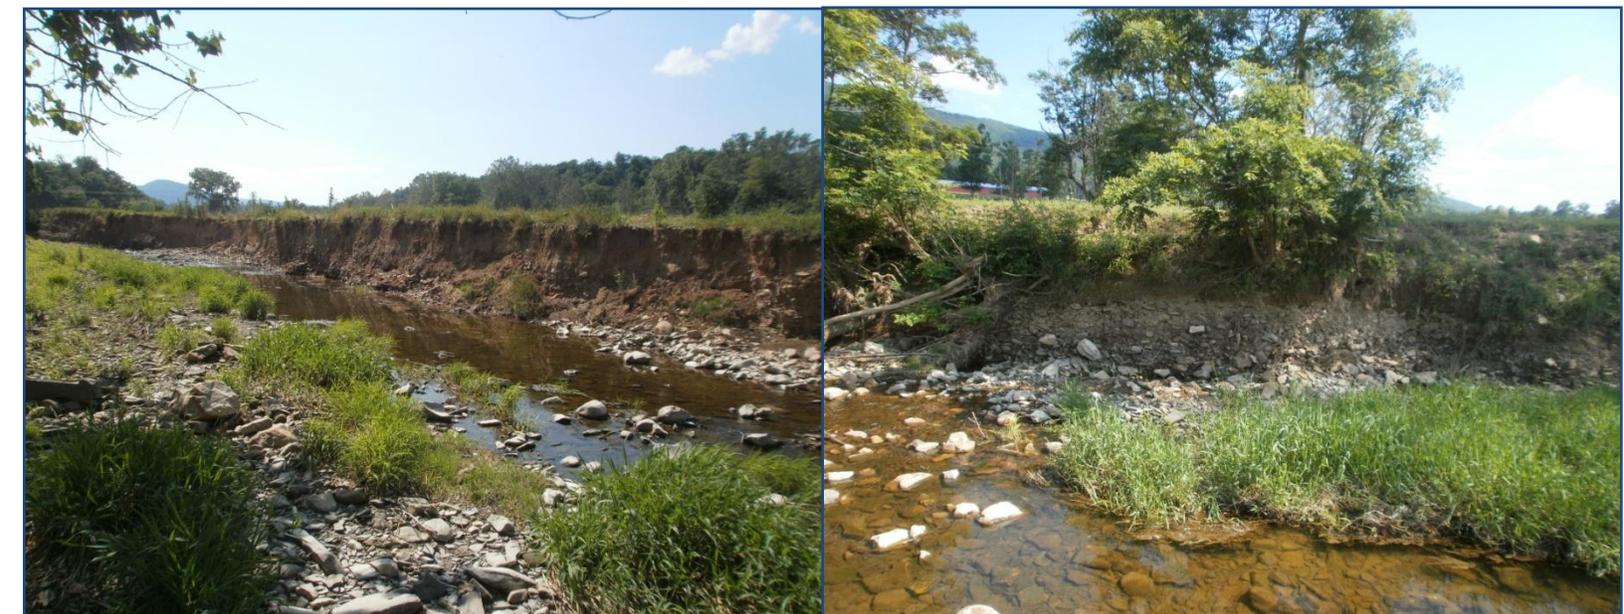
Miller Stream Enhancement and Bank Stabilization Project Pre-Construction

The original site condition was characterized by significant active erosion caused by hoof shearing and agricultural land loss. Fourteen structures were built within the reach- ten cross-vanes and four j-hooks. The structures were built to reduce erodibility of the constructed bankfull benches while the riparian vegetation establishes. The cross-vanes will help stabilize the channel by providing grade control for the newly constructed facet slopes. The structures will also improve habitat quality and quantity by maintaining the proper profile throughout the reach. A stabilized stream crossing was installed which

Pre-construction conditions on the Miller site.

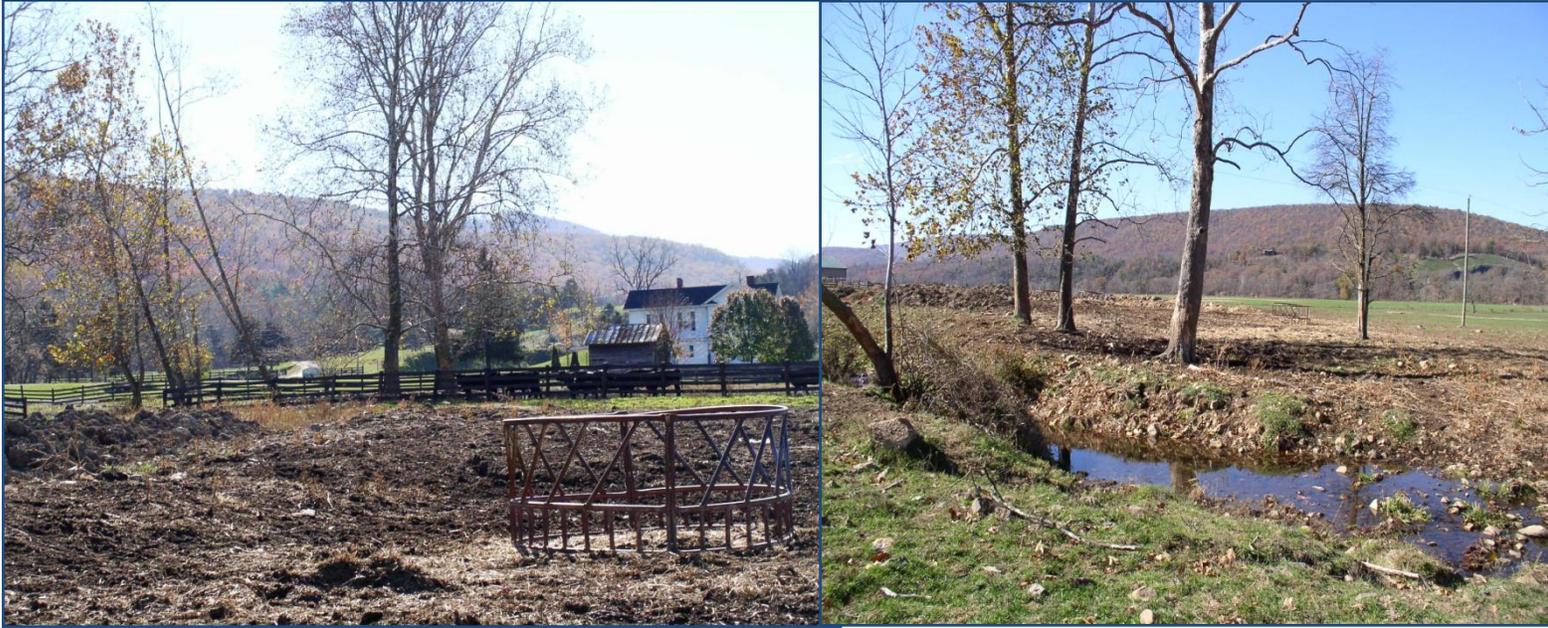
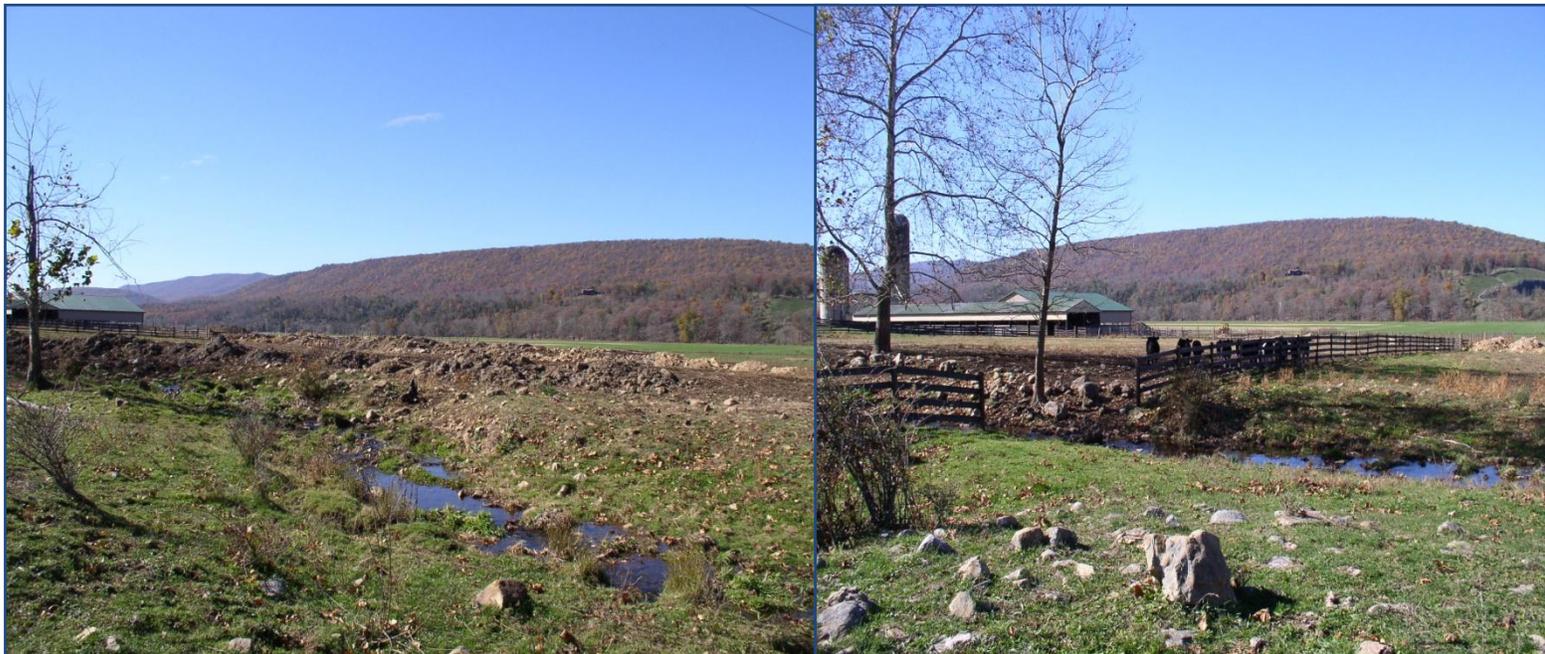
Teets Beef Feeding Facility and Manure Stacker- Before

Cattle were fed adjacent to the tributary and manure was piled in the fields until it could be properly spread
