APPENDIX 2

A-2. ELK RUN/DEAKIN RUN

A-2.1 Watershed Information

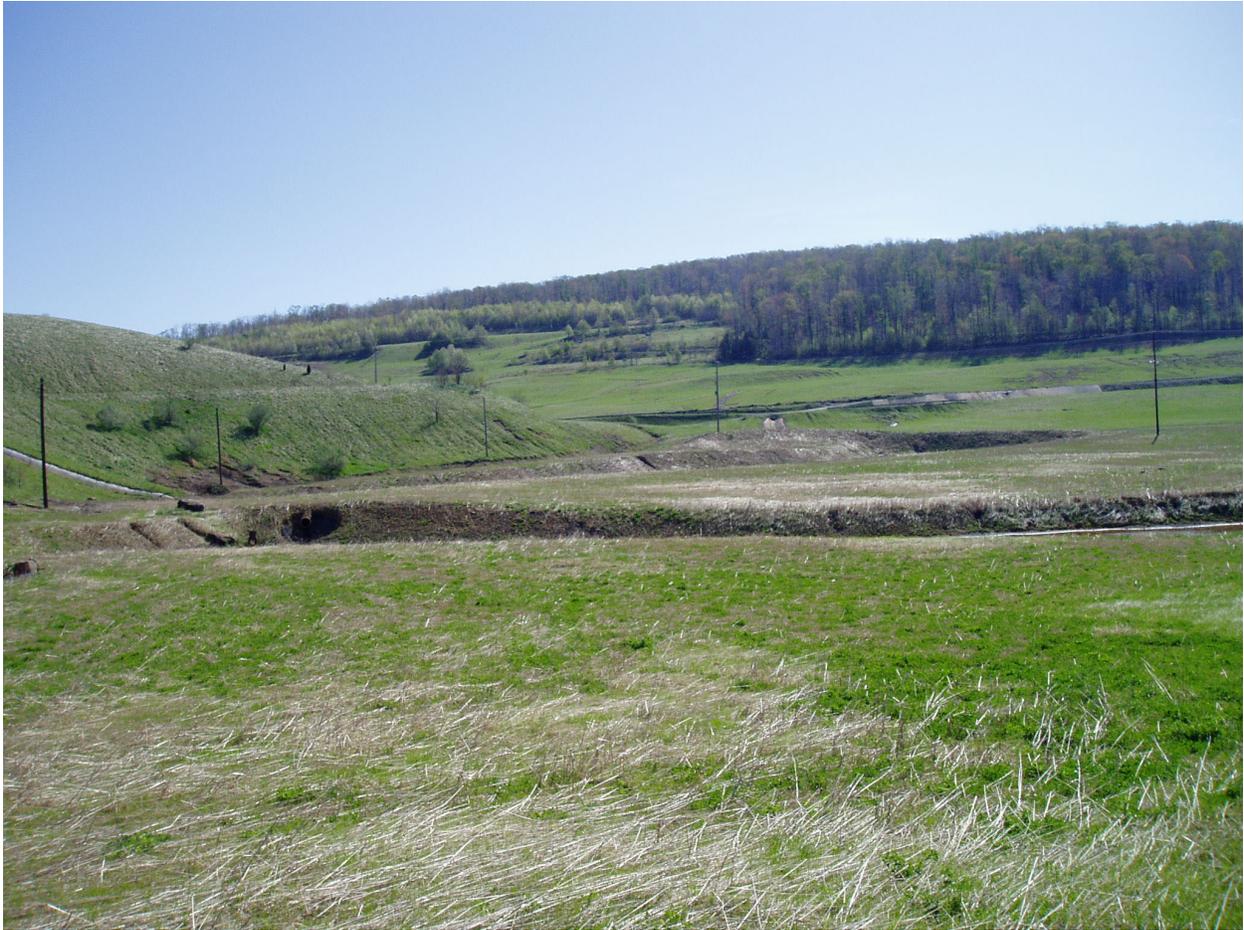
Figure A-2-2. Large refuse disposal area in the vicinity of the original Elk Run stream channel.

Elk Run/Deakin Run is located in the western part of the North Branch/Potomac River watershed (Figure A-2-1). The Elk Run/Deakin Run watershed is in Grant County between Kempton Junction and Henry on the Davis, West Virginia USGS 7.5 minute topographic map. Originally, Elk Run was a direct tributary of the North Branch Potomac; however, because of mining activities, Elk Run was rerouted to join Deakin Run (Figures A-2-2, A-2-3 and A-2-4) just downstream of a large pond and wetland.

Source tracking efforts confirmed that Elk Run is rerouted from its original channel around a large refuse disposal area. This rerouted portion of Elk Run flows parallel to the pond/wetland area on Deakin Run and eventually joins Deakin Run below the pond/wetland area. The iron impairment in Elk Run has been attributed to seepage from the refuse disposal area permitted under SMCRA Permit No. O-130-83. Iron oxide was observed in Elk Run in the vicinity of the refuse disposal area. DEP's monthly monitoring stations bracket the disposal area, and the observed instream iron concentrations are elevated at the downstream location.

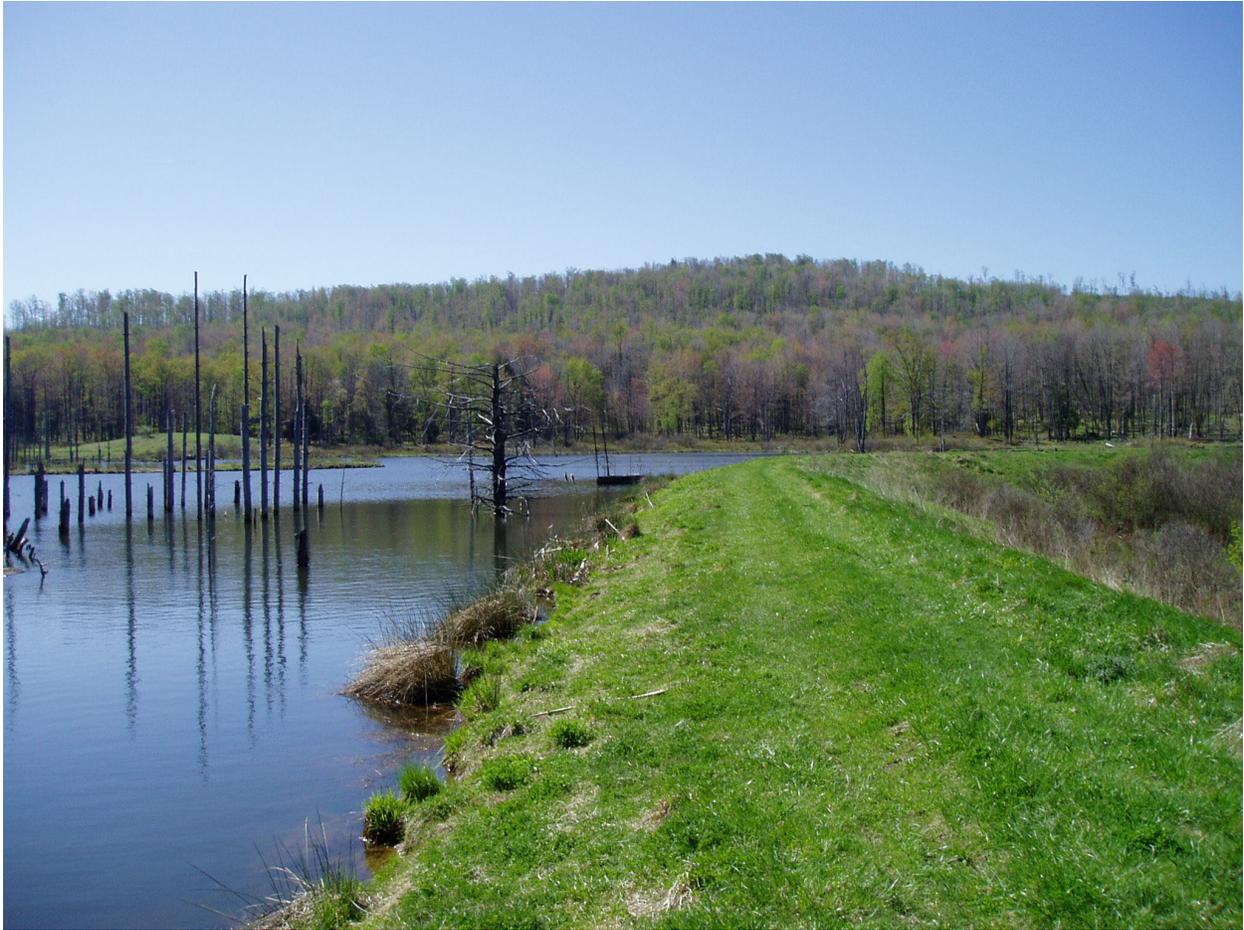
Figure A-2-3. Rerouted Elk Run separated by embankment from Deakin Run pond/wetland area. Elk Run joins Deakin Run below pond/wetland area.

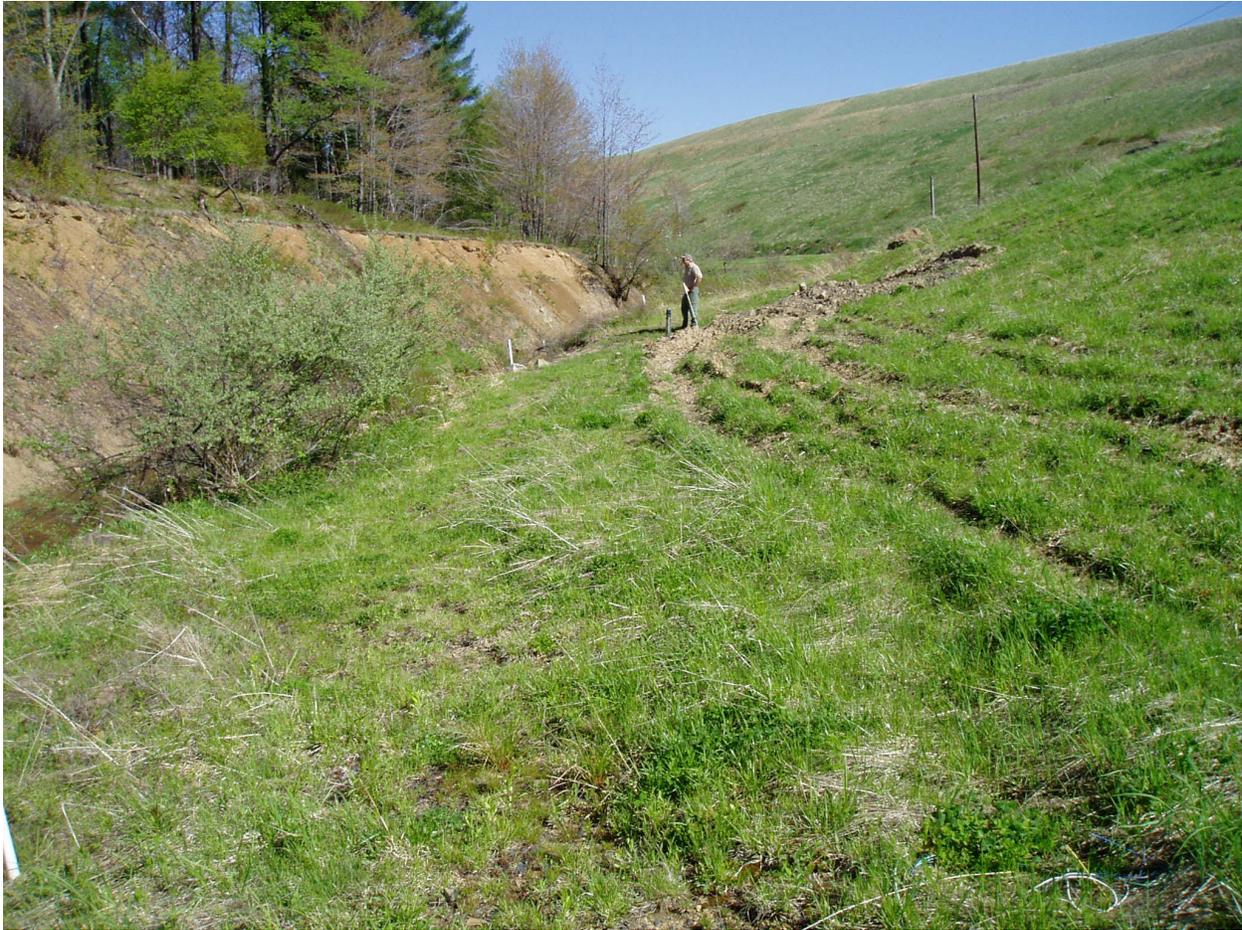
Figure A-2-4. Rerouted Elk Run adjacent to the refuse disposal area.

The dominant land use in the watershed is forest, which covers 82.1 percent of the watershed. Other important land use types include pasture (9.4 percent) and barren/mining land (3.3 percent). All other individual land cover types account for less than 5.2 percent of the total watershed area. Elk Run is the only impaired stream in the watershed and it is impaired relative to the iron water quality criterion. Figure A-2-5 shows the impaired segments and the pollutants for which each is impaired. Figure A-2-4 shows the rerouted portion of Elk Run adjacent to the refuse pile.

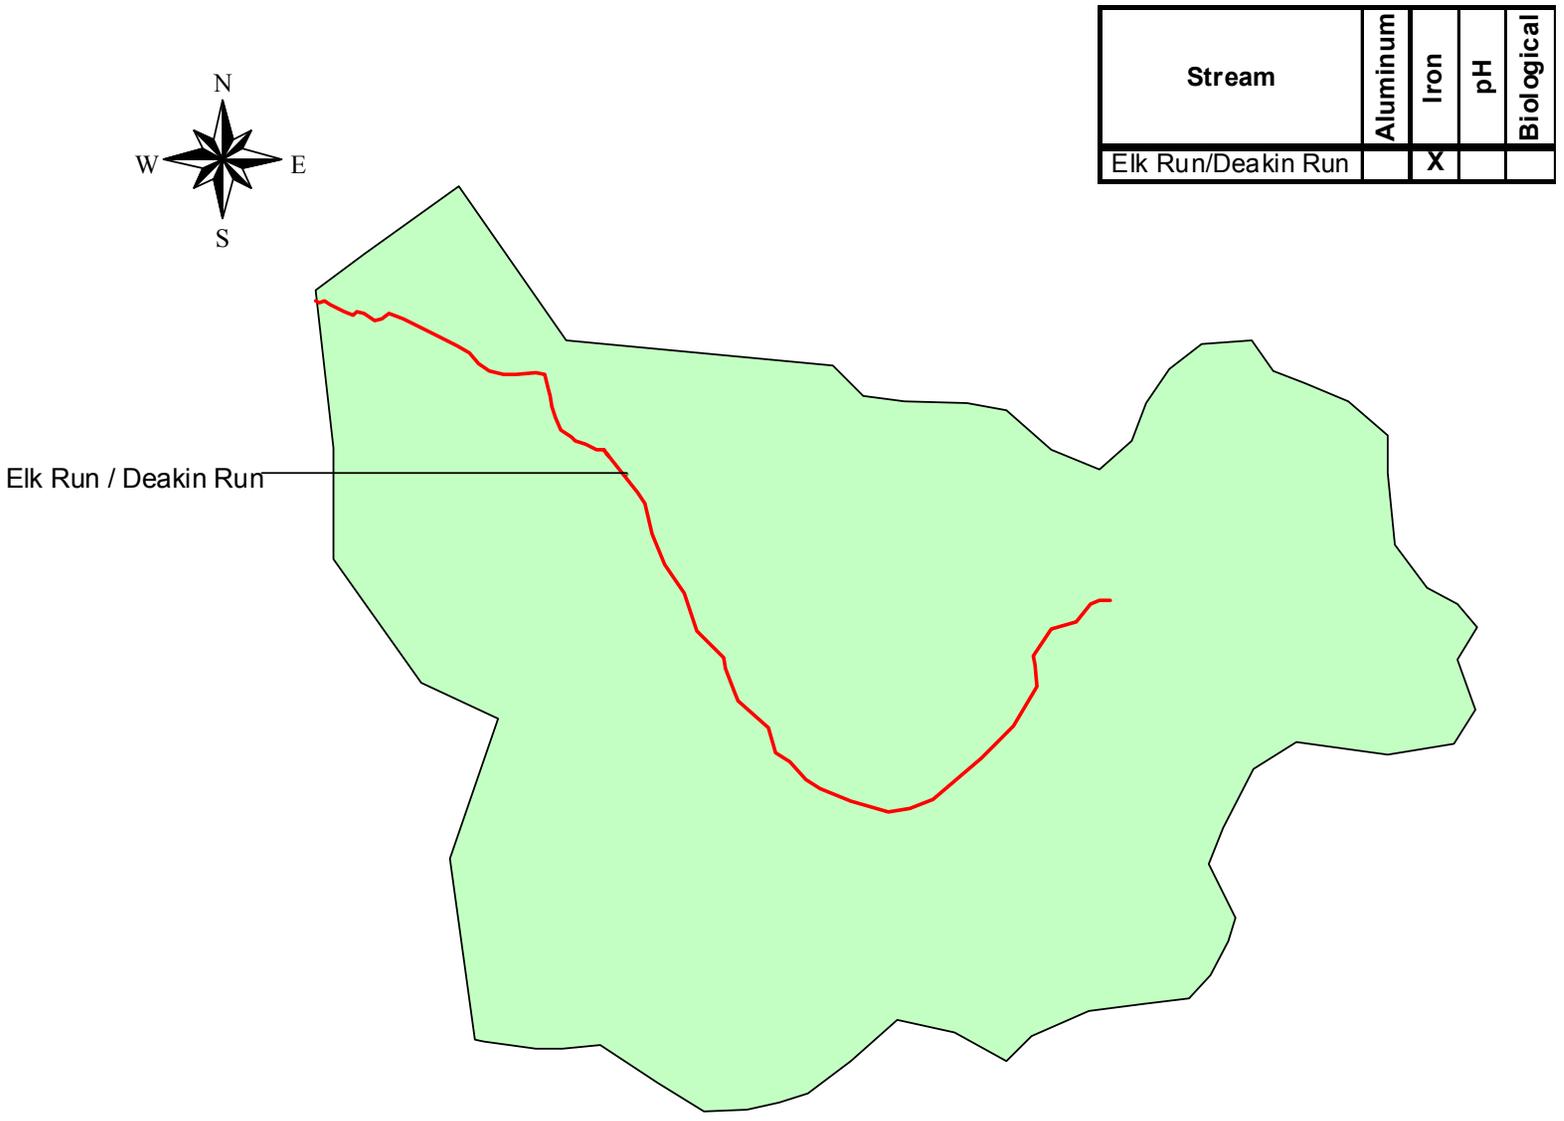
Figure A-2-5. Impaired waterbodies in the Elk Run/Deakin Run watershed.

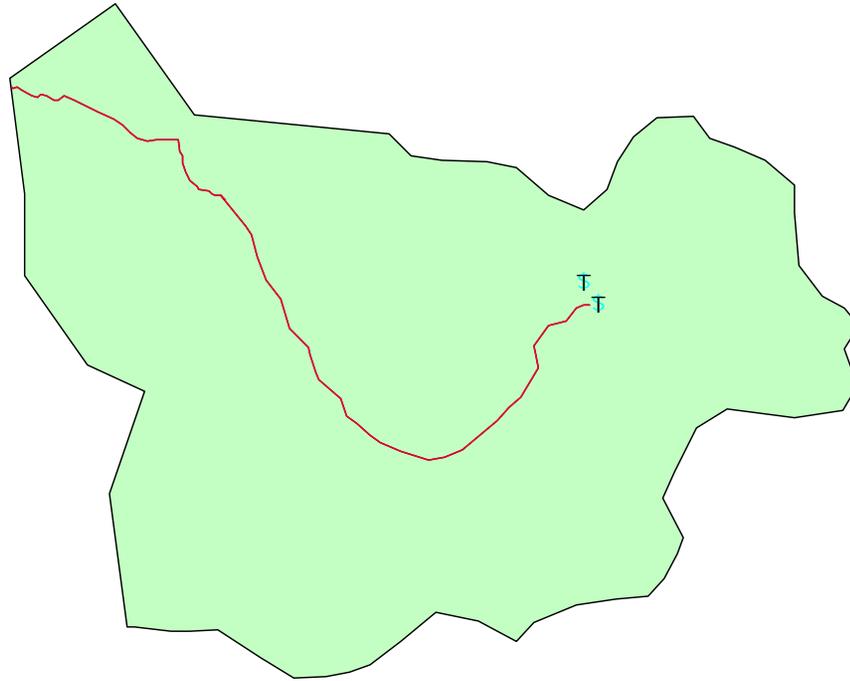
Figure A-2-6. Metals sources in the Elk Run/Deakin Run watershed.

Pollution sources were identified using statewide geographic information system (GIS) coverages of point and nonpoint sources, and through field reconnaissance. As part of the TMDL process, WVDEP documented pollution sources by describing the pollution source in detail, collecting Global Positioning System data, and if necessary, collecting a water quality sample for laboratory analysis. WVDEP personnel recorded physical descriptions of the pollutant sources, such as the number of outfalls, the source of the outfalls, and the general condition of the stream in the vicinity of each outfall. These records were compiled and electronically plotted on maps using GIS software. This information was used in conjunction with other information to characterize pollutant sources. Significant metals sources in the watershed are shown in Figure A-2-6.

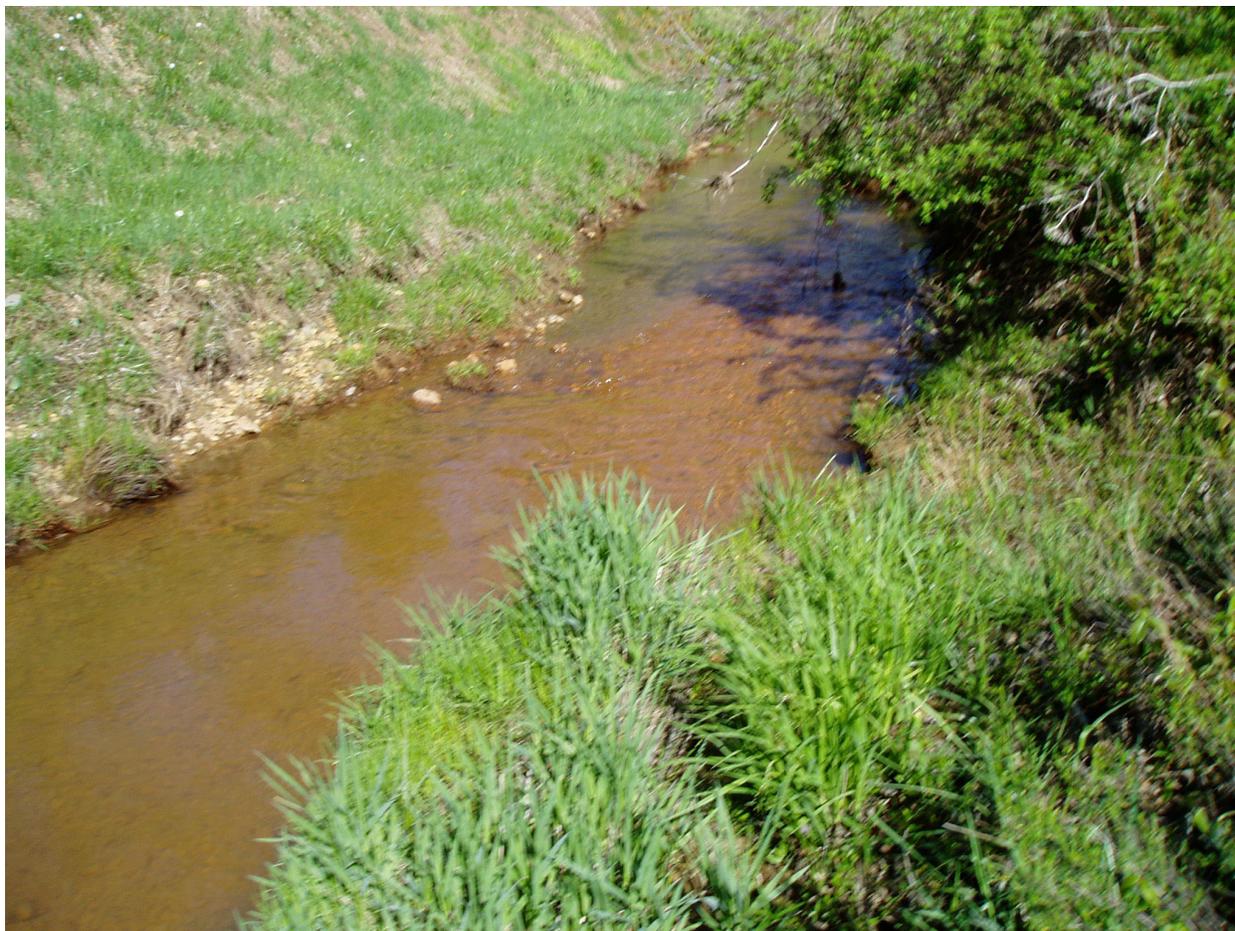
Figure A-2-7. Elk Run adjacent to the refuse disposal area, iron oxide coating present in the stream bottom.

SMCRA Permit No. O-130-83 has no associated WV/NPDES outlets that discharge into the modeled segment of Elk Run. Historically, the impact of the seepage was much more severe and the permittee installed a series of sumps and pumps to lower the phreatic surface in the refuse below stream level, capture the seepage, and pump it outside the watershed for treatment. The collection and transport system remains in operation.

While the present impact of the seepage is less severe, its iron loading causes Elk Run to exceed water quality criteria. The WVDEP Division of Mining and Reclamation is aware of the situation and will direct corrective actions to resolve the impairment. As there is no point source discharge into Elk Run, this TMDL does not grant a wasteload allocation for the refuse disposal area.
