**An Ecological Assessment of the
Cheat River Watershed**

An Ecological Assessment of the Cheat River Watershed 1996

Report number - 0502004 - 1996

Watershed Assessment Program
Office of Water Resources
West Virginia Division of Environmental Protection
1201 Greenbrier Street, Charleston, West Virginia 25311

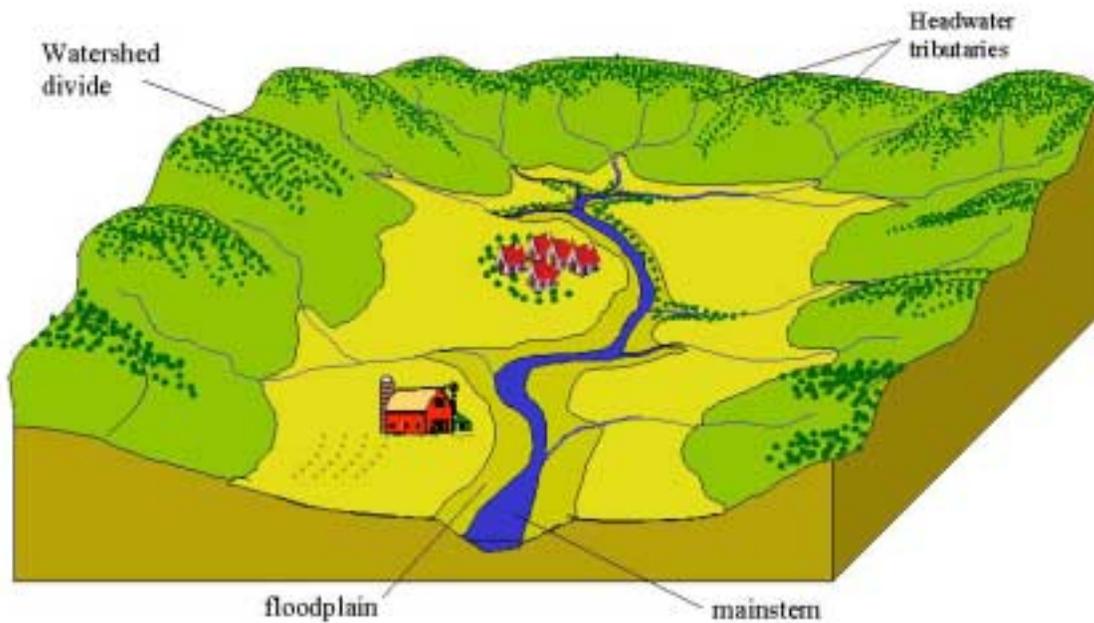
Figure 1: A Generalized Watershed

WATERSHED – In several dictionaries, the first definition of watershed is the divide between adjoining drainage areas. In this report, though, watershed is defined as the land surface that drains water to a specific point.

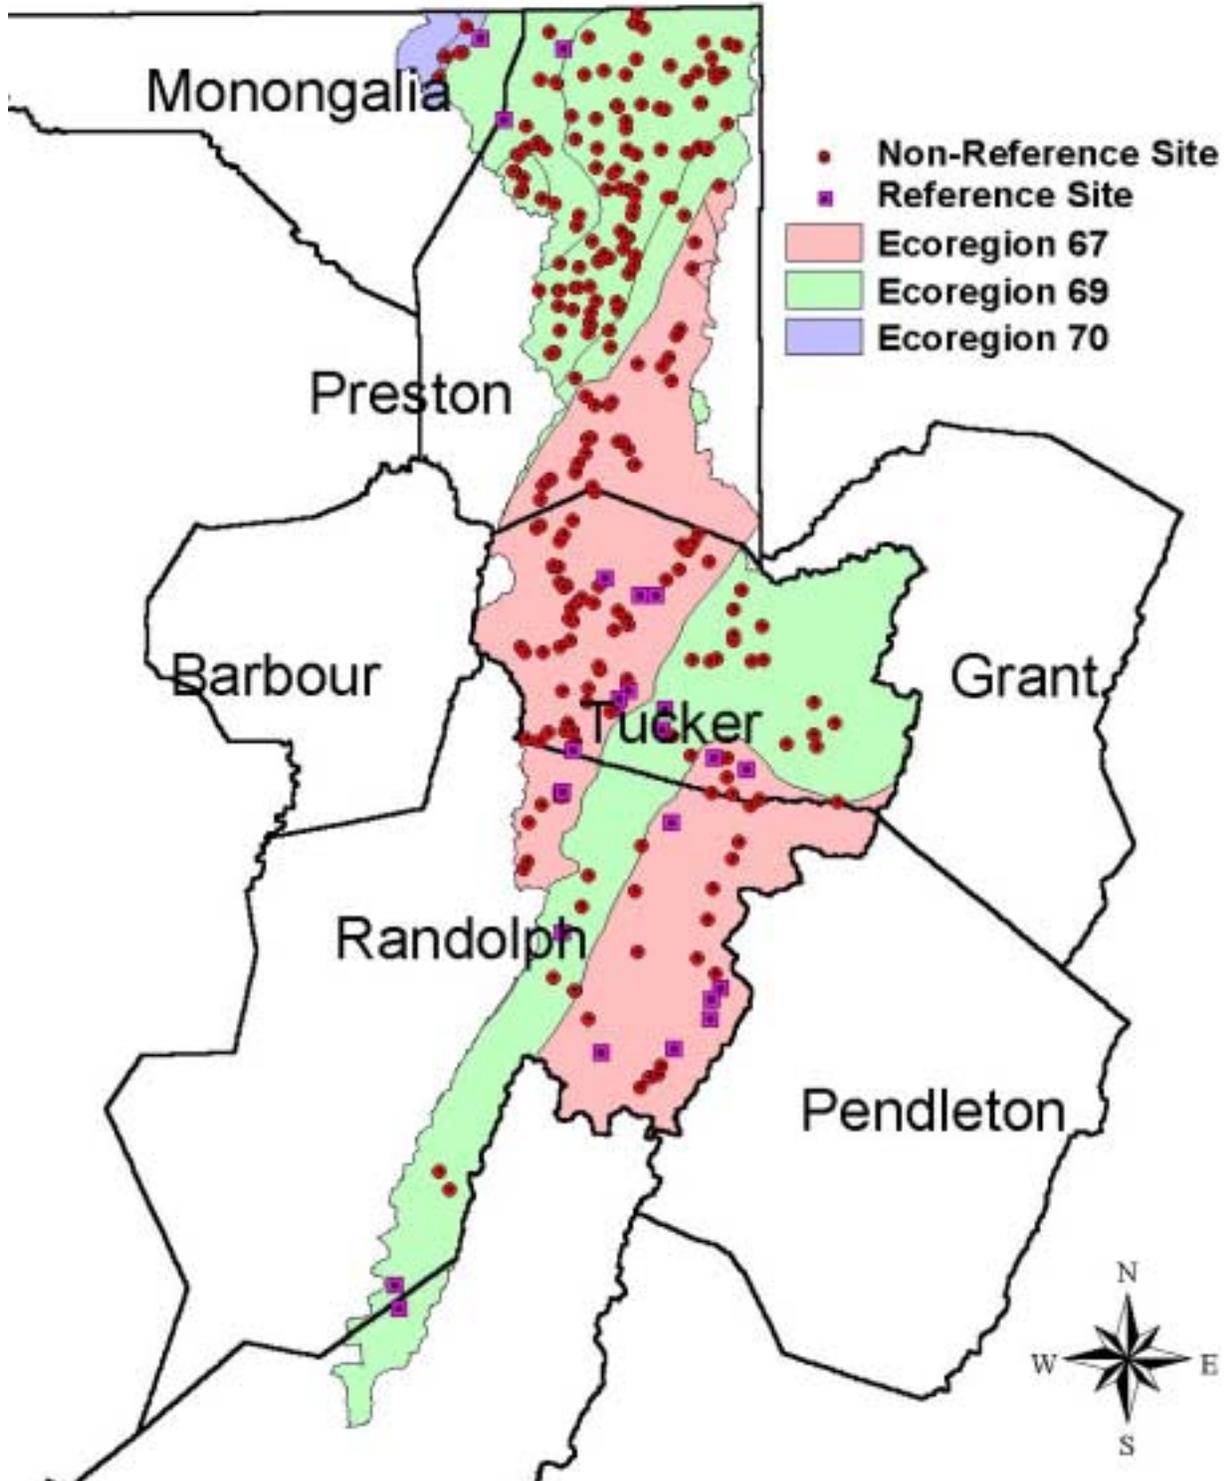
Figure 6: Sample Sites in the Cheat River Watershed

A total of 276 assessment sites were visited during the Cheat River watershed study (Table 6). Figure 6 provides a graphic illustration of the assessment sites. A full benthic macroinvertebrate sample was collected at 216 of these sites (see Table 4 for sampling summary). Seven samples were considered non-comparable because of variations in sampling techniques. For the purposes of this report, comparable means collected from similar habitat, from equal sampling area and using the same sampling technique.

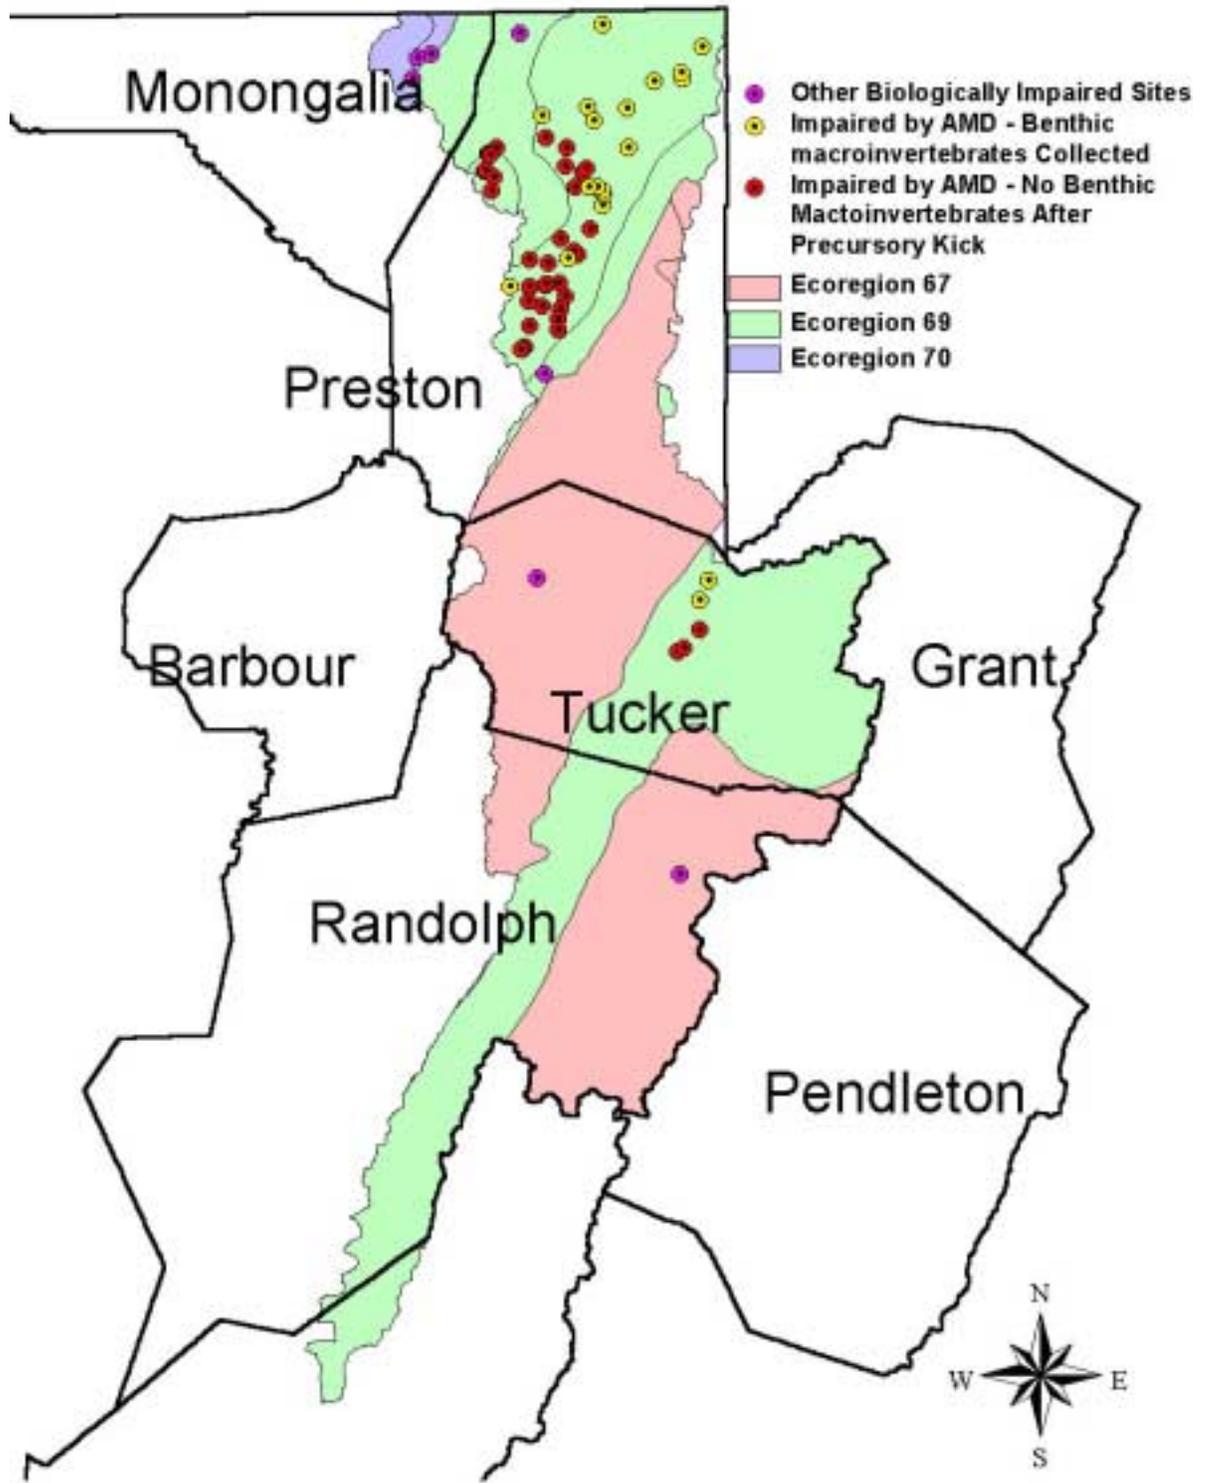
Figure 12: Biologically Impaired Sites

A discussion of the biologically impaired (bioscore < 50) streams is presented below. Data pertaining to this discussion (i.e., benthic metrics, physico-chemical data, rapid habitat data and human disturbances) can be found in corresponding tables of Appendix A.

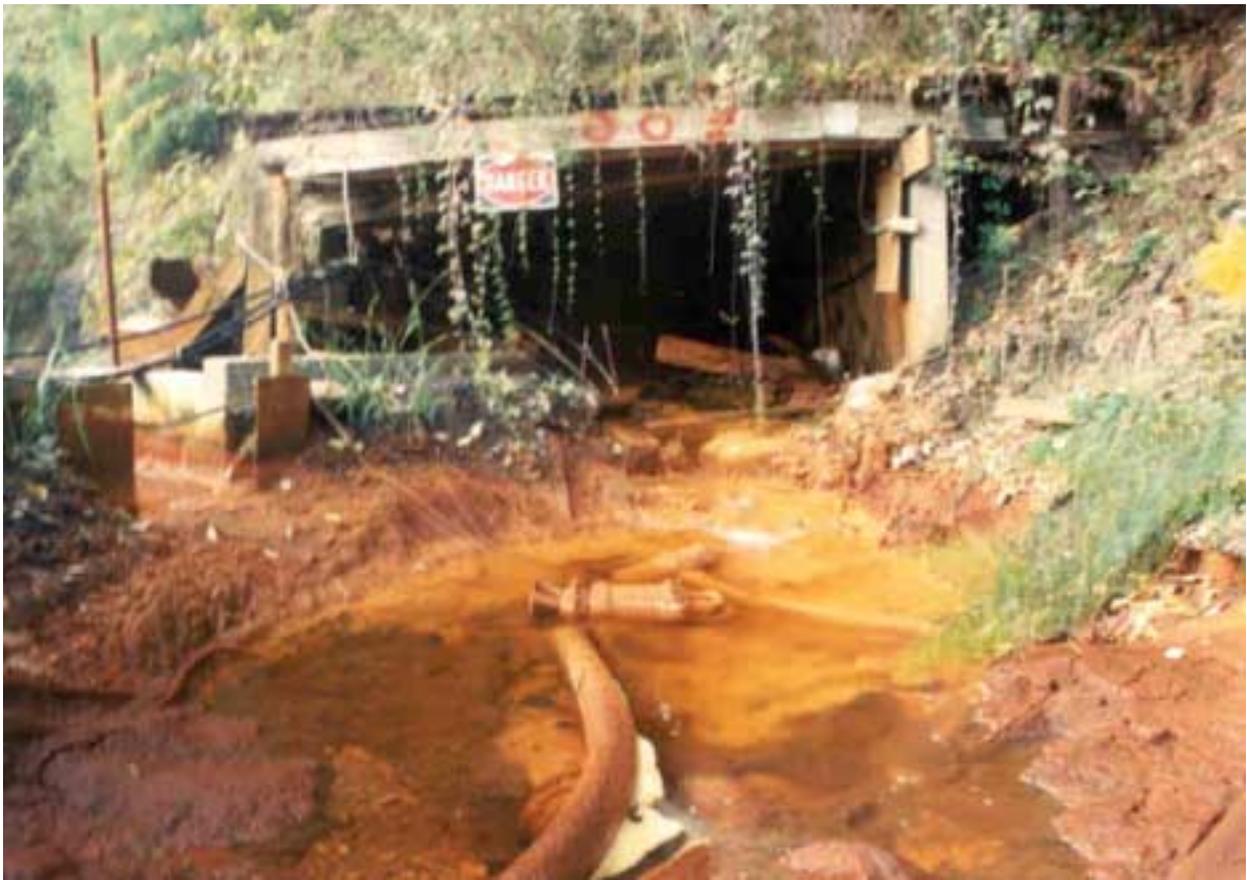
T&T MINE PORTAL

Metals (i.e., iron, aluminum, manganese) associated with mine drainage can damage aquatic life directly. In their dissolved form, metals can be highly toxic since they are free to interact with living organisms. Precipitates, known as metal hydroxides, often coat the stream bottoms. Heavy deposits of metal hydroxides can clog gills and smother the living spaces utilized by macroinvertebrates.

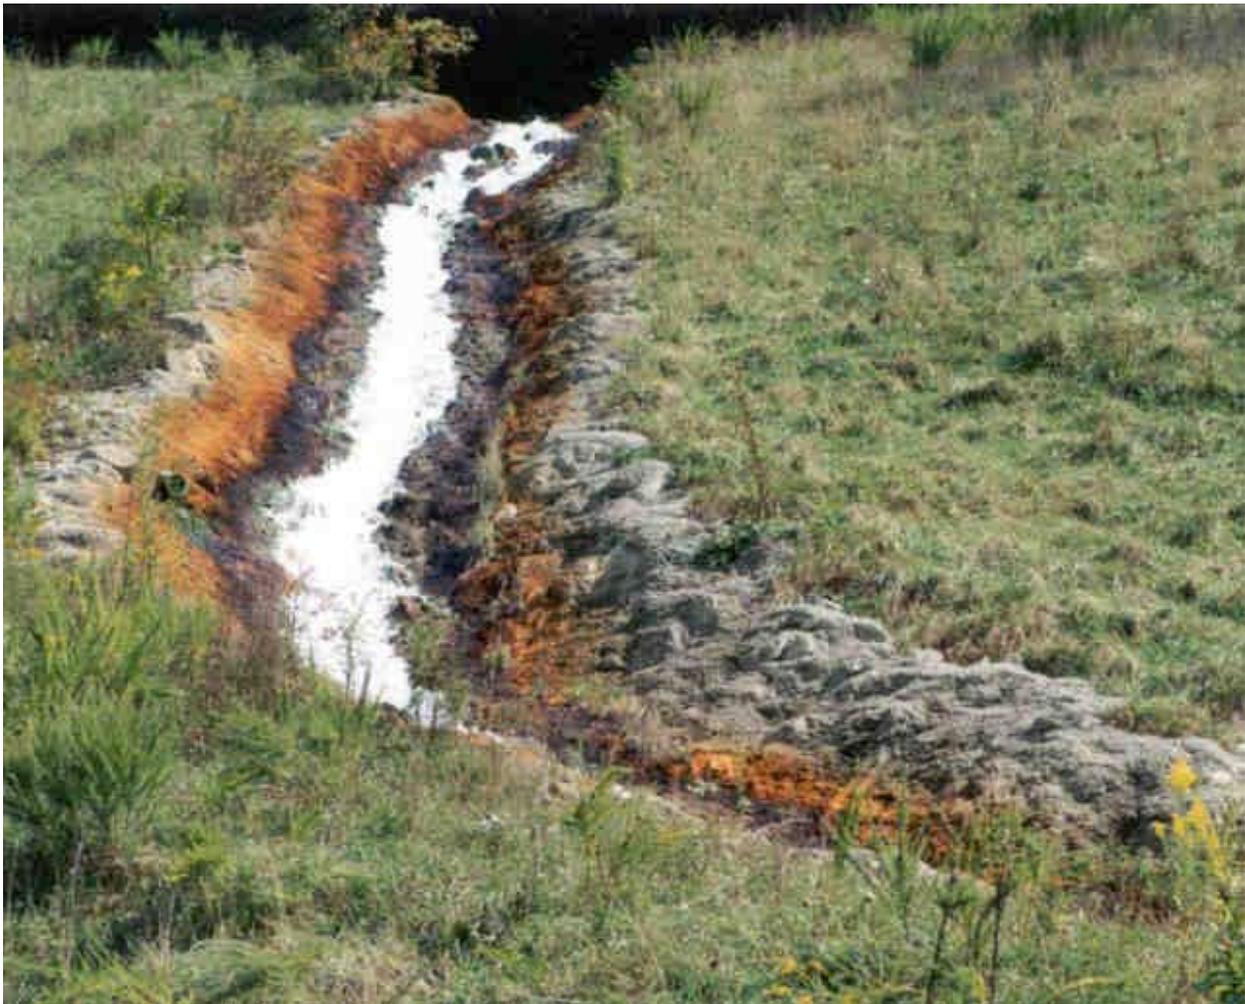
UNTREATED AMD DISCHARGE TO MUDDY CREEK
Photo by Julia Lucas, Friends of the Cheat

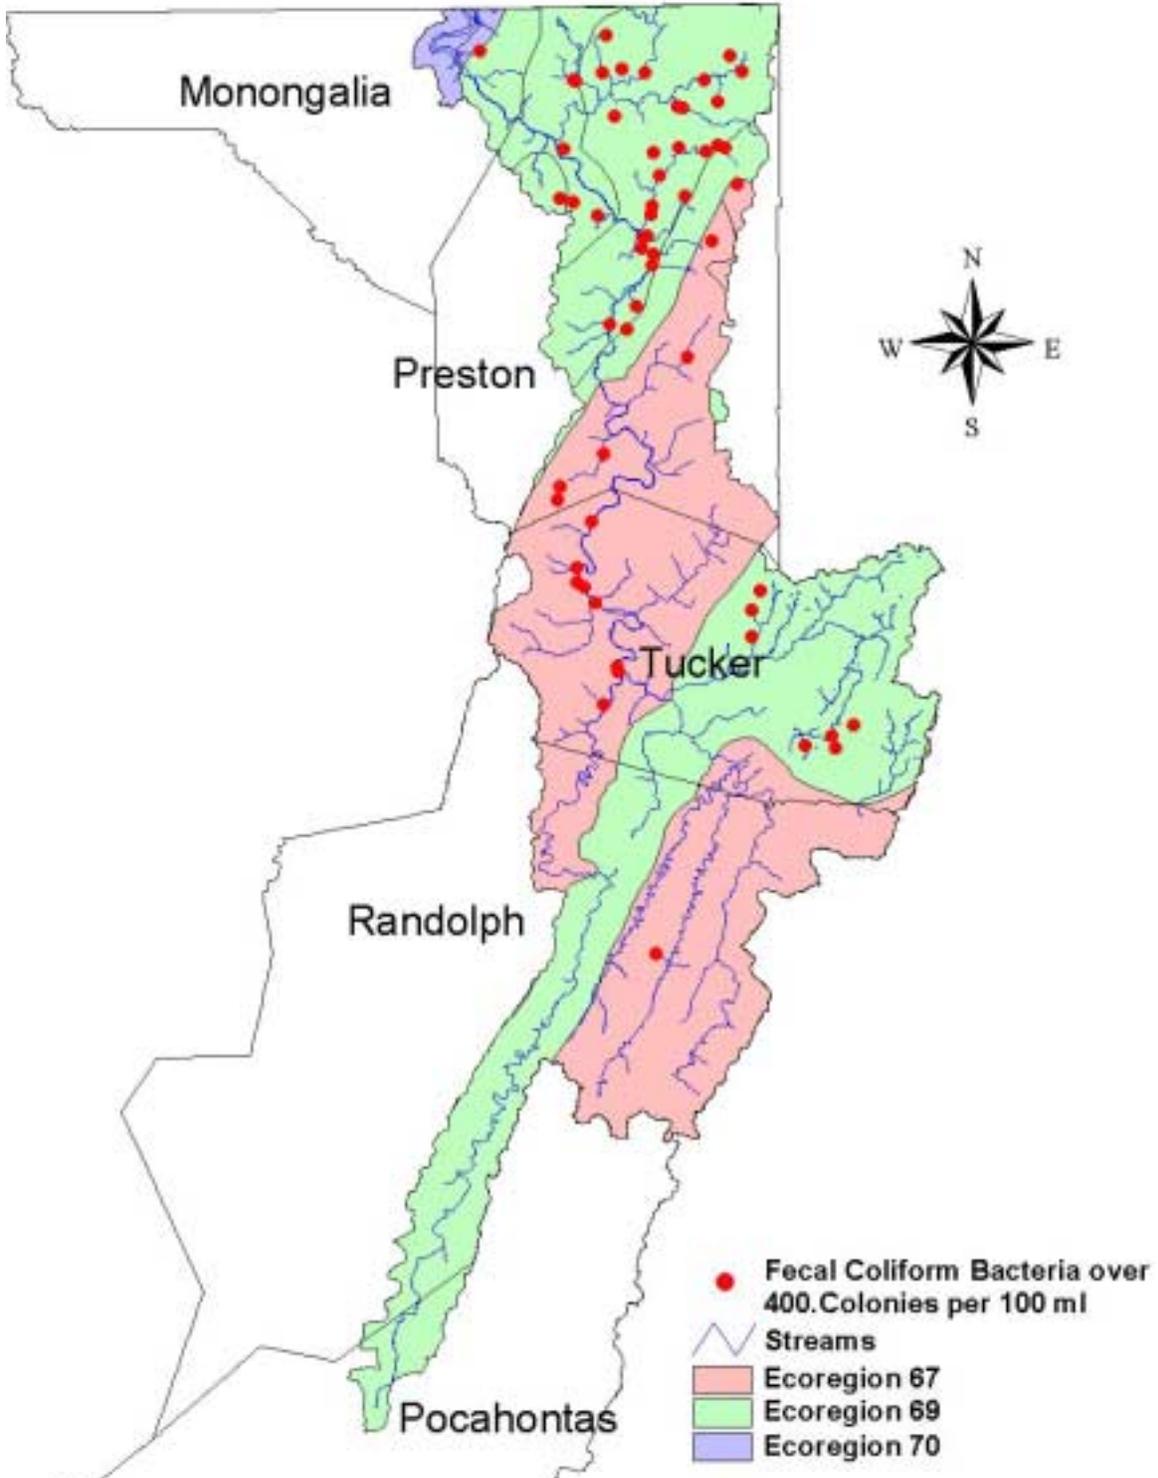
Figure 15: Violations of the Fecal Coliform Bacteria Standard

Considering all assessment sites sampled for fecal coliform bacteria in the watershed, 25.8% (n = 225) had fecal coliform concentrations exceeding 400 colonies/100ml (Figure 16). There was a distinct difference between ecoregions in the percentage of sites exceeding the standard for fecal coliform bacteria. Only 12.5% (n = 120) of the assessment sites in Ecoregion 67 exceeded the standard. In contrast, the percentage of sites exceeding the standard in Ecoregions 69/70 was 41.0 (n = 105, includes 3 Ecoregion 70 sites).

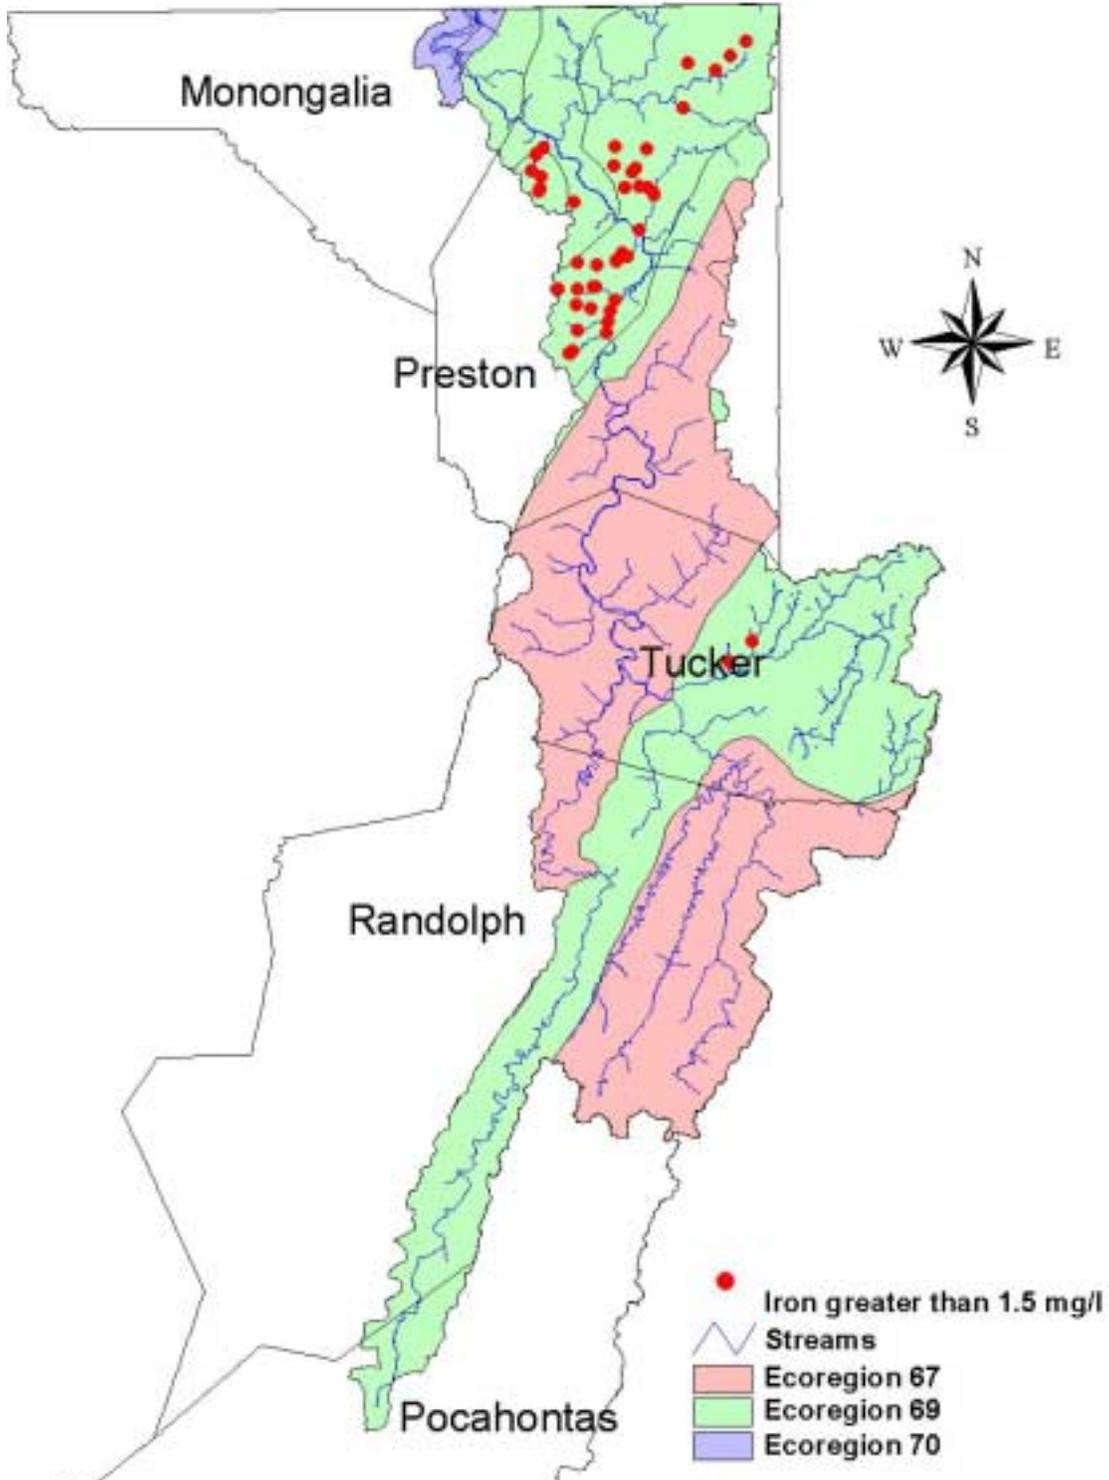
Figure 19: Sites Violating the Water Quality Standard for Iron

The water quality standard (chronic) for iron is 1.5 mg/l. The Program sampled 47 (41.2%, n = 114) sites with iron concentrations exceeding the standard (Table 23). All violations were from sites sampled in Ecoregions 69/70 (43.1% of sites, n = 109). Figure 19 presents a location map of the sites violating the standard for iron. Iron concentrations ranged from 0.20 mg/l at the mouth of Big Sandy Creek (WVMC-12- {00}), to 680.0 mg/l at the mouth of Fickey Run (WVMC-17-A-.5- {0}). Fickey Run at the mouth was one of the most severely impaired sites encountered (sampled for benthic macroinvertebrates) during the study that supported at least some benthic macroinvertebrates. In addition to a low pH and high concentrations of metals, other mining related impacts were documented. The assessment team described the substrate as fused from heavy iron and sand deposits. The stream water was described as red in color. The team also noted the existence of a surface mine in the vicinity of the assessment site.

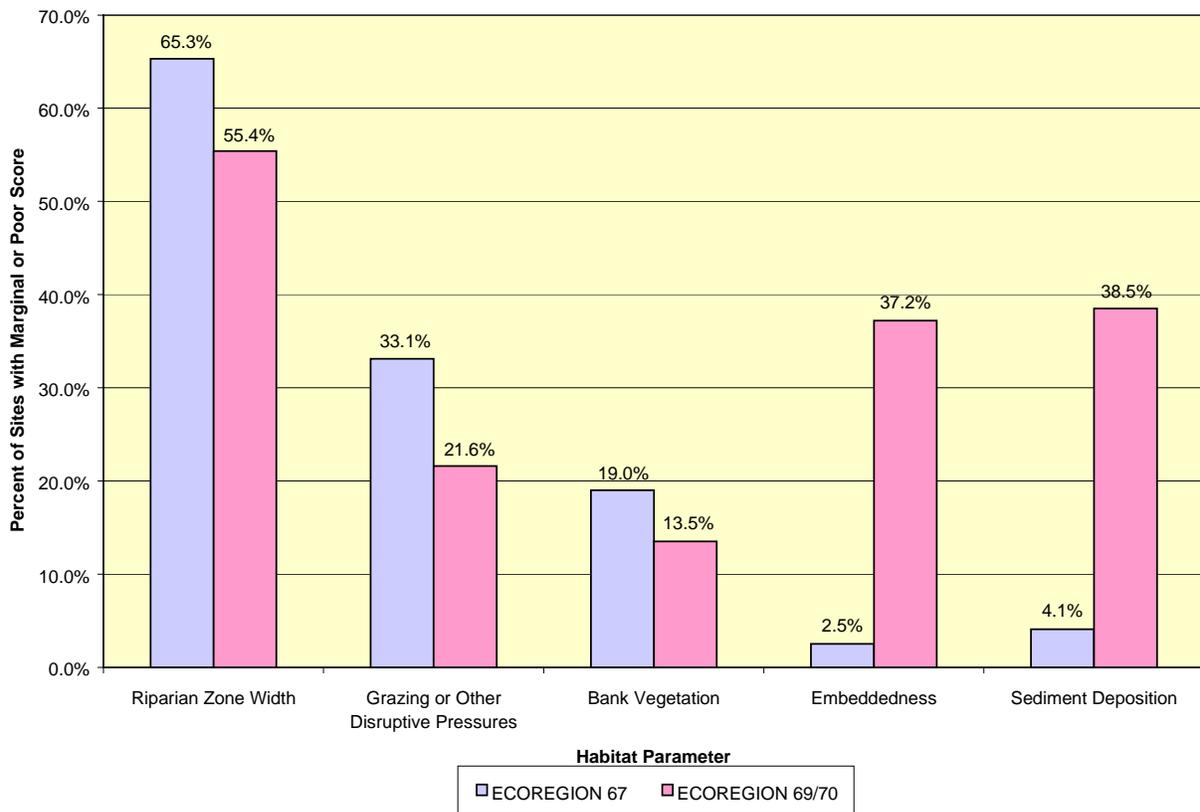
Figure 21: Degraded Stream Habitat Parameters

An examination of average habitat scores showed that the non-reference sites in Ecoregion 67 were less degraded than the non-reference in Ecoregions 69/70 (Figure 21). The average score for Ecoregion 67 was 173.2, 30 points less than its respective reference site average of 202.8. The average score for Ecoregions 69/70 was 167.7, 36 points less than its respective reference site average of 204.1.

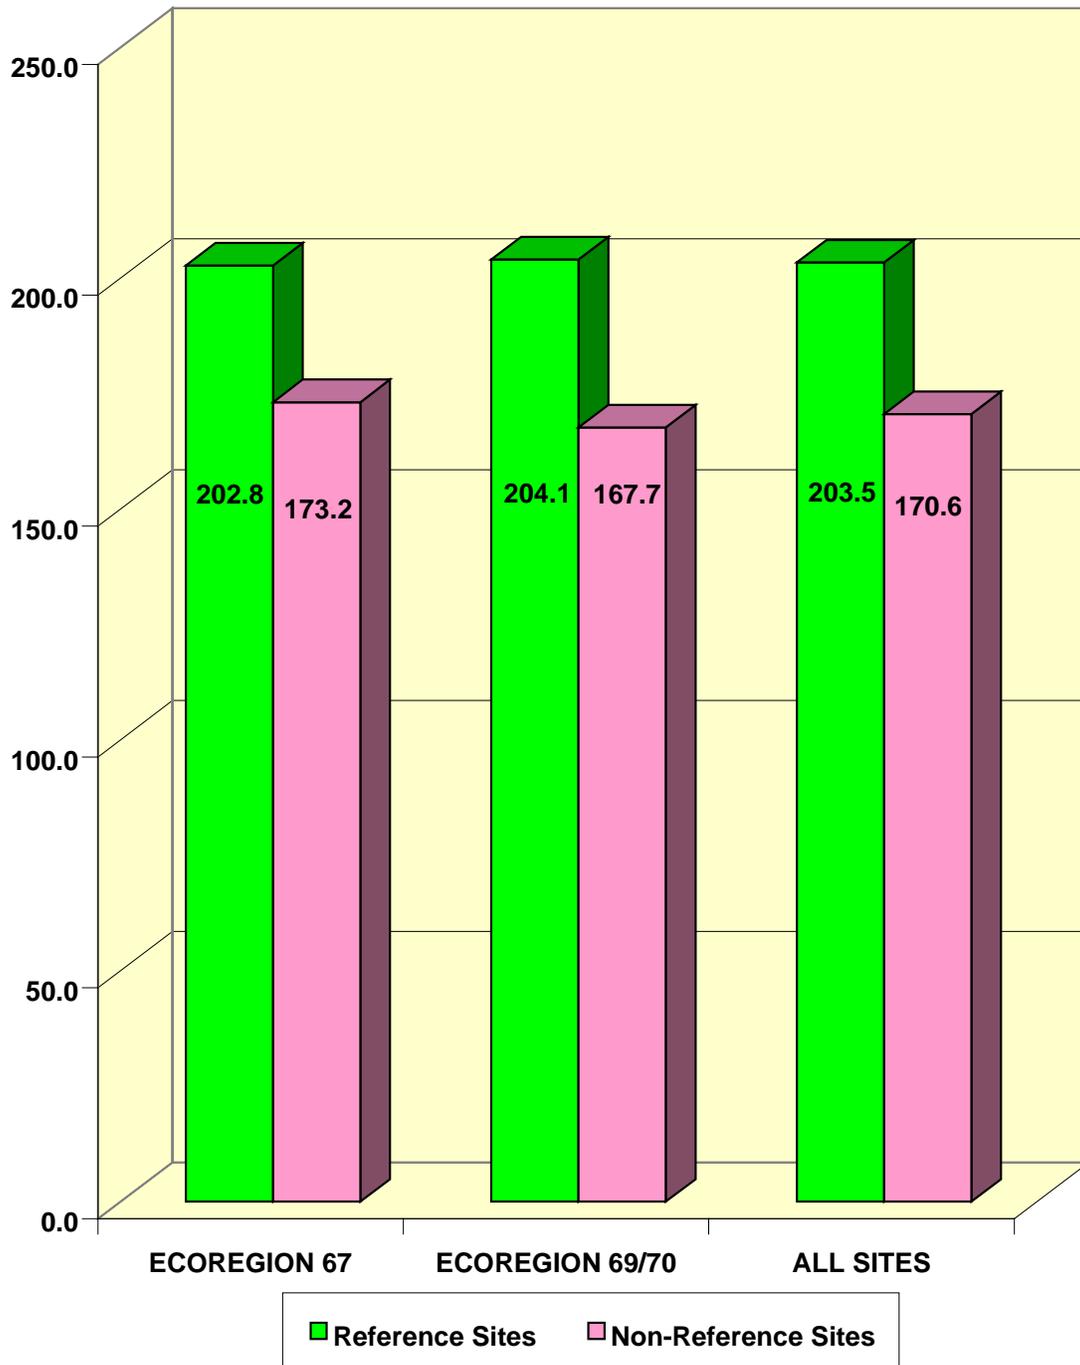
Figure 22: Summary of Average Rapid Habitat Scores

An important element of each stream assessment was the completion of a two-page Rapid Habitat Assessment, which provided a numerical score (maximum 240 points) of the habitat conditions most likely to affect aquatic life. The lowest individual score for a site was at Smoky Hollow with a score of 44. A site on Otter Creek received the highest score of 225. In general, the watershed as a whole exhibited relatively good habitat with an average total score of 170.6 for non-reference sites. This score is high enough to be in the upper sub-optimal category, which is defined as less than desirable but satisfies expectations in most areas.

Although a sub-optimal rating is basically good, a comparison to the average total score of the reference sites (205.3 = optimal category) indicates a possibility for improvement. The habitat parameters that exhibited the most degradation were riparian vegetation zone width, grazing or other disruptive pressure, sediment deposition and embeddedness.

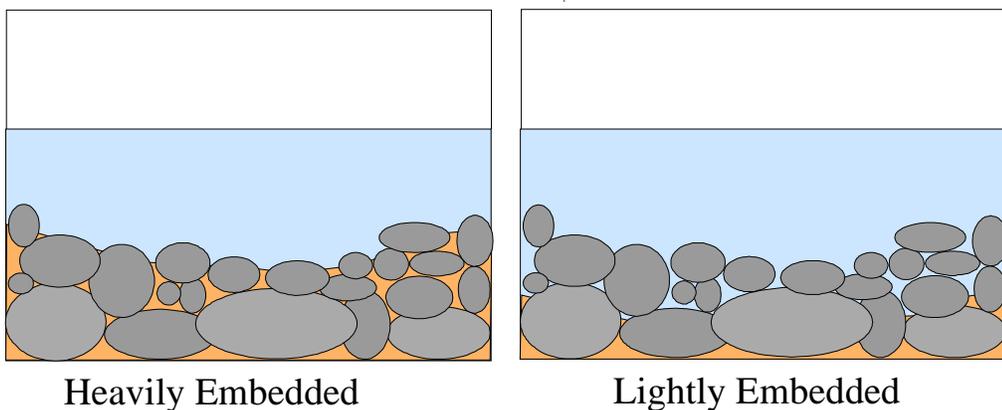
Figure 23. Illustration of Embeddedness

Marginal or poor scores for sediment deposition and embeddedness were given much less frequently in Ecoregion 67. For embeddedness only 4.9 % of the assessment sites in Ecoregion 67 received marginal or poor scores while only 2.9% of the sites received marginal or poor scores for sediment deposition. The disparity in these parameters may be attributed to the extensive mining activities in Ecoregions 69/70. The major earth disturbing activities associated with mining activities overwhelm streams with sediment and metal hydroxides. High levels of sediment deposition create unstable and continually changing environments that become unsuitable for many benthic macroinvertebrates. Embeddedness refers to the extent to which rocks (boulders, cobble or gravel) are covered or sunken into the silt, sand or mud of the stream bottom. Generally, as rocks become more embedded, the surface area (living spaces) available to macroinvertebrates is decreased (see Figure 23).

The view on the left is heavily embedded with sand and silt. Notice the different amounts of interstitial space (the space between rocks and gravel).

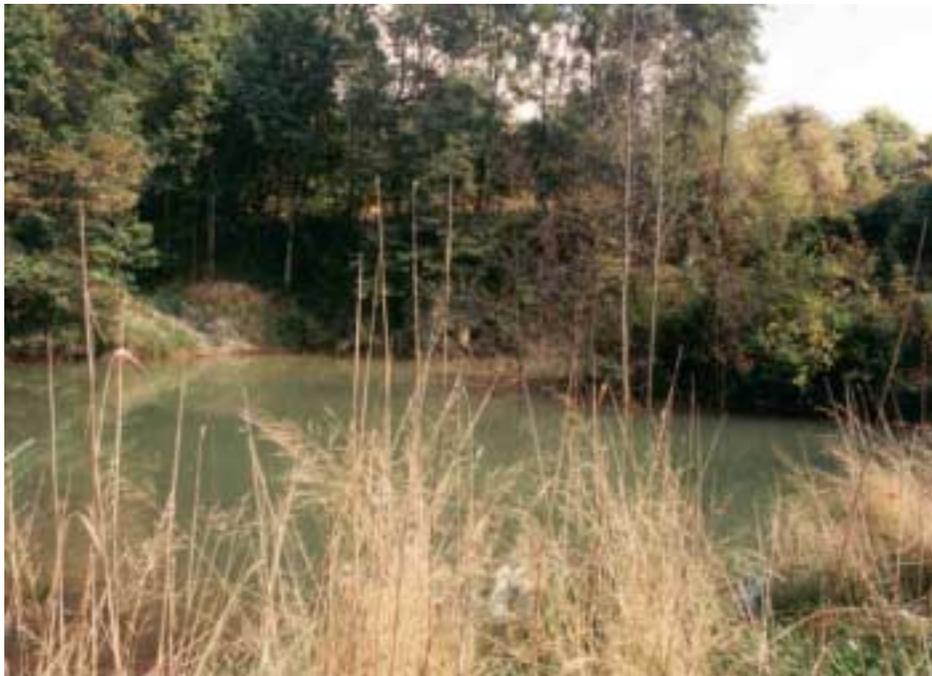
Other remedial activities for Sovern Run include the reconstruction of a pond to flood the mine, the installation of a 650 foot open limestone channel, the construction of a catchment basin for collecting metal precipitates and the reclamation of refuse piles. The Friends of the Cheat association should be commended for their efforts in establishing partnership organizations and securing the resources necessary to restore Sovern Run. Their efforts set an example for other AMD restoration projects, which might include projects on some of the streams identified by the Program in its study of the Cheat River watershed. Restoration plans should be developed for the AMD streams not currently being treated.

TREATMENT ON SOVERN RUN
Photo by Julia Lucas, Friends of the Cheat
