VRP Project #: **15017**
Brownfield Site: Yes No
Report Date: **4-15-15**
Page 1 of 5

OFFICE OF ENVIRONMENTAL REMEDIATION
VOLUNTARY REMEDIATION PROJECT
SITE VISIT/INSPECTION REPORT

FREEDOM INDUSTRIES
 1015 BARLOW DRIVE, CHARLESTON, WEST VIRGINIA
 OH003003.0001

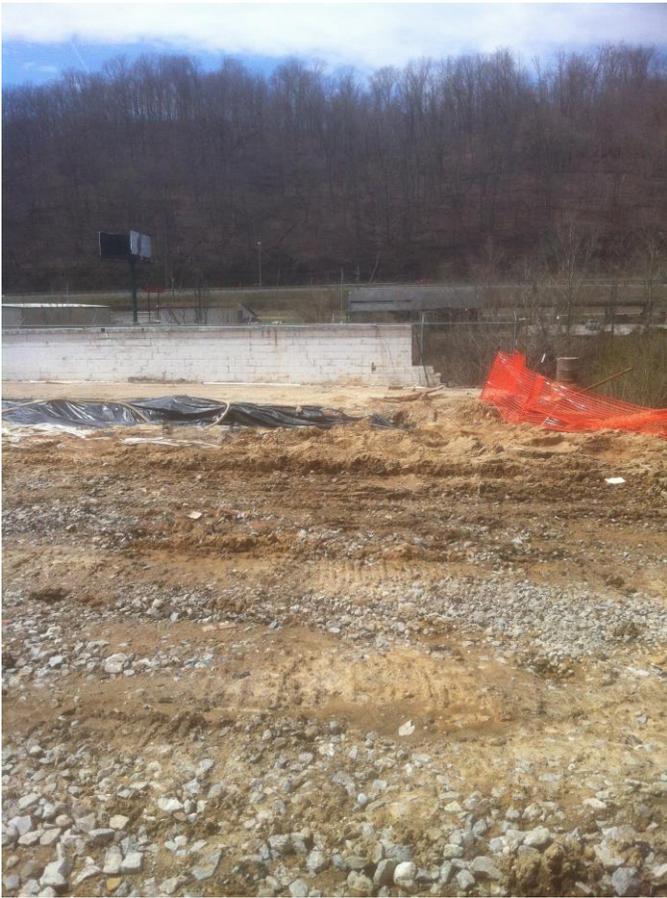
1. Former AST area and remaining secondary containment wall on western side of site (looking towards Elk River)
2. Looking north towards the northern end of the site, past the area of the MCHM/PPH spill
3. Brick rubble from the former fire house
4. Footprint of AST's #399 and 400.
5. Looking south towards warehouse/office building.
6. Baker tanks and former loading rack area
7. Tanker truck receiving water from Baker tanks
8. Stormwater collection trench on lower terrace below spill area and northernmost sump/pump.

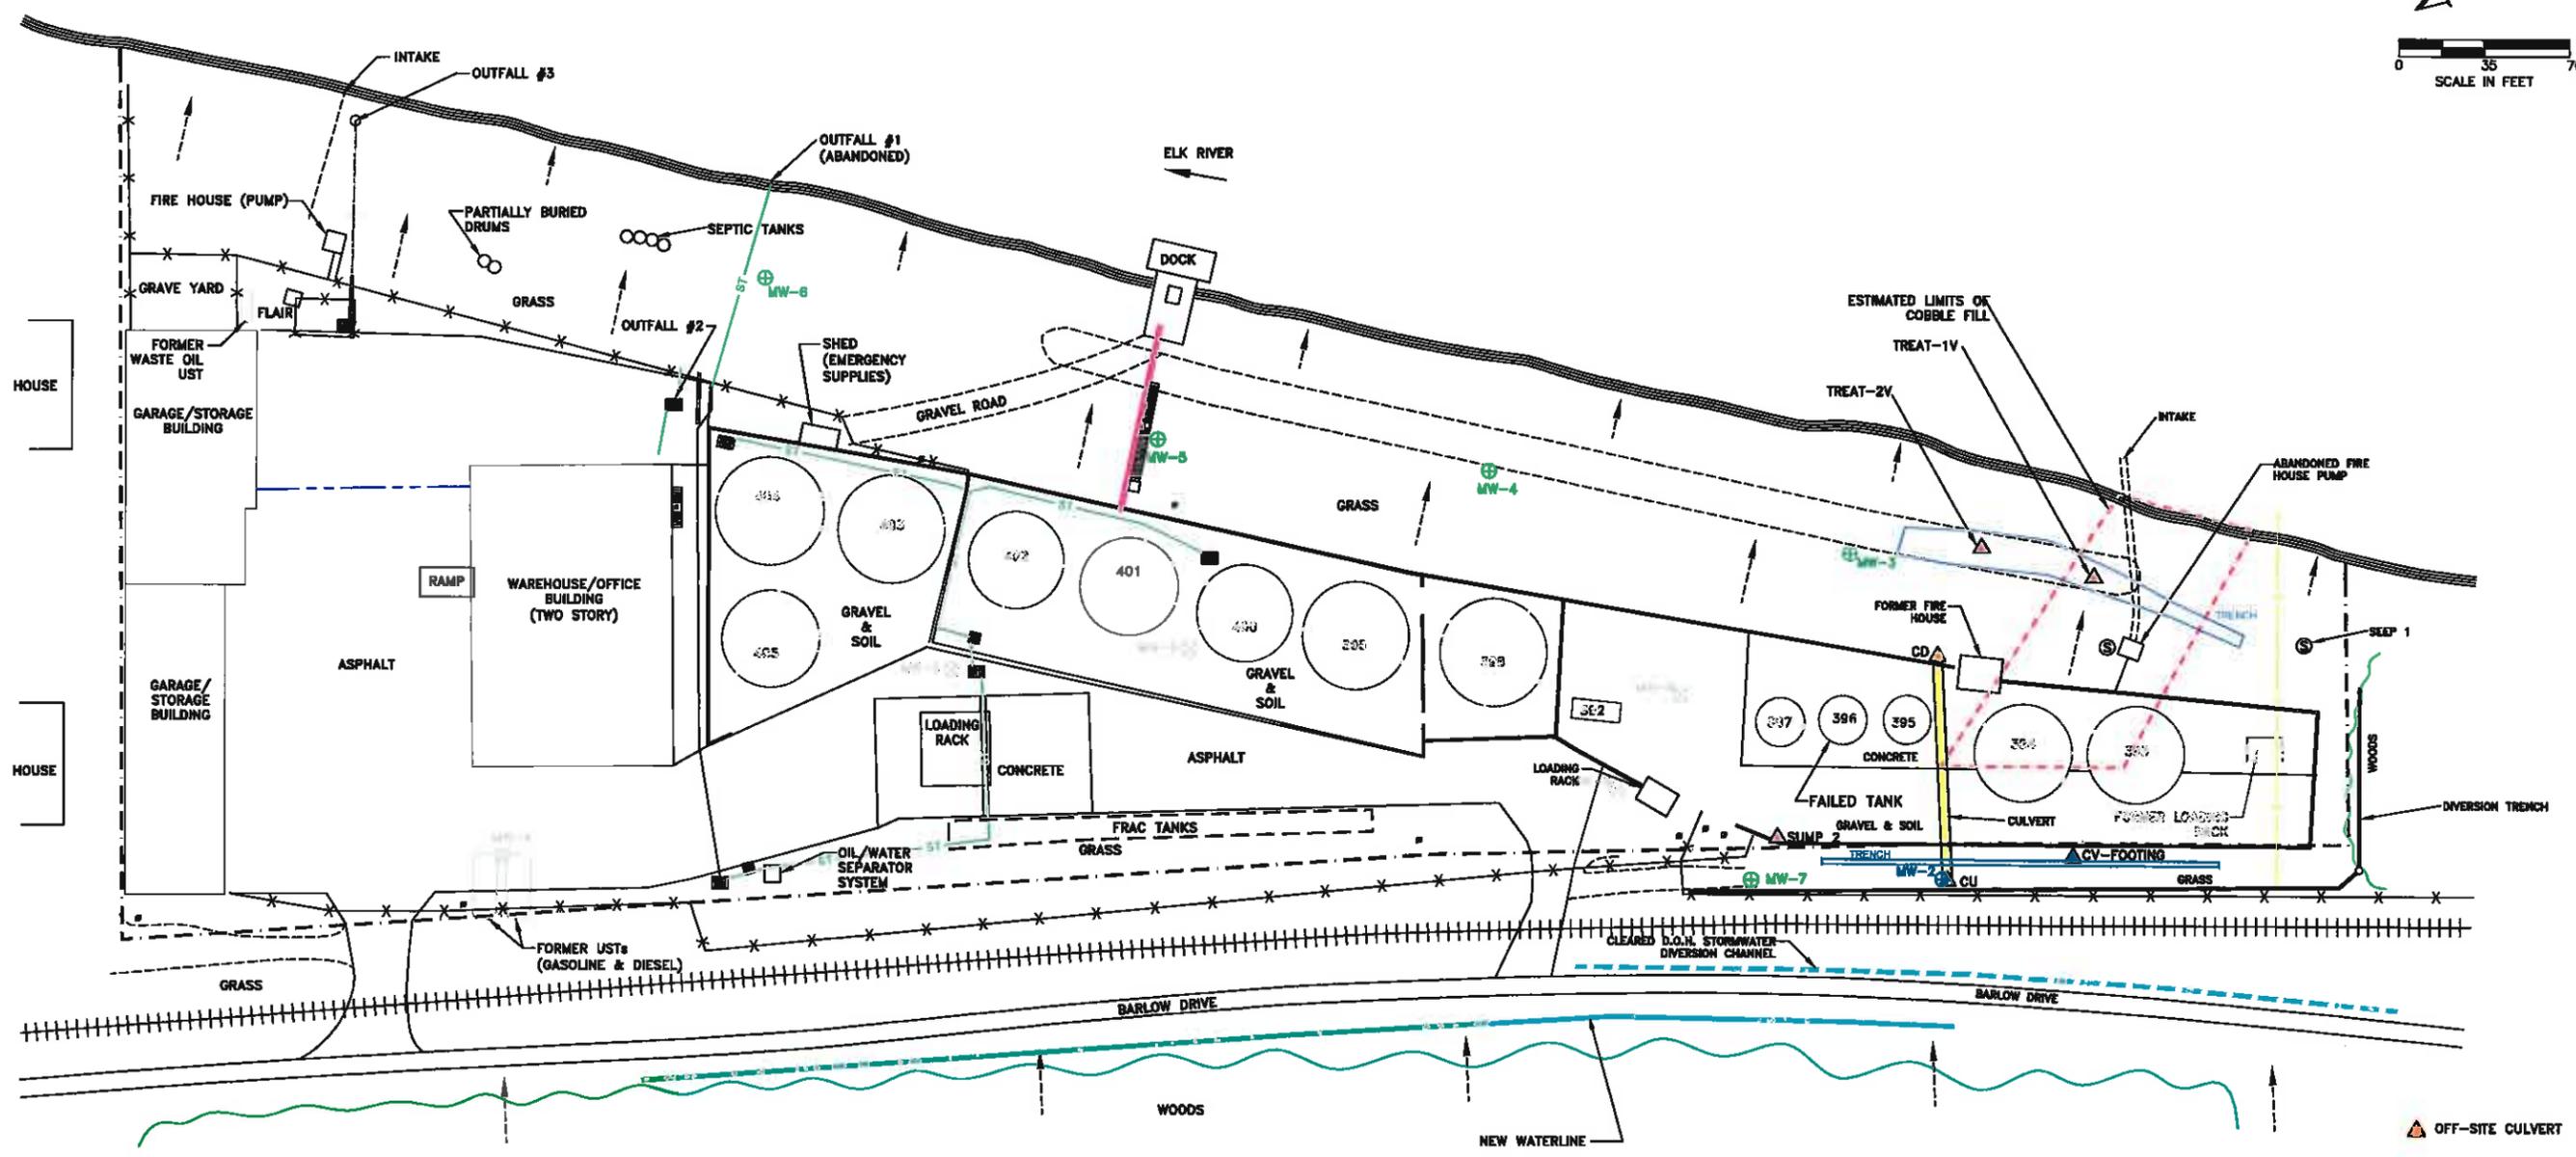
FIGURE
2

A site map used during the site walkover is attached to this report.

SITE MAP
