VRP Project #: **15017**  
Brownfield Site: Yes  No   
Report Date: **01-14-2016**  
Page 1 of 3

**OFFICE OF ENVIRONMENTAL REMEDIATION**  
**VOLUNTARY REMEDIATION PROJECT**  
**SITE VISIT/INSPECTION REPORT**

FACILITY: <b>Freedom Industries</b>			STREET ADDRESS: <b>1015 Barlow Drive</b>					
CITY: <b>Charleston</b>			COUNTY: <b>Kanawha</b>			PHONE: ( ) ( ) ( )		
DATE OF VISIT: <b>01-14-2016</b>			TIME IN: <b>11:55pm</b>			TIME OUT: <b>15:15PM</b>

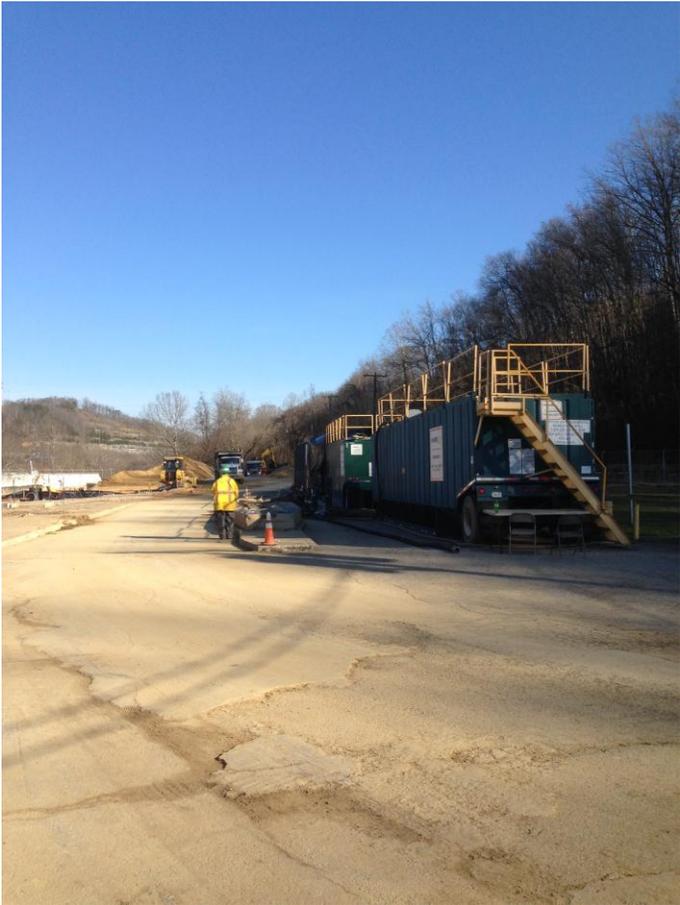
**Figure 1 – A view from the truck staging area**

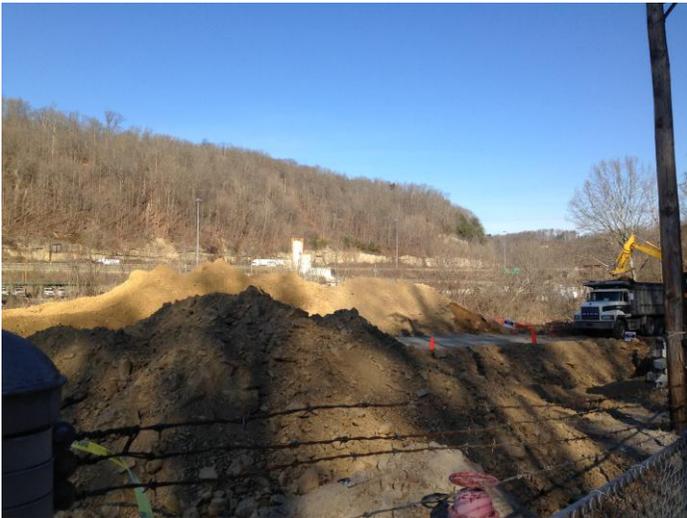
**Figure 2 – Stockpiled soil awaiting to be backfilled**

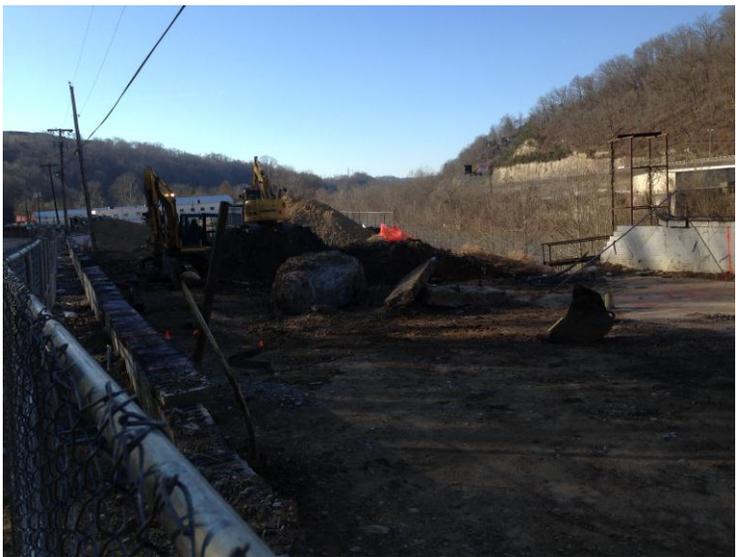
**Figure 3 – A general view of the work area from the NW corner of the facility**

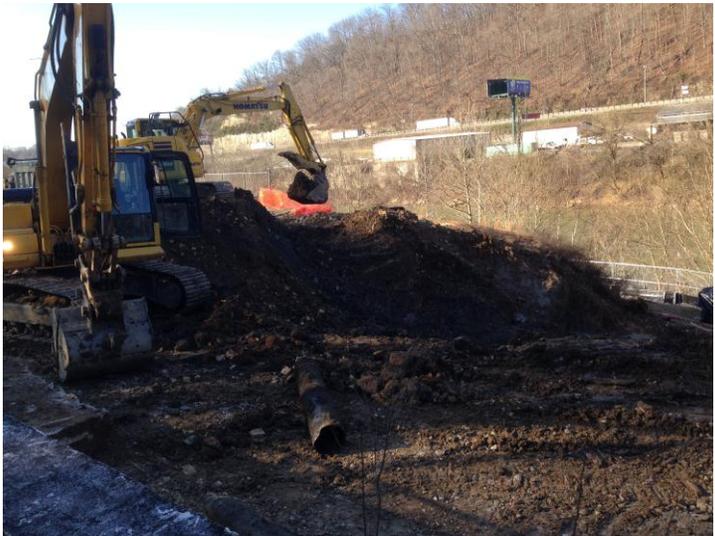
**Figure 4 – A close-up view of the excavation on Areas 3 and 4. An inactive gas line (in the center) came out during the operation**

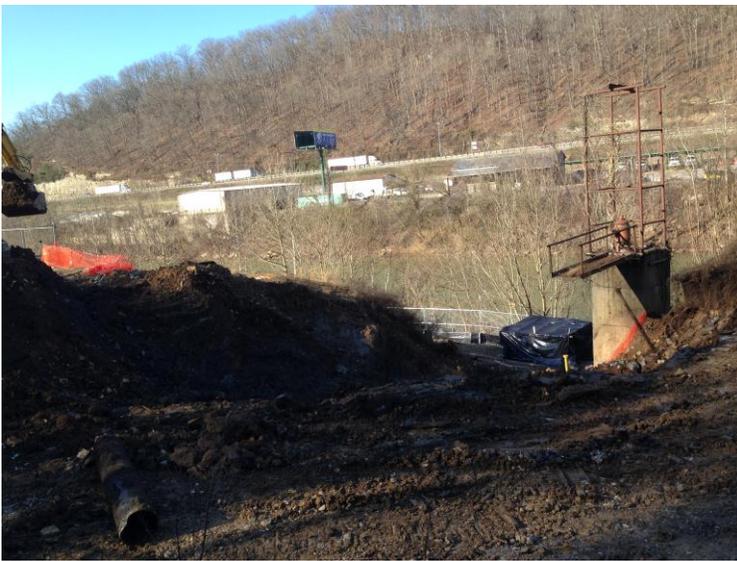
**Figure 5 - A further close-up view of the excavation on Areas 3 and 4, showing a deep cut into the site. An inactive gas line (in the center) came out during the operation**

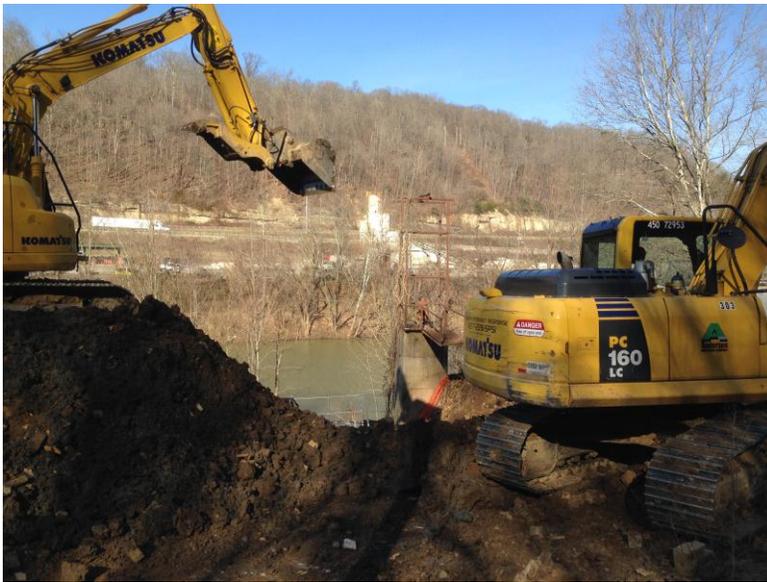
**Figure 7 – Another close up shot into the work areas 3 and 4 showing a deep cut in the site with Elk River revealed in the background**

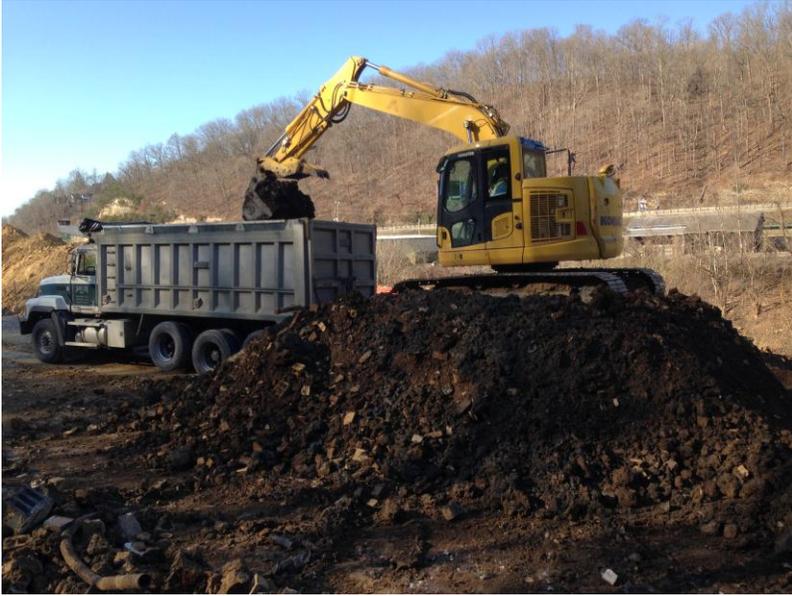
**Figure 6 – A truck being filled with the stockpiled soil and C & D mix with a dark-color stain due to petroleum content. One could smell the petroleum product with some help from the wind.**
