west virginia department of environmental remediation
Office of Environmental Remediation

VRP Project #: **15017**
Brownfield Site: Yes No
Report Date: **12-21-15**
Page 1 of 3

OFFICE OF ENVIRONMENTAL REMEDIATION
VOLUNTARY REMEDIATION PROJECT
SITE VISIT/INSPECTION REPORT

FACILITY: Freedom Industries			STREET ADDRESS: 1015 Barlow Drive								
CITY: Charleston			COUNTY: Kanawha			PHONE: ()					
DATE OF VISIT: December 21, 2015			TIME IN: ~10:00 am			TIME OUT: ~ 11:15 am

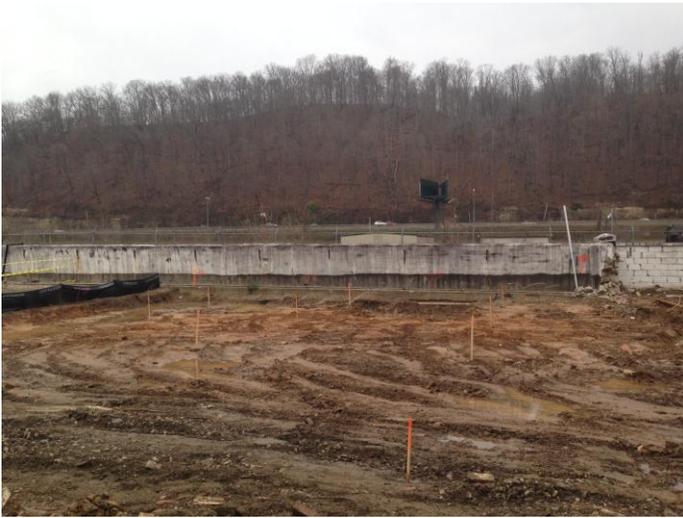
1. View of shallow excavation in Area 1A - looking west
2. View of deeper excavation in Area 1B with caution tape - looking north-northwest
3. View of deeper excavation in Area 1B - looking southwest
4. View of shallow excavated area in Area 1B - orange flags note confirmation sample locations - looking west
