VRP Project #: **15017**
Brownfield Site: Yes No
Report Date: **12-28-15**
Page **1** of **3**

OFFICE OF ENVIRONMENTAL REMEDIATION
VOLUNTARY REMEDIATION PROJECT
SITE VISIT/INSPECTION REPORT

FACILITY: Freedom Industries				STREET ADDRESS: 1015 Barlow Drive							
CITY: Charleston				COUNTY: Kanawha				PHONE: ()			
DATE OF VISIT: December 28, 2015				TIME IN: ~9:00 am				TIME OUT: ~ 11:30 am

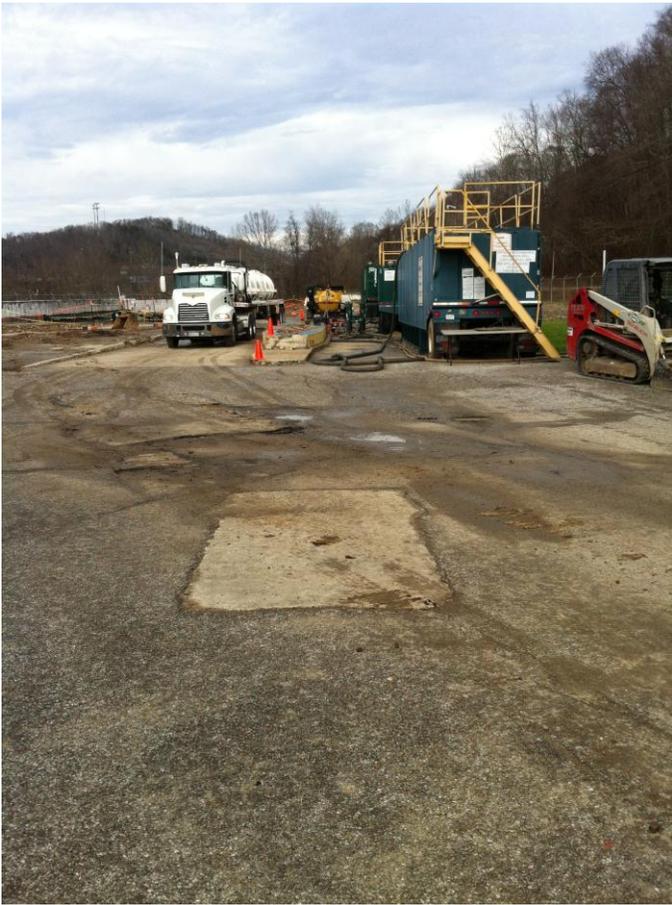
1. BBU truck loading water for disposal
2. Area 1A partially dewatered
3. Pumping water from frac tank for disposal
4. 2nd BBU truck on-site for water disposal

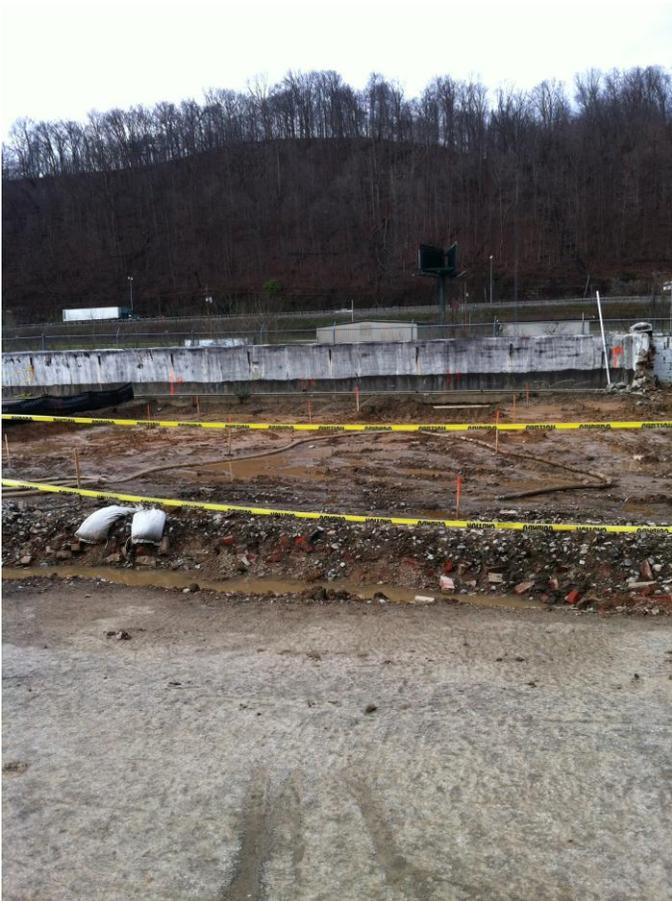
2.

May try to excavate additional soil from areas 1A and 1B today if able to completely dewater these areas.
