west virginia department of environmental remediation
Office of Environmental Remediation

VRP Project #: **15017**
Brownfield Site: Yes No
Report Date: **12-9-15**
Page **1** of **3**

OFFICE OF ENVIRONMENTAL REMEDIATION
VOLUNTARY REMEDIATION PROJECT
SITE VISIT/INSPECTION REPORT

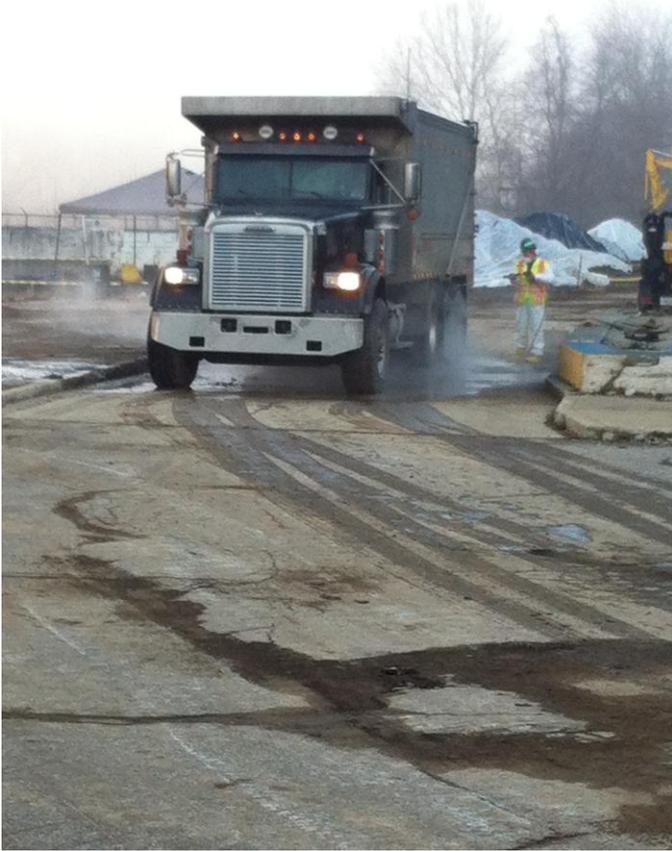
1. Decontamination of first truck loaded today - looking north
2. Brick wall and metal plates in road show boundary between decontamination zone and safe zone - looking west
3. Dozer and excavator working to load soil into trucks - looking southwest
4. Truck at truck entrance on Barlow Drive waiting to be loaded - looking south
