West Virginia Department of Environmental Remediation  
Office of Environmental Remediation

VRP Project #: **15017**  
Brownfield Site: Yes  No   
Report Date: **02-03-2016**  
Page 1 of 2

**OFFICE OF ENVIRONMENTAL REMEDIATION**  
**VOLUNTARY REMEDIATION PROJECT**  
**SITE VISIT/INSPECTION REPORT**

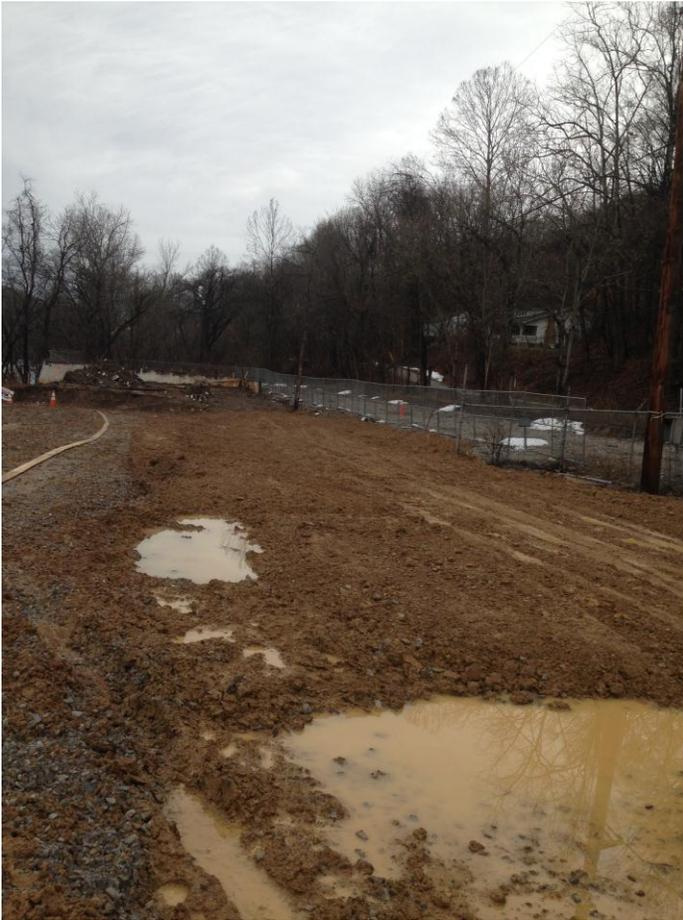
**Figure 1 – Overview of the eastern part of the site, with freshly leveled cleared backfill soil. Water puddles have formed from the recent snow melt and the rainfall over night.**

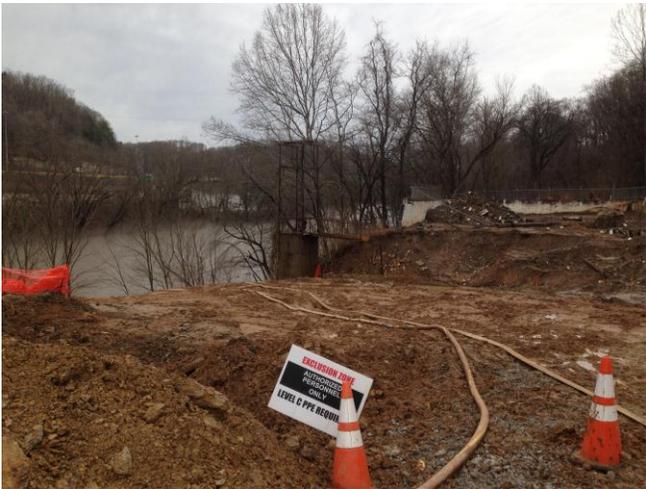
**Figure 2 – Northwestern corner of the site waiting for analysis results to be backfilled and leveled.**

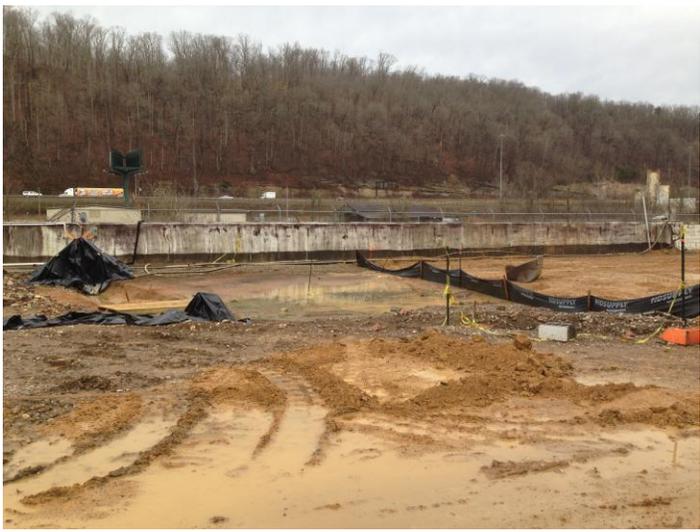
**Figure 3 – Looking toward the western edge of site on the river side, which is maintained with three auto-sumps for surface water management (note the control trench on the center right leading into one of the sumps).**

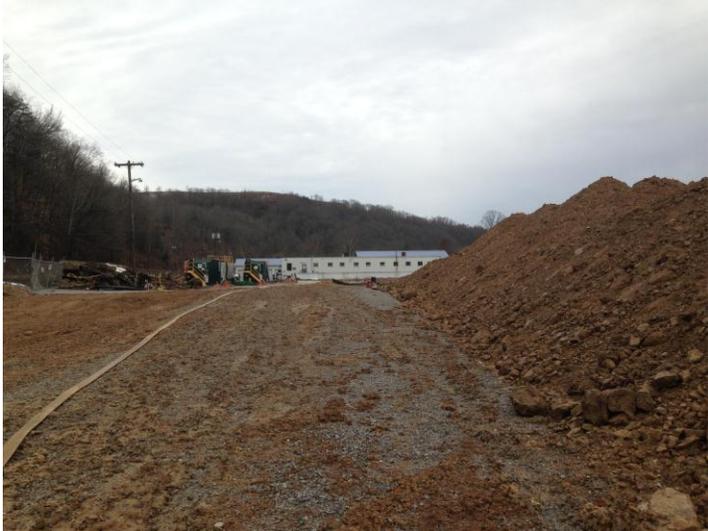
**Figure 4 – A ridge of the clean stockpiled soil from off-site (right) waiting to be backfilled.**
