VRP Project #: **15017**
Brownfield Site: Yes No
Report Date: **2-4-16**
Page **1** of **4**

OFFICE OF ENVIRONMENTAL REMEDIATION
VOLUNTARY REMEDIATION PROJECT
SITE VISIT/INSPECTION REPORT

FACILITY: Freedom Industries			STREET ADDRESS: 1015 Barlow Drive								
CITY: Charleston			COUNTY: Kanawha			PHONE: ()					
DATE OF VISIT: February 4, 2016			TIME IN: ~ 9:15 am			TIME OUT: ~ 2:45 pm

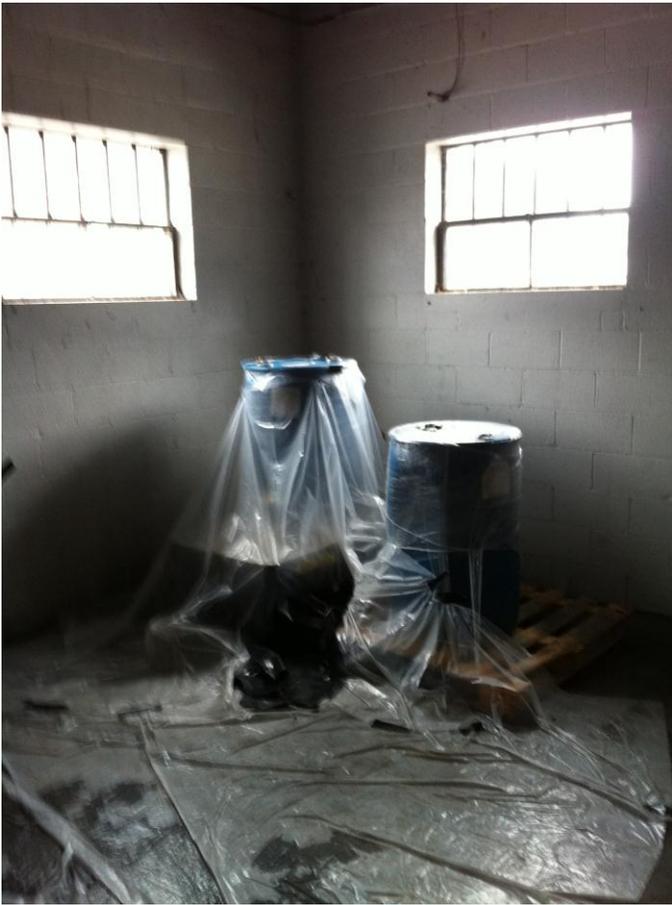
1. Two locked drums of MCHM still present in the office building.
2. Oil pit/hydraulic lift area in garage.
3. Pipe leading down to stormwater outfall at southern end of site.
4. PVC pipe leading down to manhole.
5. Barge dock area on lower bench (note rising water level in Elk River).

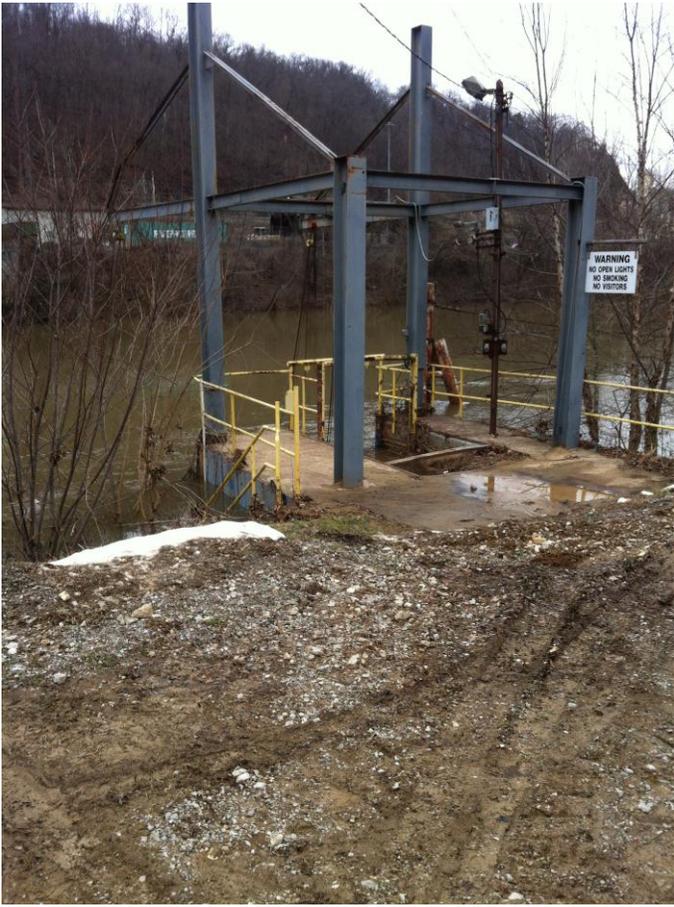
5.

Drove over to excavation Areas 3&4 so that Mr. Jones could observe these areas and take GIS readings. Also drove down to lower bench of site (collection trench area) for additional GIS readings. Water level in the Elk River is almost up to the bottom of the collection trench. Also walked to southern end of the site to investigate stormwater outfall areas.
