VRP Project #: **15017**
Brownfield Site: Yes No
Report Date: **3-23-16**
Page **1** of **4**

OFFICE OF ENVIRONMENTAL REMEDIATION
VOLUNTARY REMEDIATION PROJECT
SITE VISIT/INSPECTION REPORT

FACILITY: Freedom Industries			STREET ADDRESS: 1015 Barlow Drive								
CITY: Charleston			COUNTY: Kanawha			PHONE: ()					
DATE OF VISIT: March 23, 2016			TIME IN: ~ 4:30 pm			TIME OUT: ~ 5:30 pm

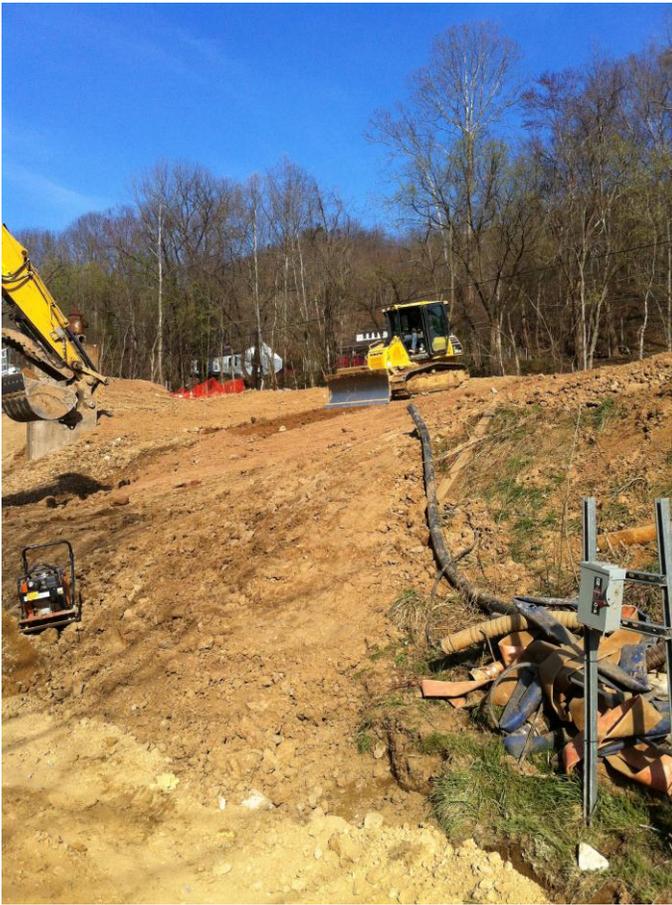
1. Looking upslope (northeast) - dozer spreading clay over french drain.
2. Excavator placing soil on river side of buttress for support.
3. Close-up of plate compactor used to compact soil & clay cap in wet areas.
4. Spreading and compacting clay over french drain in upper slope area.
5. View of upper slope area looking south.
6. View of concrete block buttress at toe of slope - looking southwest.
7. Excavator distributing bales of straw to various areas of slope.
8. Pile of straw bales.
