west virginia department of environmental remediation
Office of Environmental Remediation

VRP Project #: **15017**
Brownfield Site: Yes No
Report Date: **7-30-15**
Page **1** of **3**

OFFICE OF ENVIRONMENTAL REMEDIATION
VOLUNTARY REMEDIATION PROJECT
SITE VISIT/INSPECTION REPORT

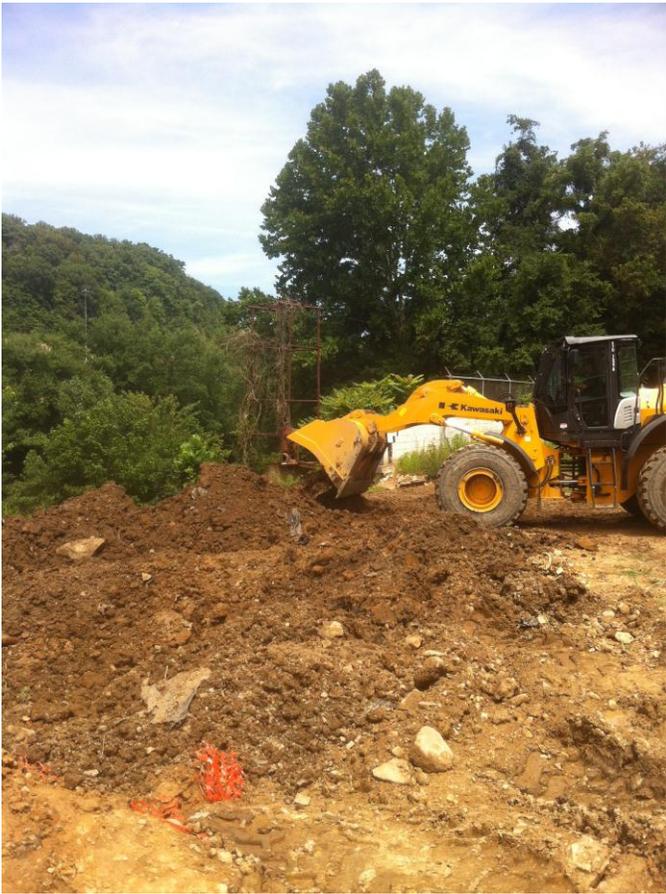
1. Backhoe/loader backfilling open pit area (former fire house area) - looking north
2. Partially backfilled open pit area - looking south
3. Former AST and open pit area - looking north
4. BBU truck picking up water from Baker tank for disposal to CSB - looking north
