VRP Project #: **15017**
Brownfield Site: Yes No
Report Date: **9-17-15**
Page 1 of 7

OFFICE OF ENVIRONMENTAL REMEDIATION
VOLUNTARY REMEDIATION PROJECT
SITE VISIT/INSPECTION REPORT

FACILITY: Freedom Industries			STREET ADDRESS: 1015 Barlow Drive					
CITY: Charleston			COUNTY: Kanawha			PHONE: ()		
DATE OF VISIT: August 26, 2015			TIME IN: ~12:15 pm			TIME OUT: ~ 5:30 pm

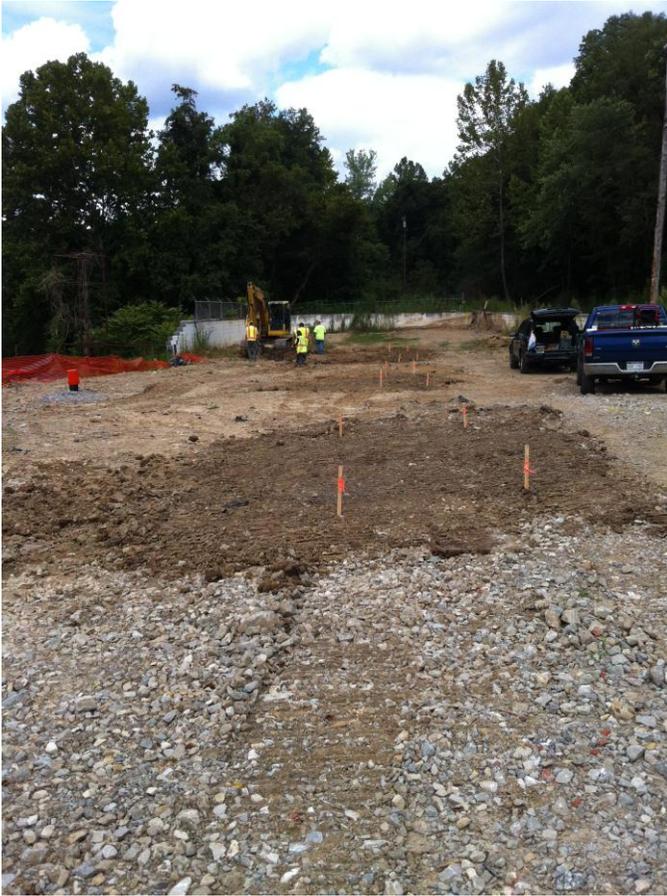
- Test Pit #'s 1-3 were excavated before I was on-site - these 3 were located on the upper portion of the site where the aboveground storage tanks (AST's) were previously located. Test pits 2 & 3 were actually located beneath where AST's #394 and #393, respectively, sat. AST's #394 and #393 most recently contained glycerin. Very little "cobble fill" material was found during the excavation of test pits #1-3, however, petroleum odors were strong and heavy staining was clearly evident. No MCHM odors were present

1. View of Test Pit locations 1-3, looking north
2. View of initial C&D debris encountered in Test Pit #4
3. Extent of C&D debris in Test Pit #4
4. Extending Test Pit #4 towards northern end of site; location with respect to northern end of site

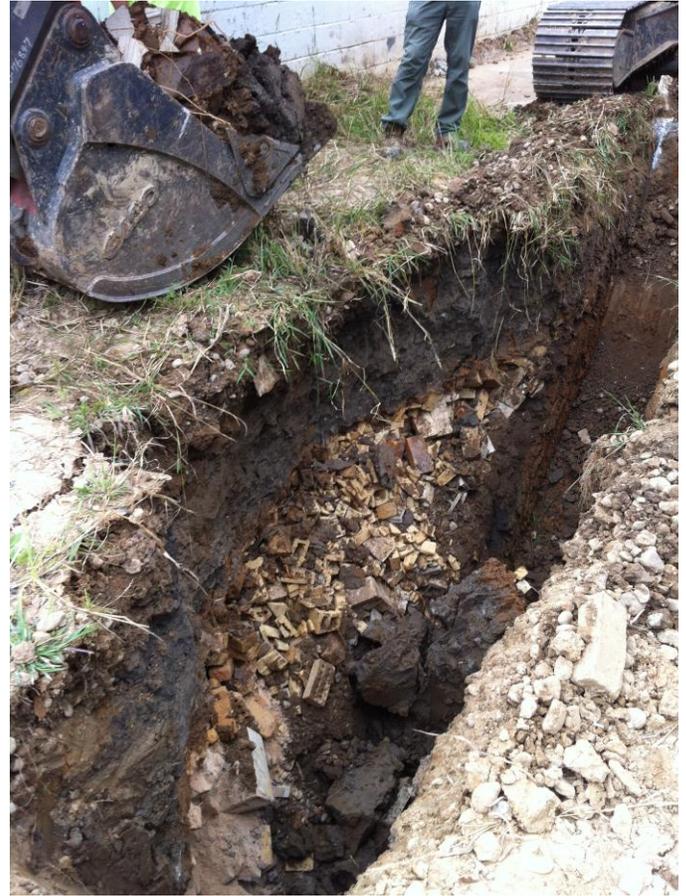
3.

- Test Pit #4 was located on the upper portion of the site along the remaining southern-most portion of the northern extent of the western secondary containment wall (see test pit #10 on the figure). Soil fill material (silty to sandy clay) was present to 4 feet. At 4 feet, yellow, grey and red brick remnants were encountered and a moderate to strong MCHM/PPH odor was noted; this appears to be what was previously referenced as "cobble fill"; for purposes of this report, this material will be referred to as construction and demolition debris (C&D debris). The C&D debris was very loosely compacted and in fact caved into the excavation as it deepened.

This material was present to approximately 8-9 feet in depth, where soil fill (or possibly native soil) was encountered. The excavation was extended toward the northern end of the site to determine the extent of the C&D debris - the debris extended approximately 27 feet past the southern end of the northern extent of the western secondary containment wall, and appeared to thin-out in this direction. For all test pits, Core screened a sample of material each two feet in depth from the surface to the total depth of the test pit with a photoionization detector (PID). Soil samples were obtained for lab analysis from the sample with the highest field-screening reading and from .5 to 1 foot below the bottom of the C&D debris. If no debris was encountered, samples were taken from the highest field-screened interval and from the deepest soil interval. All excavations were backfilled after sampling. Once the test pits were backfilled, wooden stakes were used to mark the test pit locations for later surveying.

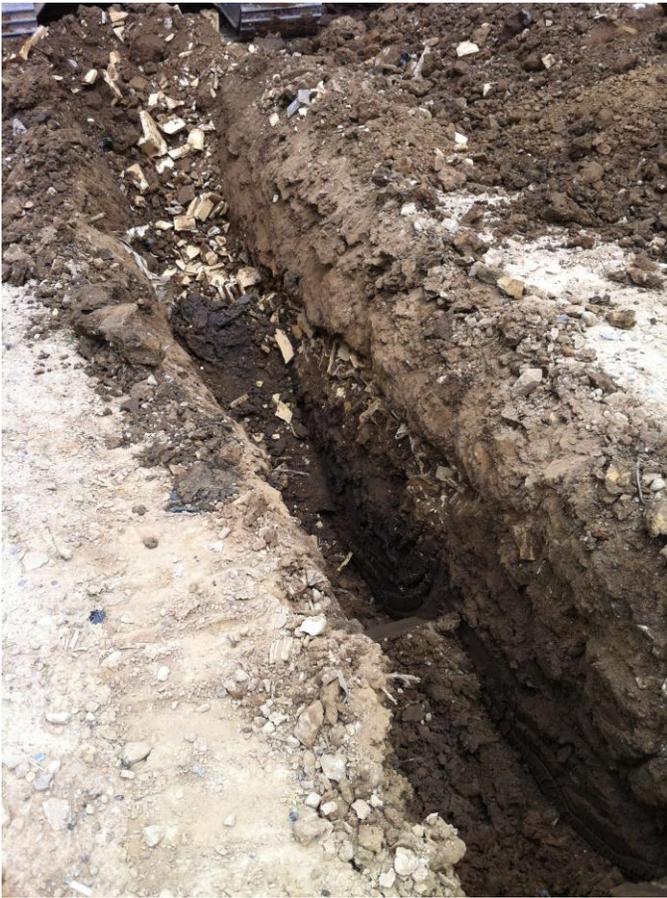
- Test Pit #5 was located on the upper portion of the site and in-between but further west of test pits 2 and 3 (see pit #1 on the figure). C&D debris was encountered at about 2 feet, but only extended to about 4 feet. A moderate petroleum odor and a slight MCHM odor were noted in this test pit. A second test pit was excavated at the northern end of #5 (#5A), but perpendicular to #5 and extended east towards Barlow Drive. C&D debris was present to the furthest extent of this excavation (approximately 25' from the eastern secondary containment wall) but the excavation was halted due to the presence of a marked natural gas line. This excavation extended further east than test pits 2 and 3, where no C&D debris was found. A petroleum odor was present, but no noticeable MCHM odor.

5. Initial C&D debris in Test Pit #5
6. Extending Test Pit #5A towards eastern side of site (towards Barlow Drive)
7. Eastern extent of Test Pit #5A
8. View of Test Pit #5 looking north

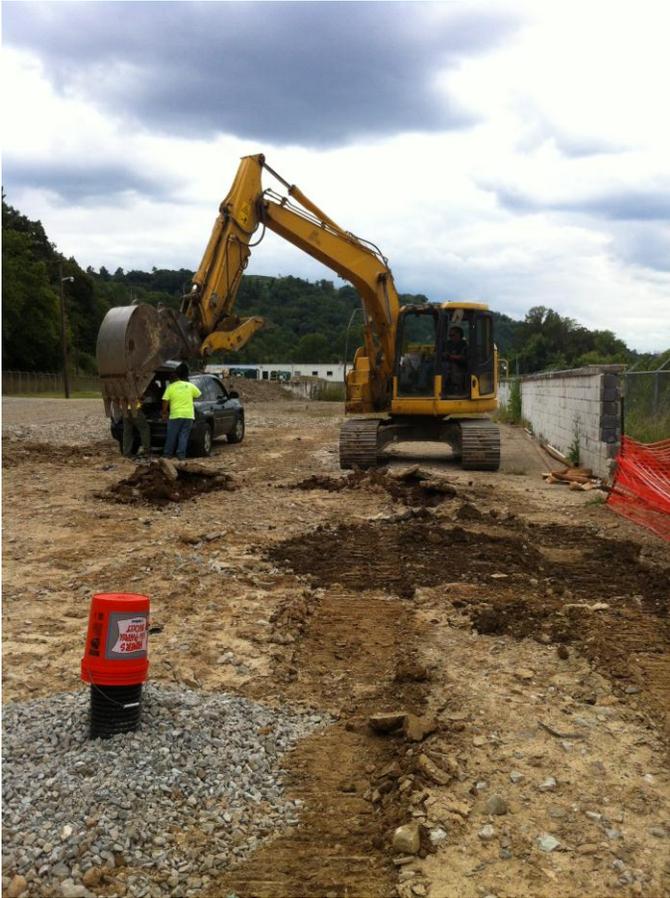
- Test Pit #6 was excavated in the area of the former fire house in the path of the spill from the AST to the top of the slope (see test pit #9 on the figure). This was also the northern extent of the southern section of the remaining western secondary containment wall. Concrete was removed in a portion of this area and MCHM/PPH odors were very strong. No C&D debris was found in this area, but an attempt was made to determine the depth of MCHM/PPH-impacted soil. Odors were strong to overpowering as the excavation deepened. Soil was moist at 10 feet and wet at 12 feet. The excavation continued an additional 2 feet and was halted; odors were still very strong to overpowering at 14 feet, total depth.

9. Location of Test Pit #6 looking south; also shown is sump access for upper sump & pump installed at the end of July
10. Location of Test Pit #6 looking southwest towards Elk River

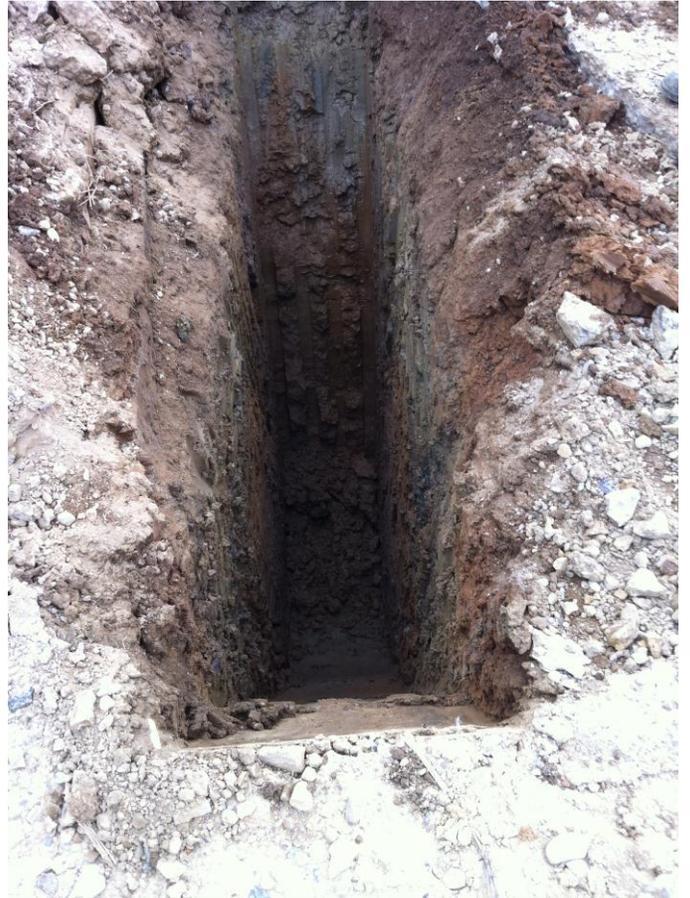
11. Test Pit #6 at 12 feet - wet at bottom
12. Location of Test Pit #7, looking downslope (southwest) towards Elk River
13. C&D debris/soil pile from excavation of Test Pit #7

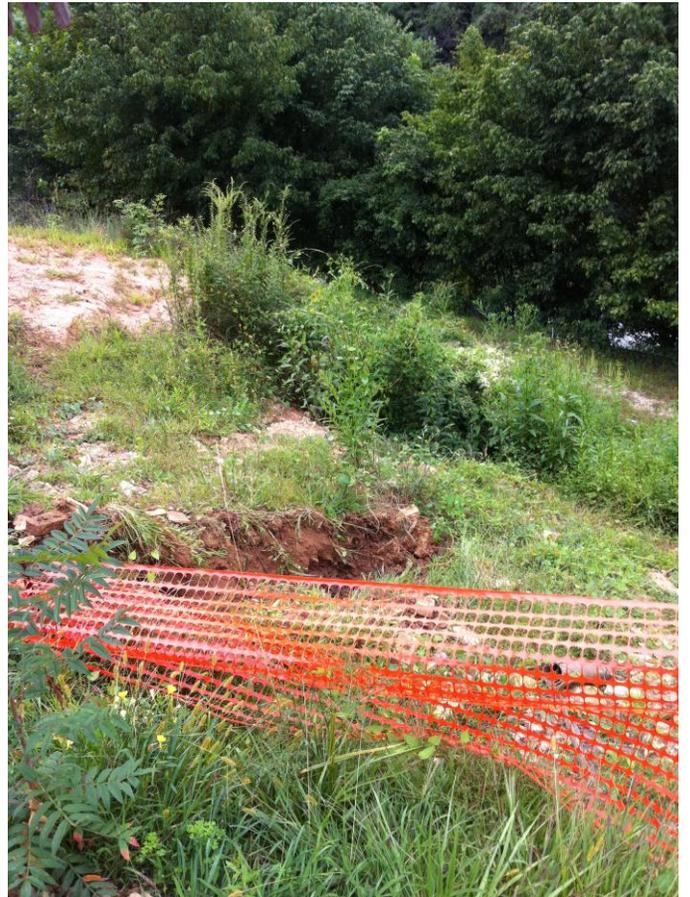
12.

- Test Pit #7 was located on the top of the slope leading down to the lower terrace (trench location), just below the southern end of Test Pit #4 (see Test pit #2 on the figure). C&D debris is present on the surface of the slope in this area mixed with soil fill material - no MCHM/PPH odors at the surface. C&D debris and soil fill present to 8 feet where first petroleum odors were noticed, but no MCHM/PPH odors. C&D debris/soil fill continued to 10 feet which appeared to be the base of the C&D debris - a slight MCHM/PPH odor and moderate petroleum odor was detected at the base of the C&D debris. A grey sand zone was encountered at approximately 11 feet with a moderate to strong petroleum odor. Encountered what appeared to be native soil (silty red/brown clay) at 12 feet, where both petroleum and MCHM/PPH odors were present. Excavation stopped at 12'.

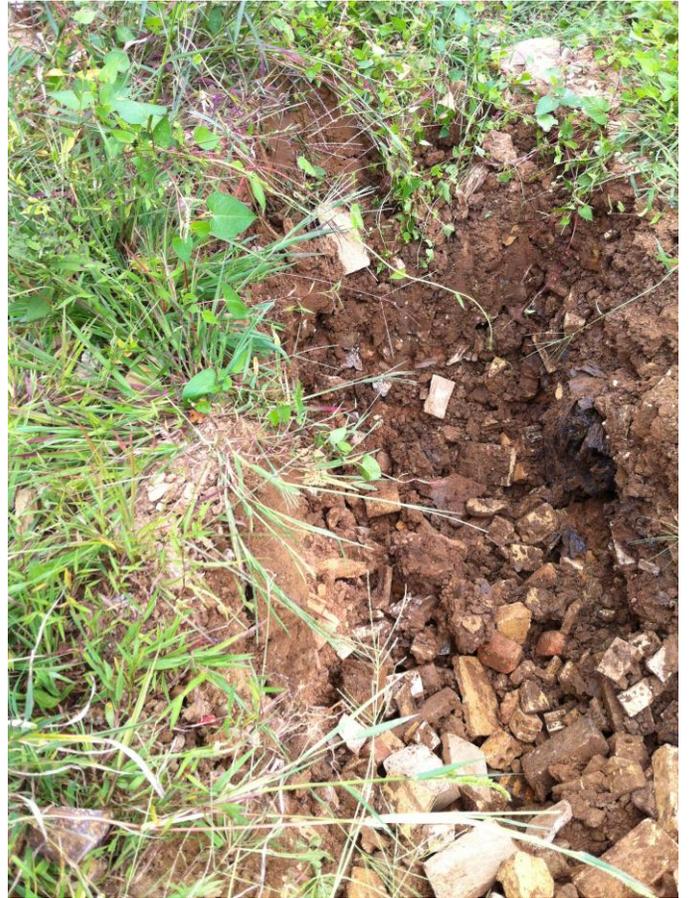
14. Obtaining samples for screening - Test Pit #7, looking north
15. C&D debris caving in Test Pit #7
16. Continuing to excavate Test Pit #7, looking northeast

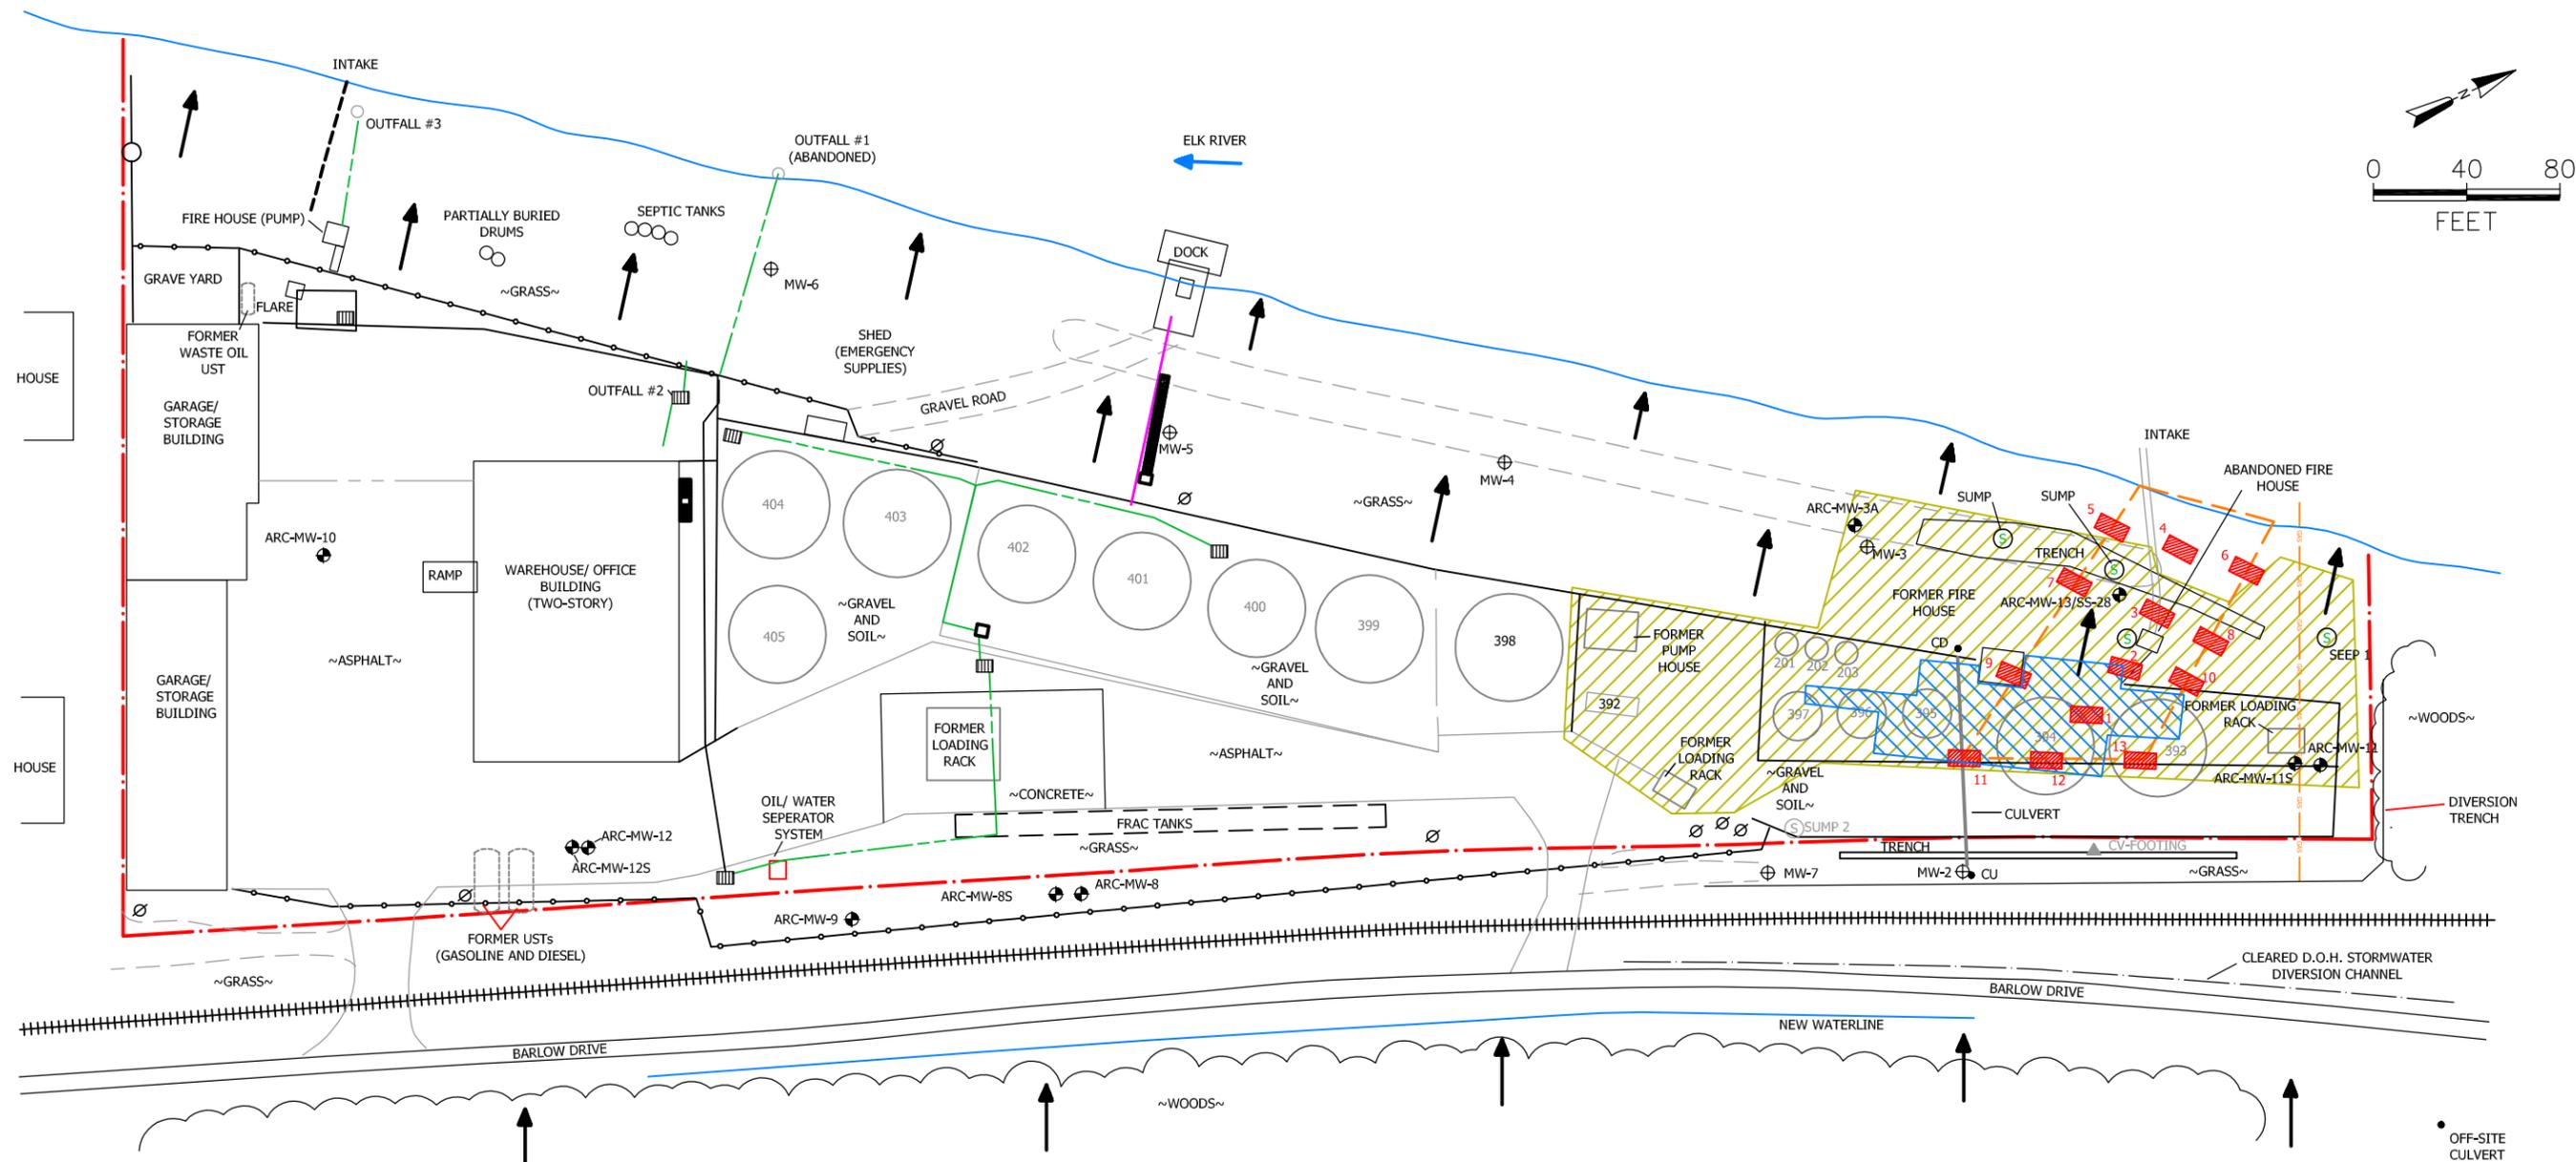
TITLE:
PROPOSED SUPPLEMENTAL SITE ASSESSMENT ACTIVITIES
FREEDOM INDUSTRIES
1015 BARLOW DRIVE
CHARLESTON, WEST VIRGINIA

On-site ~ 12:15 pm to observe test pit installations as proposed in the VRRP Interim Site Assessment Work Plan - Revision #1. The purpose of the test pits was to determine the extent of the "cobble fill" material referenced in previous reports and determine the extent of MCHM/PPH impacted material. Verbal approval to proceed with the work plan was communicated to Core on 8-25-15. Matt Ford, LRS, Jared Sommers, Field Tech, Maggie Gorczynska, Staff Scientist and Sotero Svingos, PG, Senior Scientist with CORE Environmental Services, Inc on-site. Gary Houseman of SPSI West, Inc also on-site running backhoe. Currently excavating test pit #4, however, order of test pit excavations is not the same as test pit numbers on the figure included in the work plan (Figure - Proposed Supplemental Site Assessment Activities - see attached). Order of test pit excavations with respect to the figure is as follows: Excavation/Test Pit #1 is #11 on the figure, Test Pit #2 is #12 on the figure, #3 is #13, #4 is #10, #5 is #1, #6 is #9, #7 is #2, #8 is #8, #9 is #6, #9A is an additional test pit dug perpendicular to #9, #10 is #3, #11 is #7, and #12 is located between #'s 4&5 on the figure. For this report, the test pits will be referenced in the order in which they were excavated.
