**CONSENT ORDER
ISSUED UNDER THE
WATER POLLUTION CONTROL ACT
WEST VIRGINIA CODE, CHAPTER 22, ARTICLE 11
AND THE
GROUNDWATER PROTECTION ACT
WEST VIRGINIA CODE, CHAPTER 22, ARTICLE 12
AND THE
SOLID WASTE MANAGEMENT ACT
WEST VIRGINIA CODE, CHAPTER 22, ARTICLE 15**

DATE: September 24, 2014

ORDER NO.: MM-15-01

**Sampling Event, Clayton W. Rice Property, near Grafton, US Rte. 50, Taylor County, 2-06-14
Photos by: Chuck Joseph**

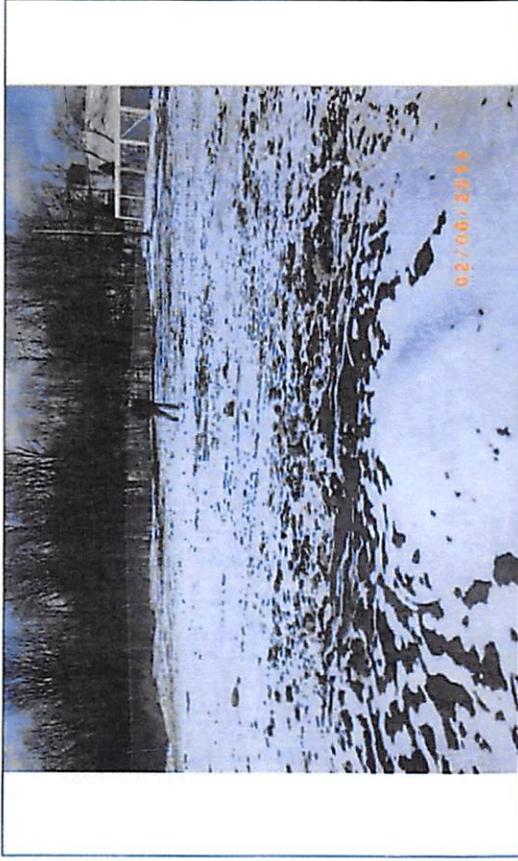
Photo # imgp4626

Photo #	Comments
IMGP4626	Photo taken for sample point verification
IMGP4627	Photo taken for sample point verification
IMGP4628	Photo taken for sample point verification
IMGP4629	Photo taken for sample point verification
IMGP4630	Photo taken for sample point verification
IMGP4631	Photo taken for sample point verification
IMGP4632	Photo taken for sample point verification
IMGP4633	Photo taken for sample point verification
IMGP4634	Photo taken for sample point verification
IMGP4635	Photo taken for sample point verification
IMGP4636	Photo taken for sample number verification
IMGP4637	Photo taken for sample number verification
