**Hydrologic Reconnaissance for Stream Stability
And Sediment Consequences
Morris Creek, West Virginia**

6/1/05

Prepared by:
Ryan Gaujot
Geologist
Canaan Valley Institute

In Partnership with:
Morris Creek Watershed Association

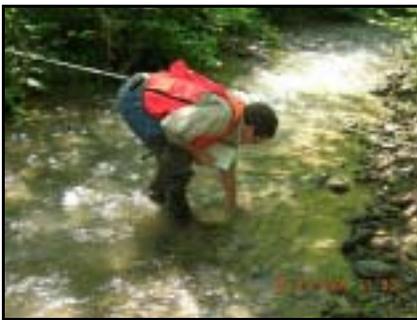
Figure 2: A riffle pebble count for Morris Creek just above the Waterfall.

Figure 2 illustrates a Riffle Pebble 100 Count for Morris Creek showing the D50 as 30mm (course gravel) particle size. Particle size from this pebble count is underestimated due to sampling more 'bankfull' particles skewing the distribution to include more sand and silt. Future pebble counts need to be accomplished upstream and downstream of this pebble count location for velocity and sediment entrainment calculations.
