West Virginia Department of Environmental Protection
Division of Water and Waste Management
Environmental Enforcement

Fly Ash Dam/Landfill Condition Evaluation

November 2009

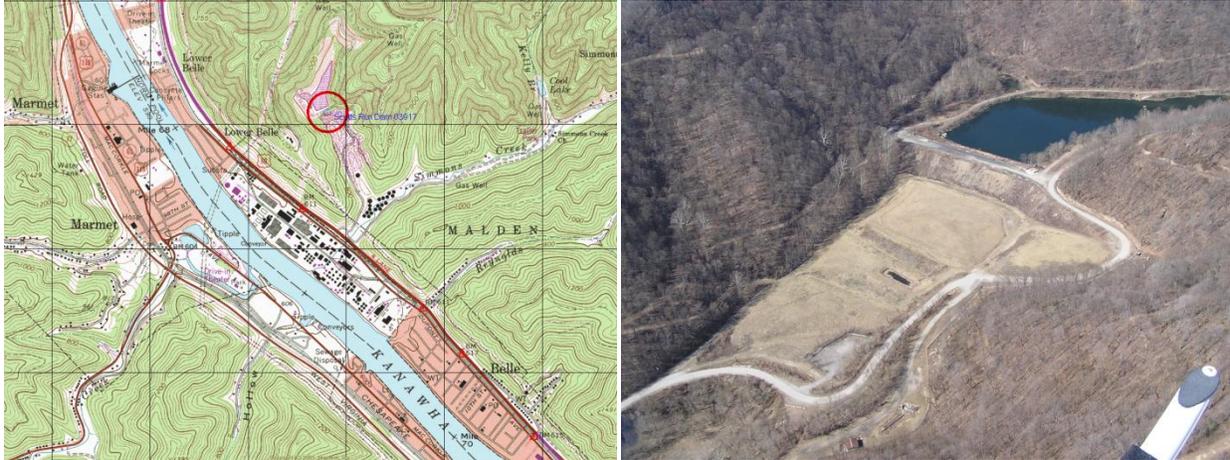
Scotts Run Dam, Kanawha County, ID # 03917

Scotts Run Dam is constructed of fly ash materials with a massive buttress of bottom ash material on the downstream face. Internal drains collect seepage water with discharge at the downstream toe at a single monitoring point. The reservoir is constructed to store the design storm and discharge it through a pipe principal spillway. The pipe spillway merges with surface drainage ditches at a transfer box along the right abutment on the crest of the embankment buttress.

1. Cut/remove vegetation from the dam embankment and within 25 feet of the embankment footprint per the Dam Safety Rule requirements.

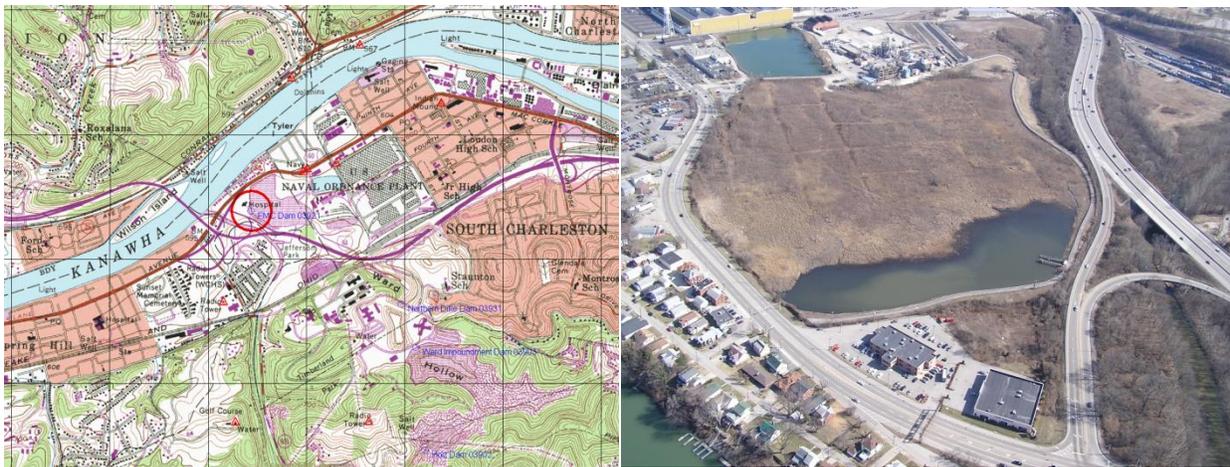
FMC Retention Dam, Kanawha County, ID # 03921

The dam embankment tapers into the abutments with a principal spillway riser to the right of center, and a conduit to the left of center that conveys storm water from the plant area to Davis Creek via a culvert under the interstate ramp. Fly ash disposal at the site stopped several years ago. The Ward Hollow stream channel flows from natural ground at the left abutment and runs laterally below the embankment toe toward the center, where it combines with discharge from the conduit to flow under the interstate ramps. The reservoir is partially overgrown with young trees, brush, and cattails.

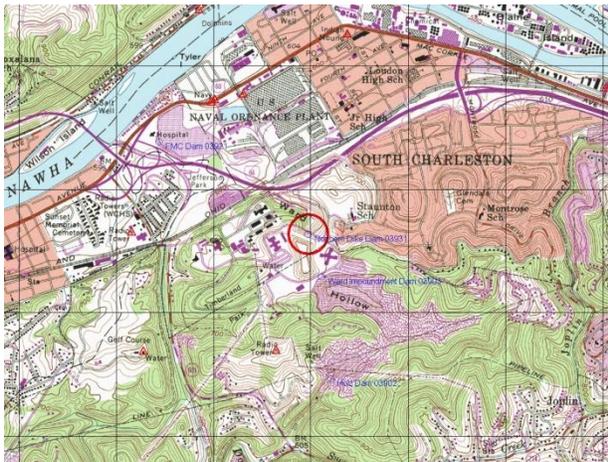
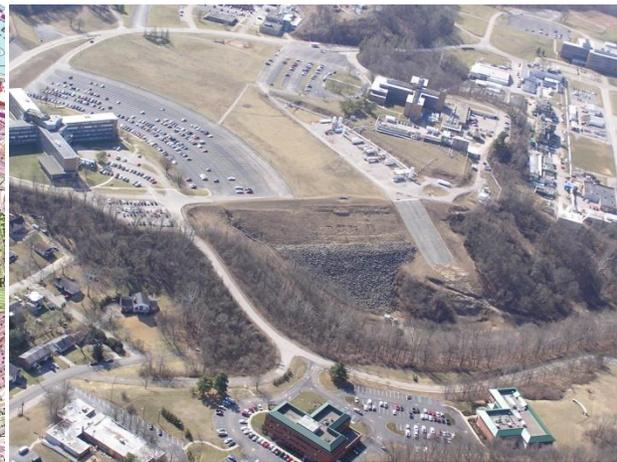
Northern Dike (Lower Ward) Dam, Kanawha County, ID # 03931

The Northern Dike Dam is an inactive fly ash disposal site. The reservoir area was previously capped with earth materials to create the appearance of a landfill. The owner installed an asphalt parking lot on the right side of the reservoir next to Building 2000. WVDEP issued approval for

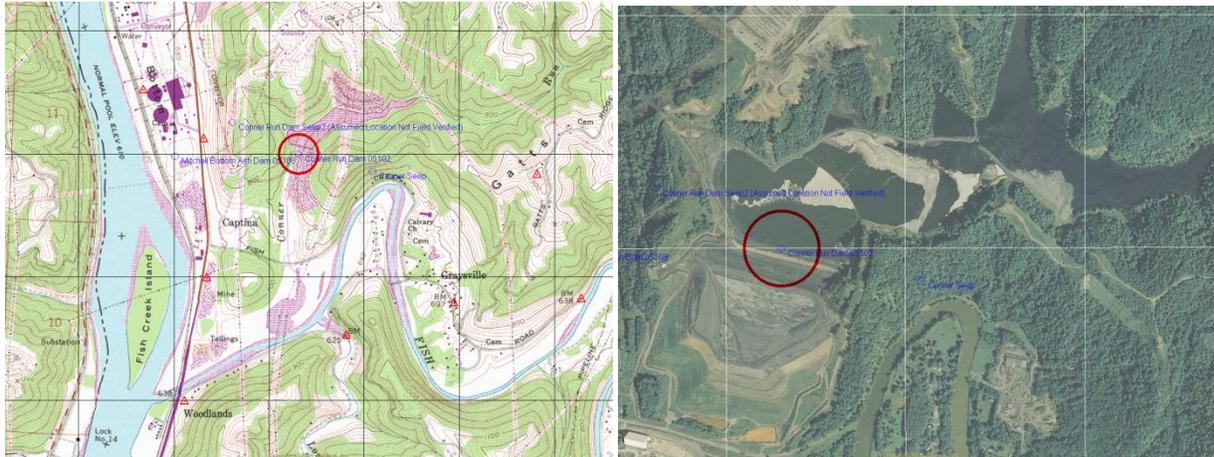
Conner Run Dam, Marshall County, ID # 05102

The Conner Run Dam is an earthen structure located on Conner Run, which is a tributary of Fish Creek/Ohio River. The main purpose of the structure is to dispose of fly ash and coal slurry in the reservoir area and coarse coal refuse on the downstream slope as a large buttress. Reservoir discharge is through a 72 inch RCP pipe at the left abutment. A major seepage zone is evident in the natural hillside on the left side of the reservoir that discharges to Fish Creek. A second smaller possible seepage zone may be located in the Ohio River hillside above the power station.

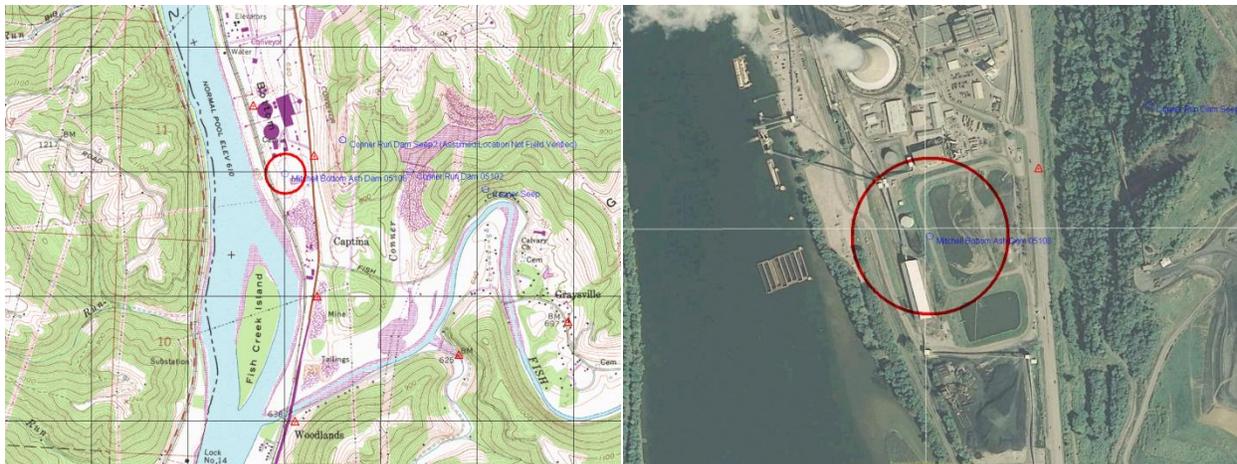
Mitchell Bottom Ash Dam, Marshall County, ID # 05108

The dam is essentially a three sided earthen dike with a lower dike through the center of the impoundment. The reservoir is more or less parallel to the Ohio River. Heavier sludge material is pumped into the upper reservoir of the dam and water flows from the upper reservoir into the lower section after settling. The lower section has three small dikes across it that are approximately perpendicular to the river that appear to have been installed to increase retention

Based on the cross sections analyzed by the engineer and the different loading conditions the engineer's results indicate that the Mitchell Bottom Ash Dam meets or exceeds the minimum factors of safety required by the Dam Safety Act & Rule. The owner's engineer did not submit rapid drawdown analyses.

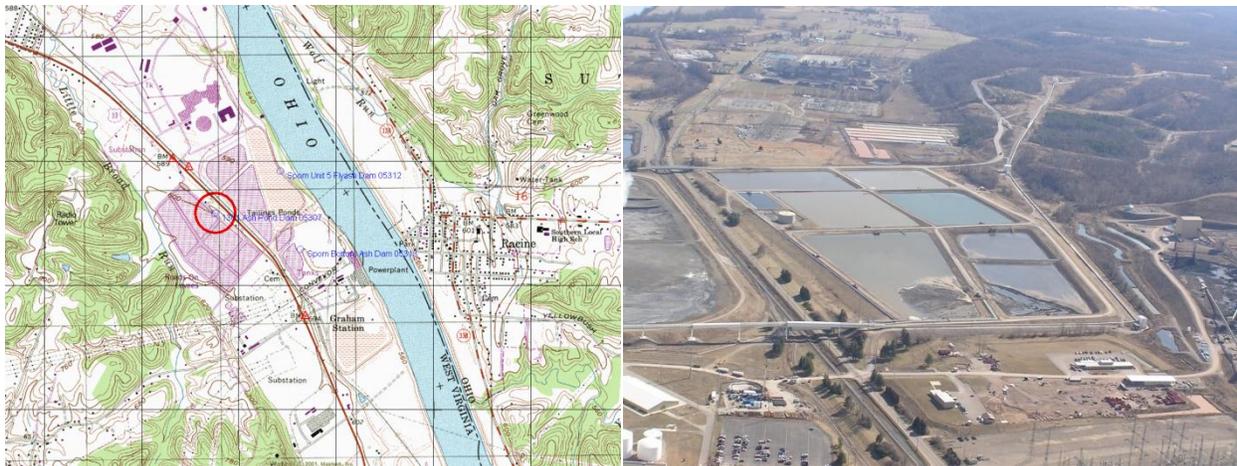
1301 Ash Pond Dam, Mason County, ID # 05307

The 1301 Ash Pond Dam is a rectangular structure, approximately 3,200 feet in crest length (east and west embankments). The north embankment crest length is approximately 1,000 feet and south embankment crest length is approximately 1,500 feet. The reservoir is sub-divided with dikes to allow alternating fly ash disposal in one area while cleaning out others.

1. Investigate and correct wet area on east exterior embankment.
2. Submit documentation regarding stability of north embankment.

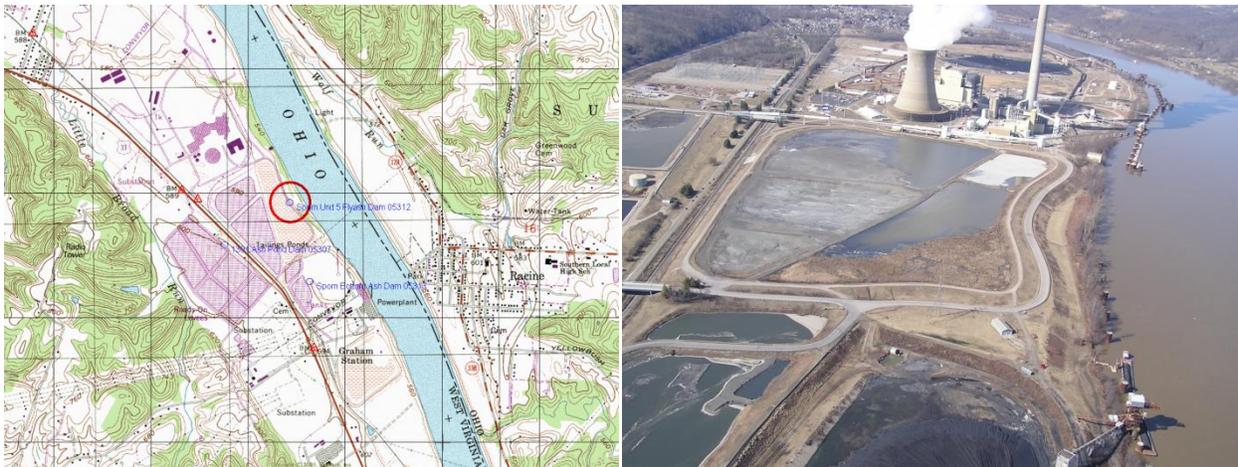
Sporn Unit 5 Fly Ash Dam, Mason County, ID # 05312

The dam is a rectangular structure next to the Ohio River. The reservoir is sub-divided with dikes to allow alternating fly ash disposal in one area while cleaning out others. In 2001, DEP approved an application to repair and modify the dam including reduction of crest height (except the east embankment), repair of instability in the west embankment near the northwest abutment using a rock buttress fill, and installation of a rock buttress across the southern portion of the lower east embankment. In 2006, DEP approved the installation of conveyor belt foundations in the north embankment.

2. A number of problems were found especially with the upstream slopes of the cross sections. Many did not meet or exceed the minimum Dam Safety Requirements. Some Cross Sections used in the analysis did not match the configuration given in the drawings. The general configuration of the eastern dike cross sections (Sections J-J, K-K, L-L & M-M) are a major concern to this writer. Higher portions of the upper dike are built completely on Fly Ash with a thin layer of material between the upper and lower dike. Additional information regarding the thin layer is necessary. The fly ash appears to be still saturated from the upstream fly ash disposal area. A potential blow-out appears to be a possibility.

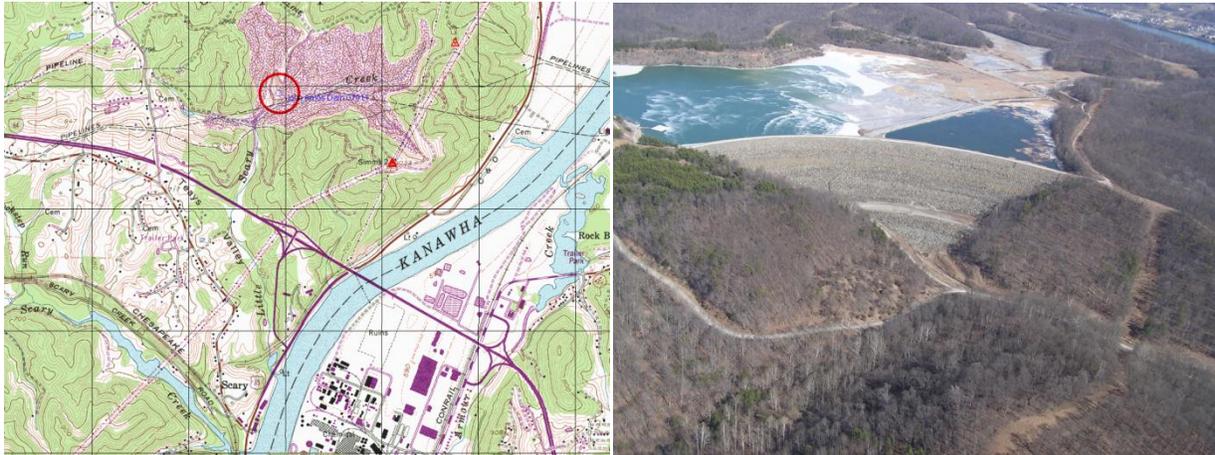
John Amos Dam, Putnam County, ID # 07911

The John Amos Fly Ash Dam is an earth & rockfill structure located in the headwaters of Little Scary Creek a tributary of the Kanawha River near Teays Valley, north of Scary in Putnam County. The dam has a concrete decant riser and discharge tunnel/pipe located in original ground off the northwest end of the dam, which discharges through the hillside into an adjacent tributary of Scary Creek. Also, excavated through the bedrock of the hillside northwest of the dam is an open channel emergency spillway. The purpose of the dam is to allow bottom ash to settle out of the John Amos Power Plants bottom ash slurry pumped to the site, then treating the water, as needed to meet environmental standards, prior to releasing the decant water to the natural stream. The bottom ash is stored/disposed off in the reservoir.

No further action is necessary at this time.

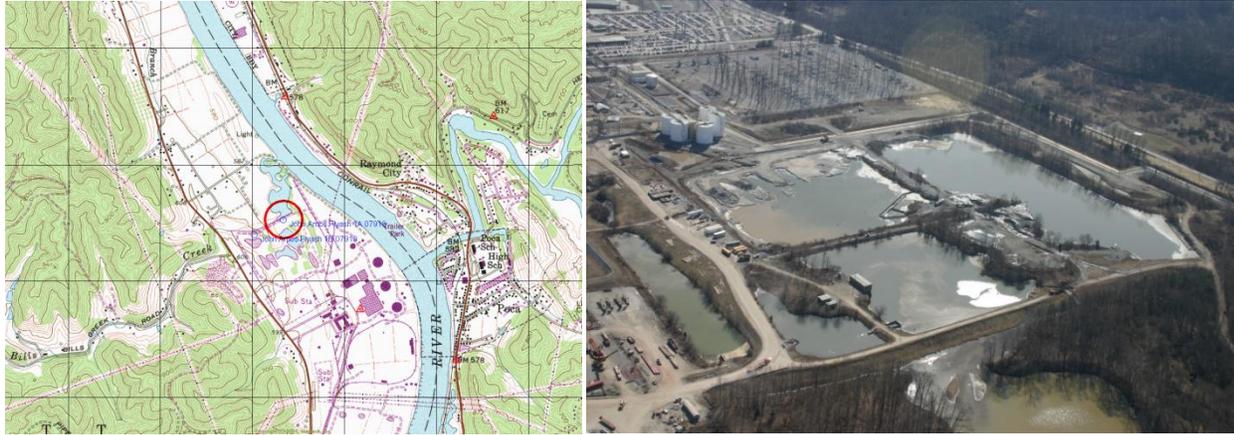
John Amos Fly/Bottom Ash Dams, Putnam County, ID # 07918 & 07919

The John Amos 1A & 1B Dams are adjacent rectangular impoundments contained by a three-sided embankment and original ground. Two of the five existing ponds utilized for fly ash temporary disposal are large enough for DEP dam safety jurisdiction. The impoundments are alternated between receiving fly ash and cleaning of fly ash for disposal at the landfill. DEP recently approved modification to combine the two reservoirs into one structure by raising the surrounding embankments. Construction to accomplish the modification has not commenced. Height and storage numbers above reflect current, not proposed, conditions.
