VRP Project #: 15017  
 Brownfield Site: Yes  No   
 Report Date: 3/03/16  
 Page 1 of 2

**OFFICE OF ENVIRONMENTAL REMEDIATION**  
**VOLUNTARY REMEDIATION PROJECT**  
**SITE VISIT/INSPECTION REPORT**

FACILITY: : <b>Freedom Industries</b>			STREET ADDRESS: : <b>1015 Barlow Drive</b>								
CITY: <b>Charleston</b>			COUNTY: <b>Kanawha</b>			PHONE: ( )					
DATE OF VISIT: <b>March 02, 2016</b>			TIME IN: <b>3:08</b>			TIME OUT: <b>3:42</b>

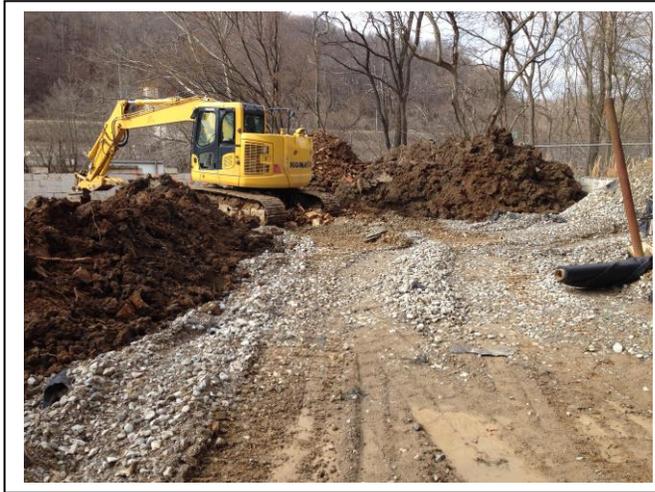
Water sample taken from sump 8 showed elevated levels of MCHM in area 4. Soil from area 4 was being stockpiled until it could be removed. No MCHM odor was detected from stockpiled soil, but temperatures were low during site visit which may have helped keep odor encapsulated. I could intermittently smell a faint petroleum odor.

Figure 1: Stockpiled soil from area 4

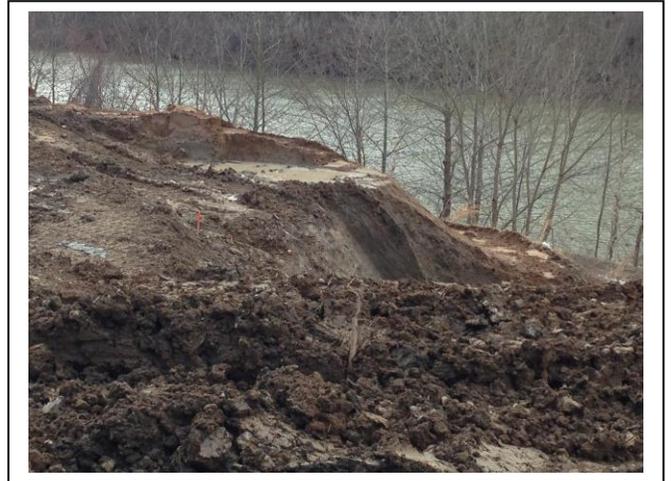
Figure 4: area 4 soil removal

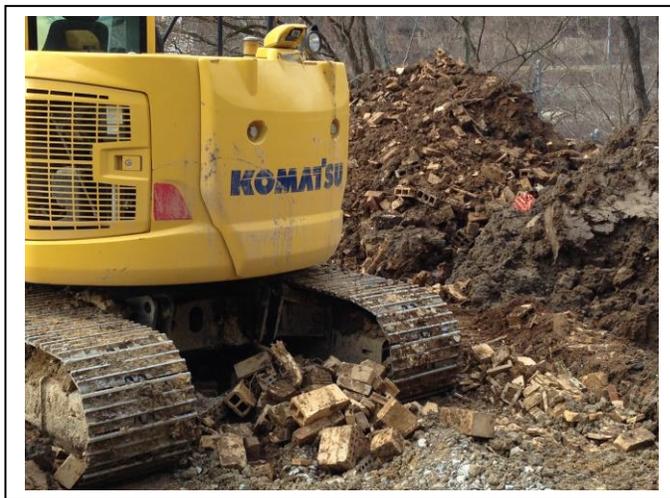
Personnel on site were were Kinder Tuckwiller of Core Environmental, and Chuck Devine who was operating the backhoe equipment. Brick and block were being excavated and piled until it could be determined if any contamination was present.

Figure 2: Close-up of stockpiled soil from area 4 on right of excavator, and stockpiled bricks and block on left

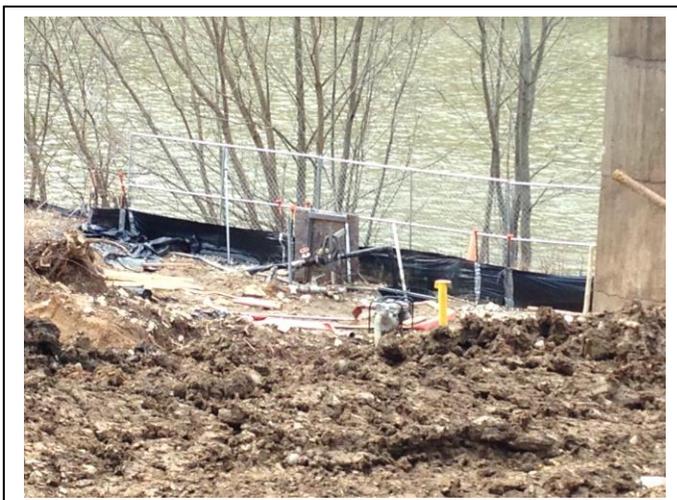
Tent was removed from sump 8.

Figure 3: Sump 8 with plastic removed
