**CONSENT ORDER
ISSUED UNDER THE
WATER POLLUTION CONTROL ACT
WEST VIRGINIA CODE, CHAPTER 22, ARTICLE 11**

ORDER NO.: 8523

Company Name: Keystone Clearwater Solutions LLC
Facility Name: Ohio River Pipeline
Location: Pleasants County
Stream: Grimes Run, UTs of McKim Creek, Shawnee Run, UTs of Shawnee Run, UTs of Sugar Creek

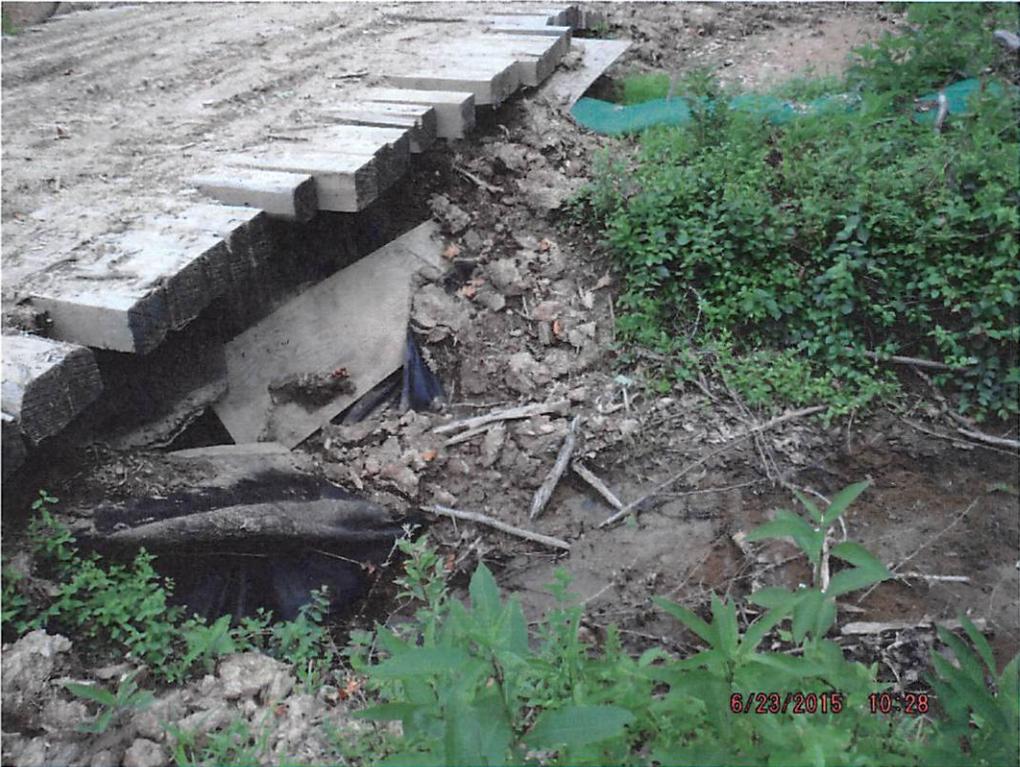
Photo #	Photographer	Description	Notice Of Violation
DSCF3717	JGT	Sediment from stream crossing on an UT of McKim Creek observed causing Conditions Not Allowable	W-NW-JGT-062315-001
DSCF3901	JGT	Sediment from stream crossing on Cave Run observed causing Conditions Not Allowable	W-NW-JGT-062315-002
DSCF3913	JGT	Sediment from stream crossing on Shawnee Run observed causing Conditions Not Allowable	W-NW-JGT-062315-003
DSCF3938 DSCF3952	JGT	Sediment observed leaving ROW through unmaintained silt fence and entering into an UT of Shawnee Run causing Conditions Not Allowable	W-NW-JGT-062315-004
DSCF3961 DSCF3977	JGT	Sediment observed leaving ROW through unmaintained silt fence and entering into an UT of Shawnee Run causing Conditions Not Allowable	W-NW-JGT-062415-001
DSCF4062 DSCF4058	JGT	Sediment observed leaving ROW through unmaintained silt fence and entering into an UT of Sugar Creek causing Conditions Not Allowable	W-NW-JGT-062415-002

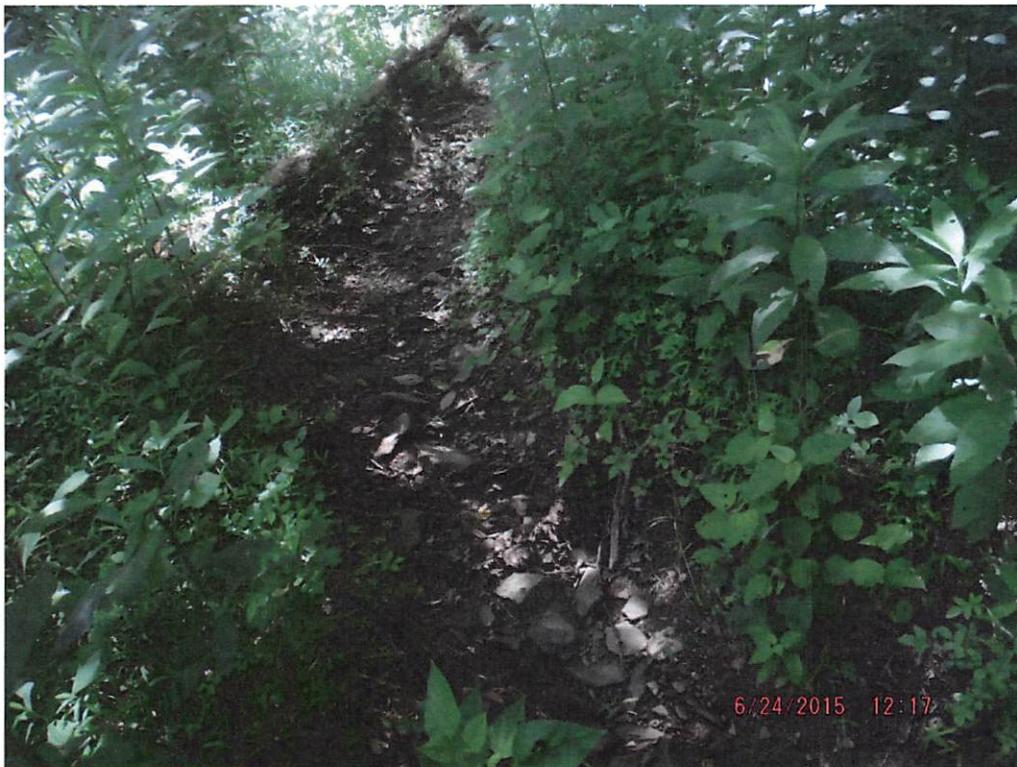
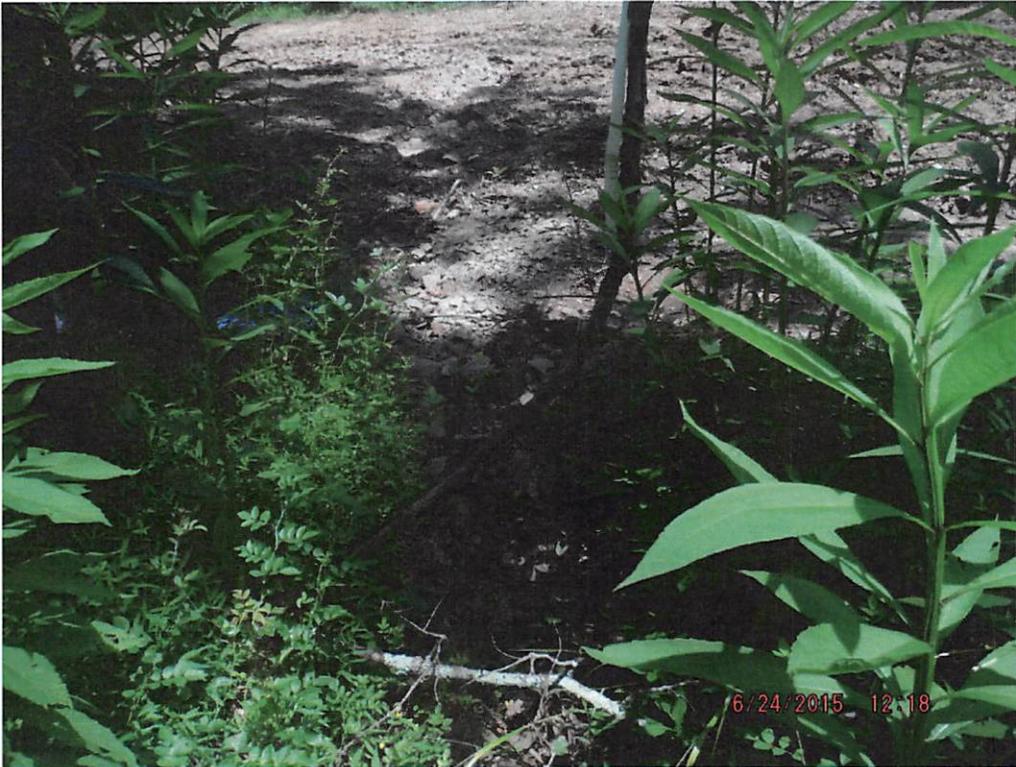
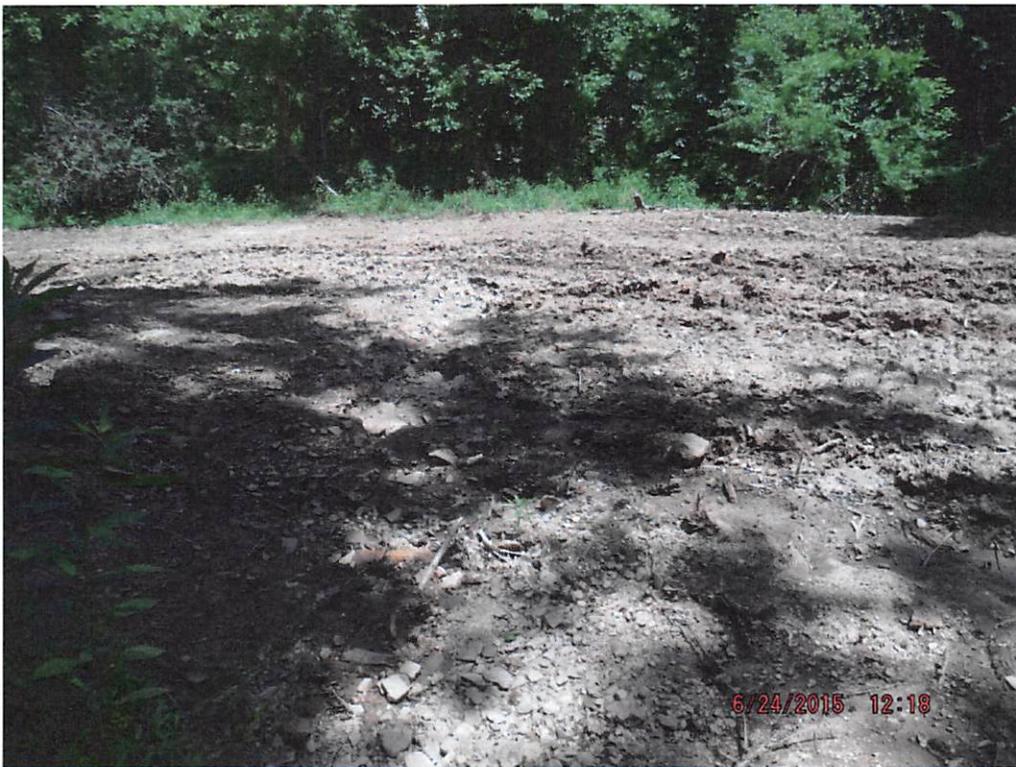
DSCF4149 DSCF4153 DSCF4156	JGT	An UT of Sugar Creek observed to be filled in where the ROW crosses	W-NW-JGT-062415-003
DSCF4181 DSCF4188	JGT	Sediment from stream crossing on an UT of Sugar Creek observed causing Conditions Not Allowable	W-NW-JGT-062415-004
DSCF4228 DSCF4237 DSCF4244 DSCF4251	JGT	Sediment from stream crossings on UTs of Sugar Creek observed causing Conditions Not Allowable	W-NW-JGT-062415-005

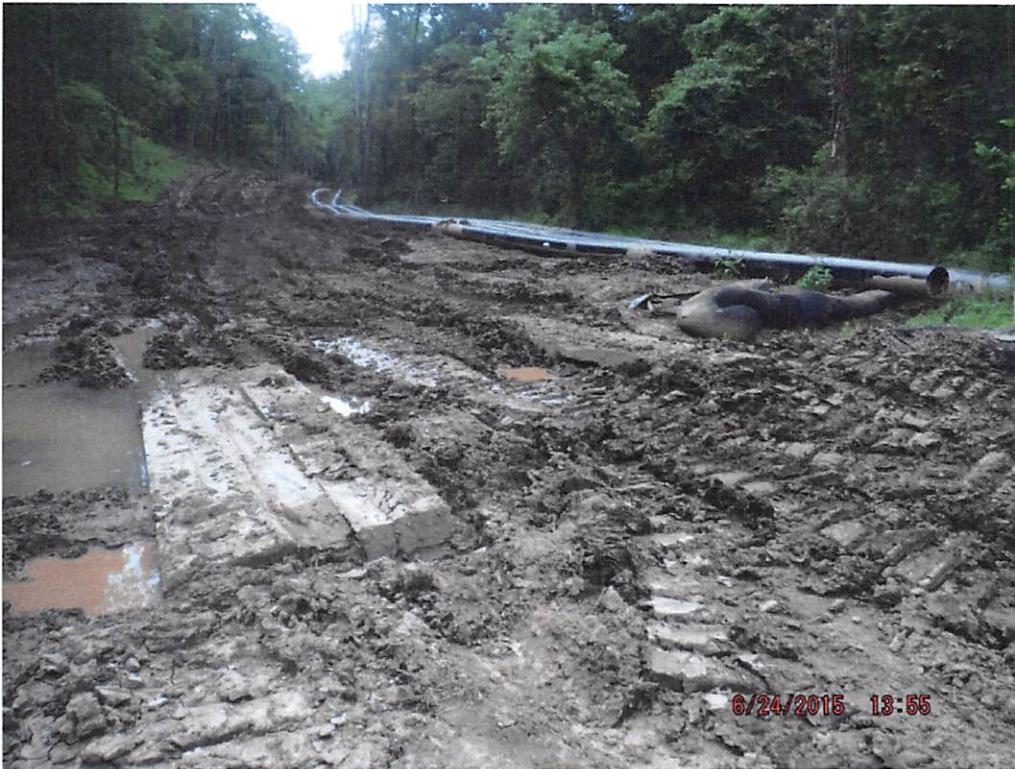
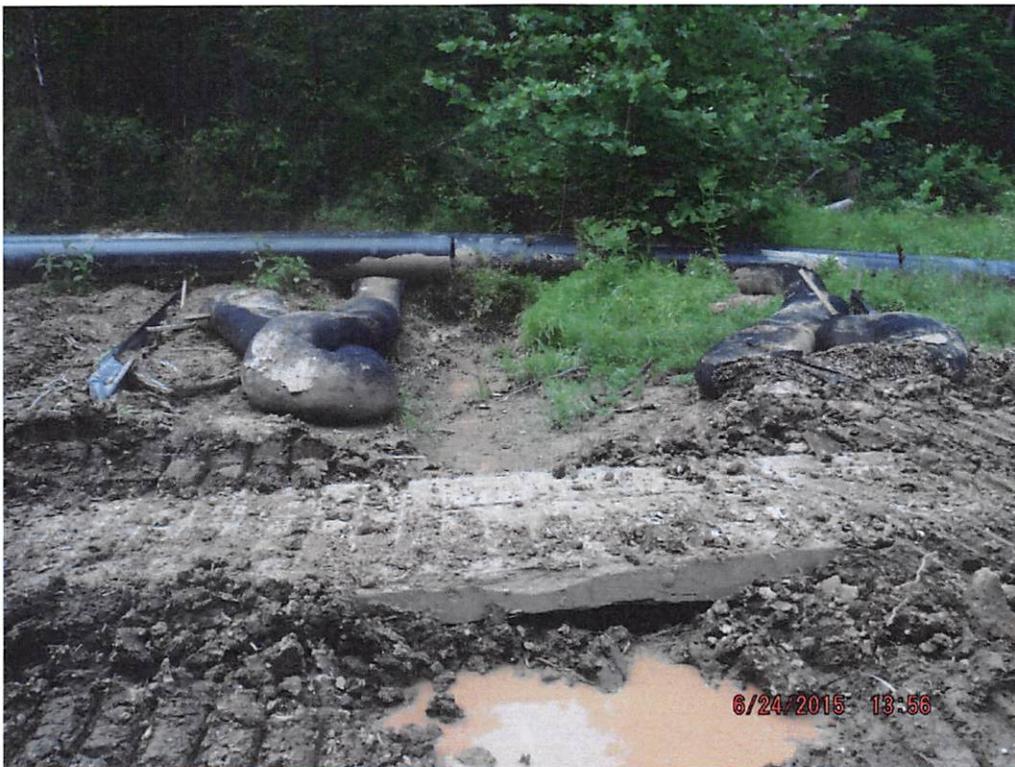
DSCF4271 DSCF4274	JGT	Sediment from stream crossing on an UT of Sugar Creek observed causing Conditions Not Allowable	W-NW-JGT-062415-006
DSCF4303 DSCF4313	JGT	Sediment from stream crossing on an UT of Sugar Creek observed causing Conditions Not Allowable	W-NW-JGT-062415-007
425 428 431	TJK	Sediment from stream crossing on Stouts Run observed causing Conditions Not Allowable	W-NW-TJK-062415-001
437 441	TJK	Sediment from stream crossing on Riggs Run observed causing Conditions Not Allowable	W-NW-TJK-062415-002
DSCF4402 DSCF4408	JGT	Sediment observed leaving ROW through unmaintained silt fence and entering into an UT of Sugar Creek causing Conditions Not Allowable	W-NW-JGT-062515-001
DSCF4457 DSCF4466	JGT	Sediment observed leaving ROW through unmaintained	W-NW-JGT-062515-002
DSCN2130 DSCN2131	TAM	Upstream and downstream views of stream crossing on an UT of McKim Creek where sediment was observed causing Conditions Not Allowable	W-NW-TAM-062515-001

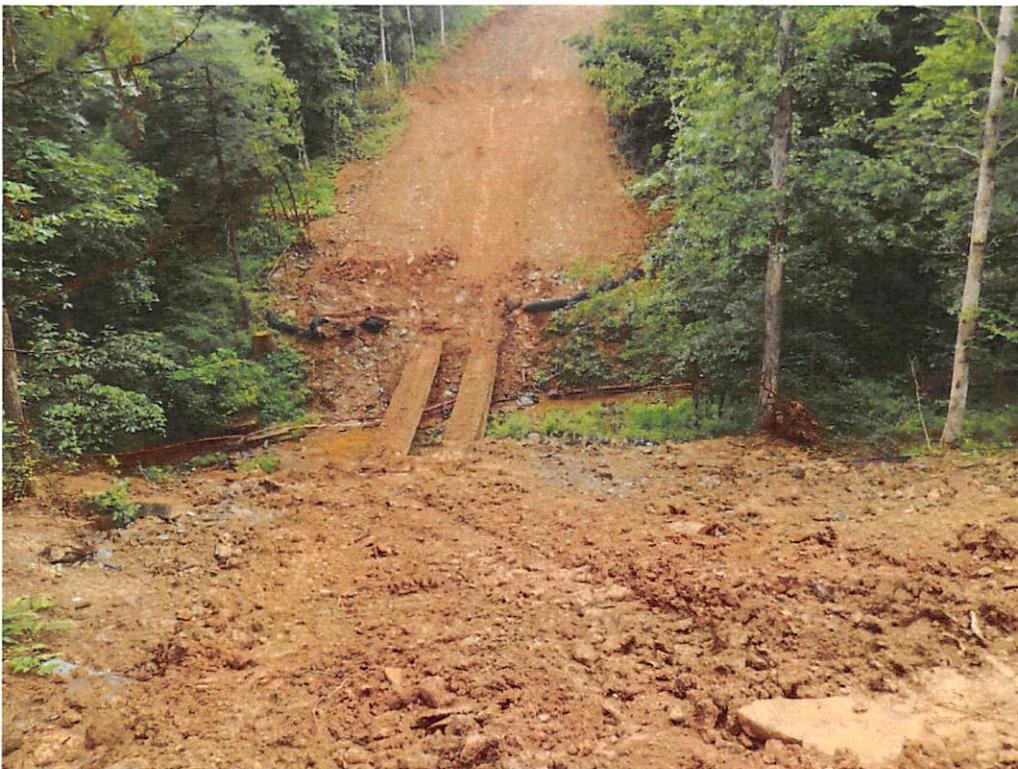
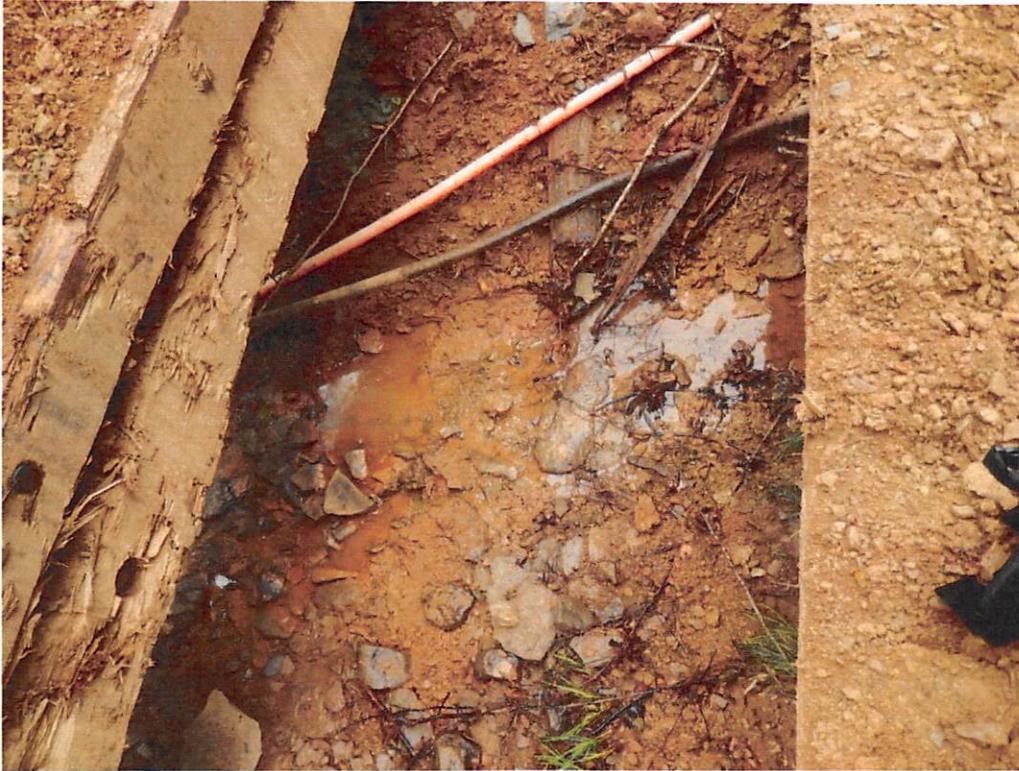
DSCN2143 DSCN2150	TAM	Sediment from stream crossing on Grimes Run observed causing Conditions Not Allowable	W-NW-TAM-062515-002
447 449	TJK	Sediment from stream crossing on an UT of Middle Island Creek observed causing Conditions Not Allowable	W-NW-TJK-062515-001
DSCF3829 DSCF3832 DSCF4500	JGT	BMPs not installed where required by approved E&S plans resulted in sediment leaving ROW without first going through an appropriate BMP	W-NW-JGT-062515-004
DSCF3908 DSCF3956 DSCF4041	JGT	Lack of a stabilized construction entrance where project crosses CR-3 and CR-28	W-NW-JGT-062515-006
DSCF5435 DSCF5447	TJK	Poorly maintained silt fencing Silt fencing not entrenched into the ground	Warning
DSCF5564 DSCF5568 DSCF5570	TJK	Sediment deposits in an Unnamed Tributary (UT) of Riggs Run. Poorly constructed timber mat stream crossing allowing sediment to enter into an UT of Riggs Run.	W-NW-TJK-081115-001
DSCF5570	TJK	Poorly constructed timber mat stream crossing allowing sediment to enter into an UT of Riggs Run	W-NW-TJK-081115-002
