**CONSENT ORDER
ISSUED UNDER THE
WATER POLLUTION CONTROL ACT
WEST VIRGINIA CODE, CHAPTER 22, ARTICLE 11**

ORDER NO.: 7511

1. OCDA operates a construction site with land and stream disturbance commonly known as Wheeling Water Supply Contract 13 (Elm Grove Pumping Station) and Contract 14 (Water Transmission) located in Wheeling, Ohio County, West Virginia. On September 14, 2010, OCDA was issued WV/NPDES General Water Pollution Control Permit for Stormwater Associated with Construction Activities (WV0115924), General Permit Registration No. WVR105008, with an expiration date of December 4, 2012. This permit is for 21.9 acres of disturbance.
2. On October 11, 2011, West Virginia Department of Environmental Protection (hereinafter, “WVDEP”) personnel conducted an inspection of the OCDA Wheeling Water Supply construction site and observed OCDA and/or its contractor and/or assigns working within Wheeling Creek. The following observations were documented:

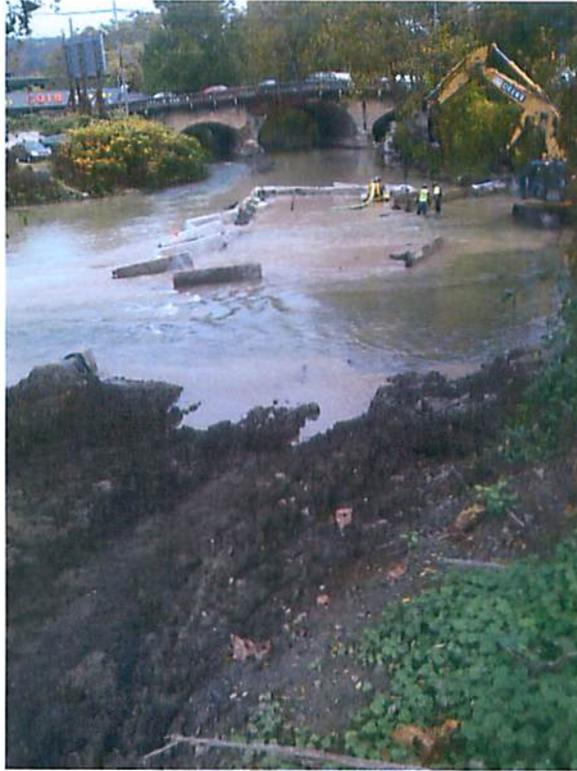
Photo 1:

Heavy equipment in Wheeling Creek creating a plume of sediment laden water. Ingress is not stabilized.

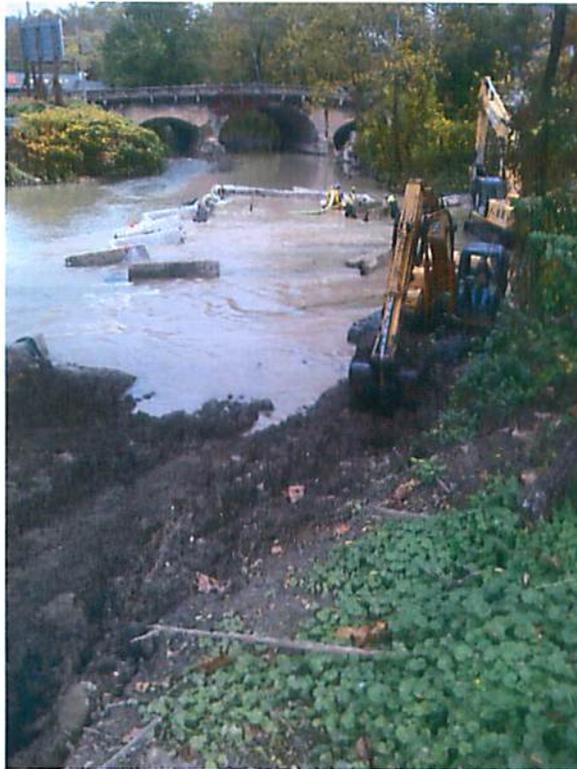
Photo 2:

Heavy equipment removing sediment from ingress area without proper controls. This created a plume of sediment laden water in Wheeling Creek.

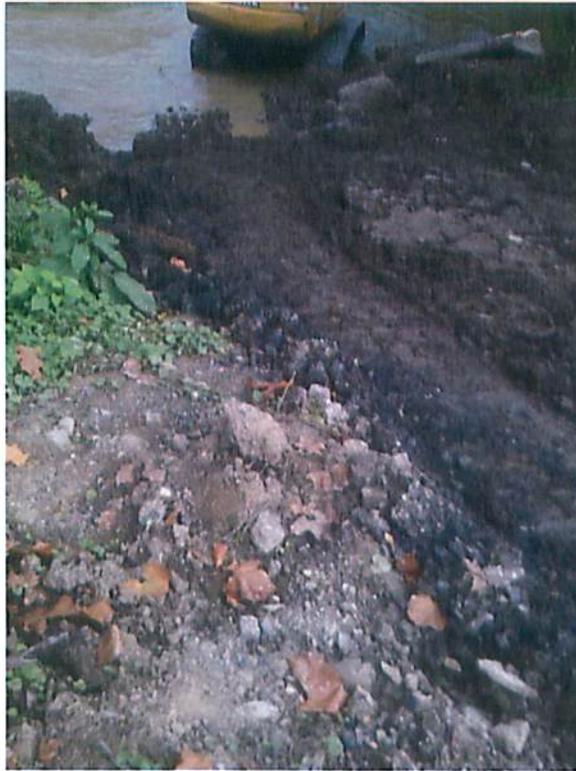
Photo 3:

Ingress for heavy equipment is not stabilized.

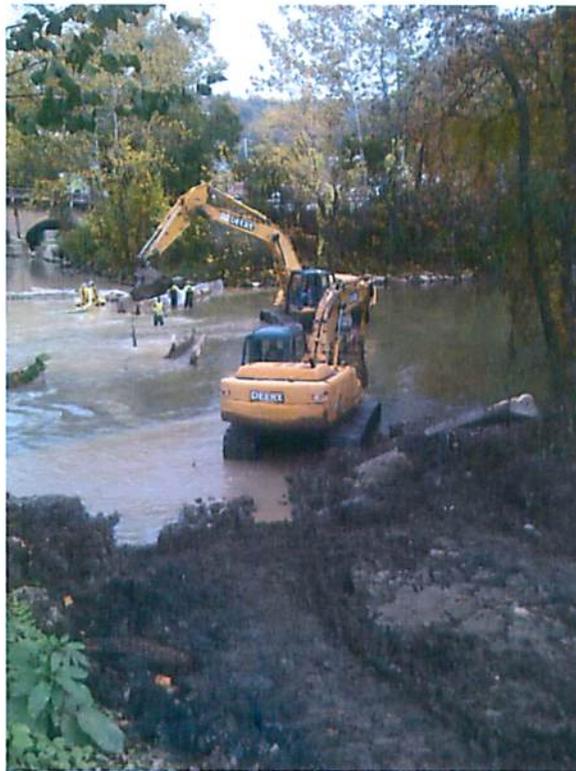
Photo 4:

An excavator entering Wheeling Creek is creating a plume of sediment laden water.

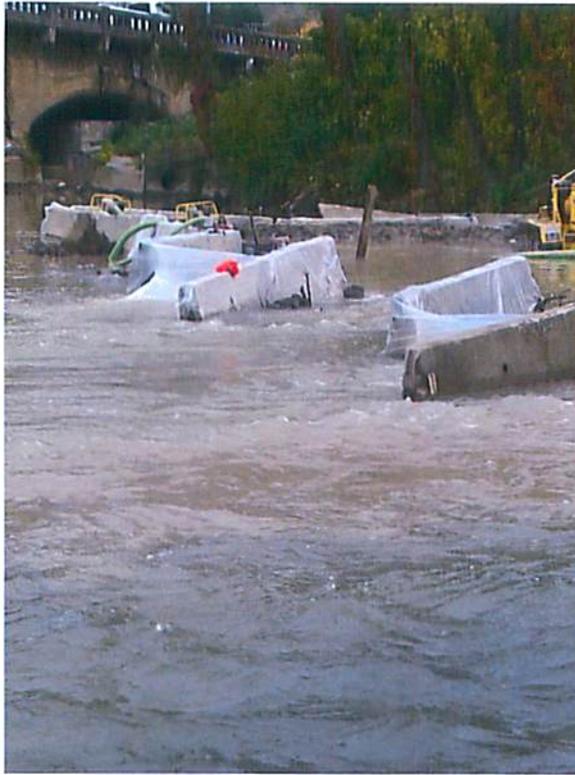
Photo 5:

- e. Concrete barriers (aka Jersey barriers) wrapped in plastic were utilized as an unauthorized temporary work area. Specifically, the barriers were not constructed in a manner to contain sediment laden water in the work area, the plastic was inappropriately stabilized with sediment, several areas of the plastic were compromised allowing sediment laden water to escape into Wheeling Creek, and material used to divert flow of the stream was an unconsolidated mixture of sand, silt and sediment. All of these deficiencies are violations of the terms and conditions of the Permit, Section G.4.e.2.A.ii.

*K-rails wrapped in plastic.
Plastic has been breached
allowing sediment laden water
to escape.*

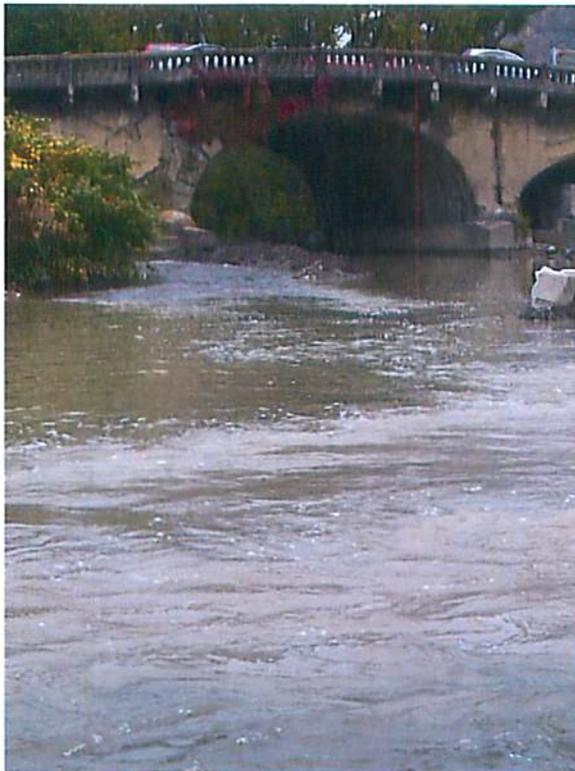
Photo 6:

- c. The material used to divert flow of the stream was a mixture of sand, silt and sediment that had not been stabilized prior to becoming functional, a violation of terms and conditions of the Permit, Section G.4.e.2.A.i.d.

*Temporary fill used to divert the
flow. Fill is comprised of sand,
silt and sediment.*
