REMEDIATION PLAN

**TANK 396 RELEASE
FREEDOM INDUSTRIES FACILITY
CHARLESTON, WEST VIRGINIA**

CEC Project 140-256

April 8, 2014

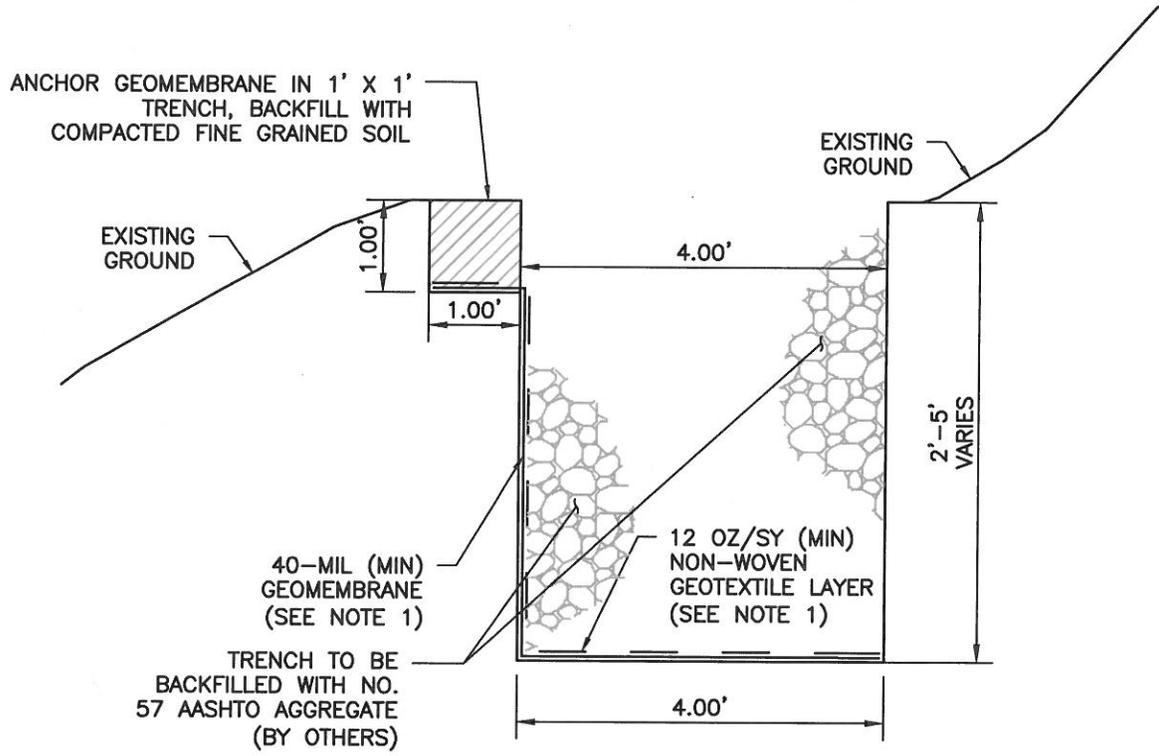
COLLECTION TRENCH
DETAIL

COLLECTION TRENCH
N.T.S.

- NOTES:**
1. GEOMEMBRANE AND GEOTEXTILE TO BE INSTALLED AT BOTTOM AND DOWNHILL SIDE OF CUTOFF TRENCH

Upon completion of the southern-most portion of the Collection Trench/Pond, the central portion of the trench was lowered to cut through the cobble fill and keyed into the clayey soil in order to capture flow from the entire cobble-filled zone. This portion of the trench was also lined with plastic liner and filled with stone (refer to Figure 3). At its lowest elevation point, a perforated

36-inch diameter plastic pipe was installed to serve as a long-term well point/dewatering sump. The remaining portion of the trench to the north was also lined with plastic that was keyed into the clayey soil along the slope so that water seeping from or flowing over the hillside was directed onto the plastic and eventually to the newly installed sump. In its current configuration, the Collection Trench/Pond captures surface water and shallow groundwater flow from the entire portion of the site within the estimated flow path of the release. Routine pumping has been conducted at the Collection Trench/Pond to keep it dewatered and to contain remaining MCHM-impacted water onsite. Water collected from the trench is pumped to one of the onsite storage tanks pending approval for treatment and/or offsite disposal.

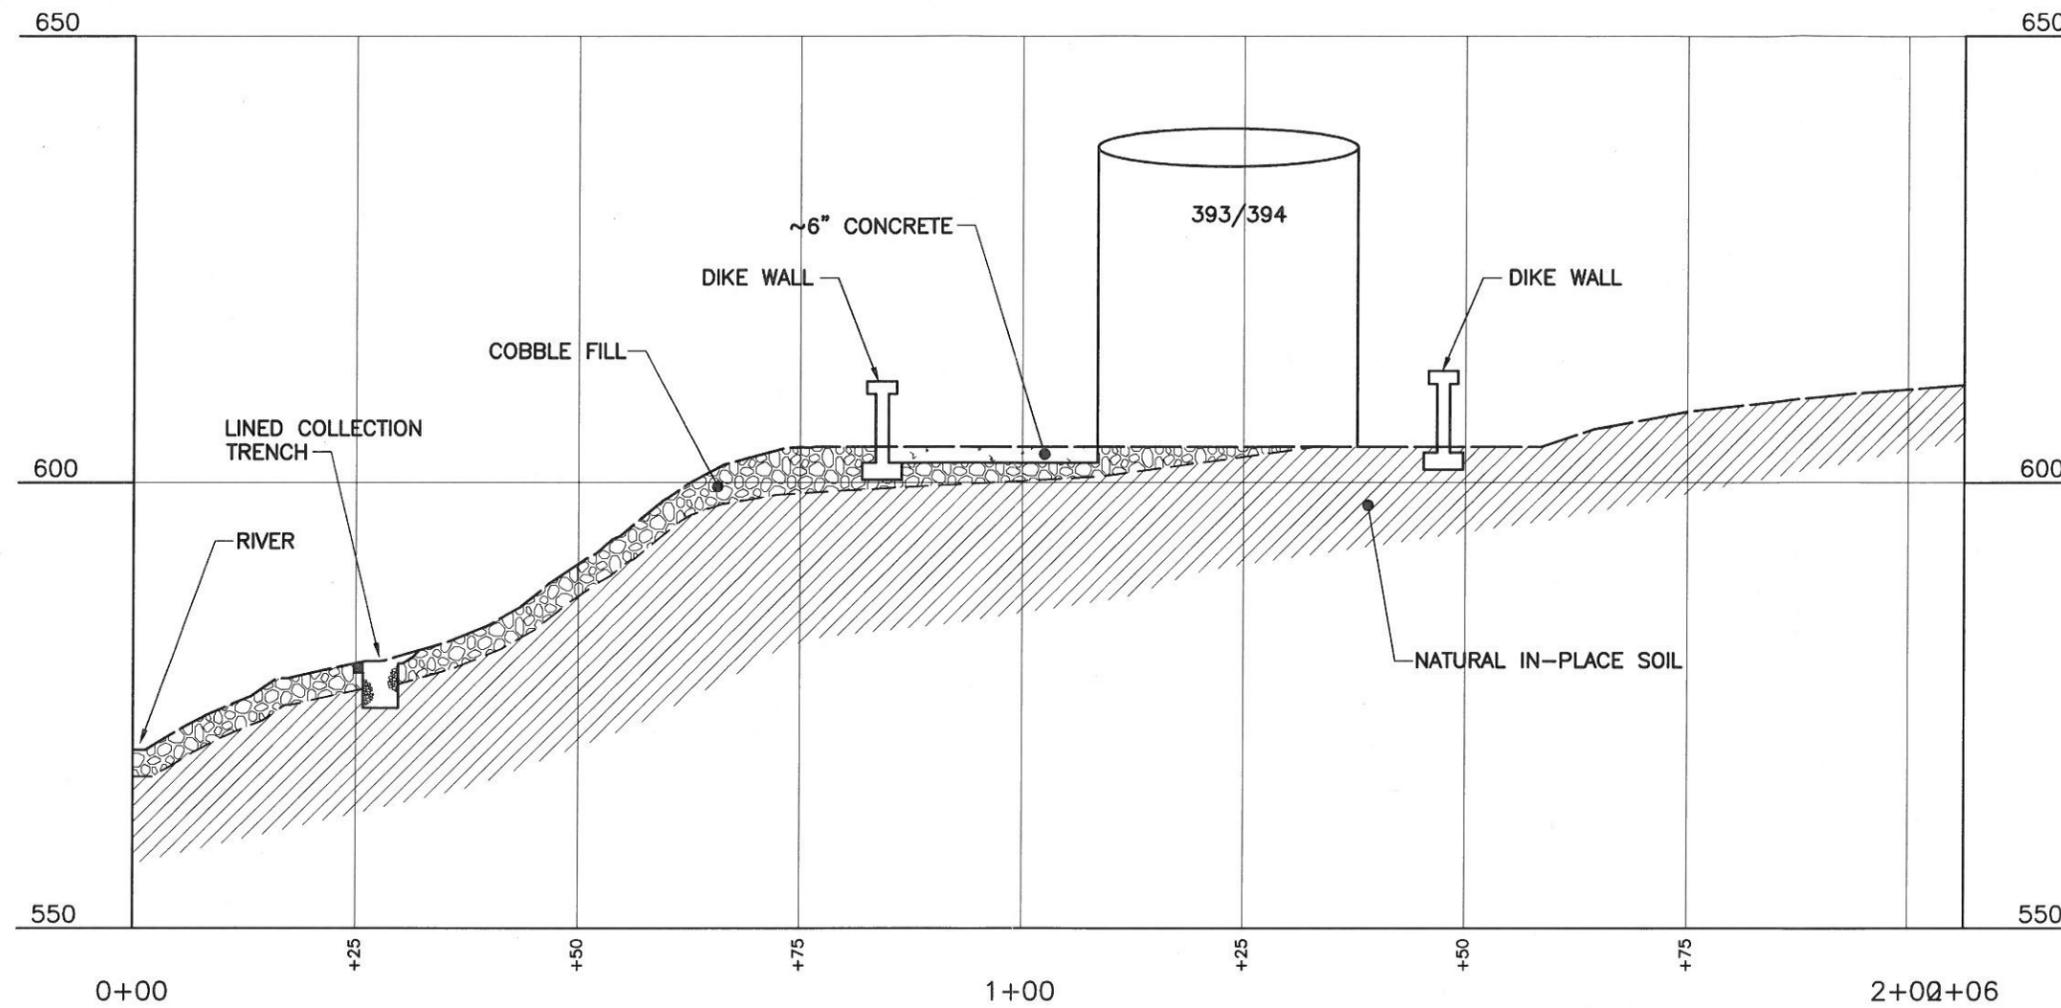
COBBLE FILL AREA CROSS-SECTION

SCALE H:1"=20'; V:1"=20'

As indicated above, the initial focus of interim remedial measures included lowering the portion of the Collection Trench/Pond that extended through the cobble fill area (refer to Figure 1). Prior to completing this effort, however, the southern-most portion of the Collection Trench/Pond needed to be lined and filled with stone to allow a track hoe to access the portion that cut through the cobble fill. This southern-most portion of the Collection Trench/Pond was lined with plastic, equipped with a drainage/extraction pipe for future pumping to keep the trench dewatered, and filled with stone.
